Condominium Capital Needs Assessment and Replacement Reserve Analysis

Bay Square Condominiums
Cambridge, MA

May 24, 2011

Final Report

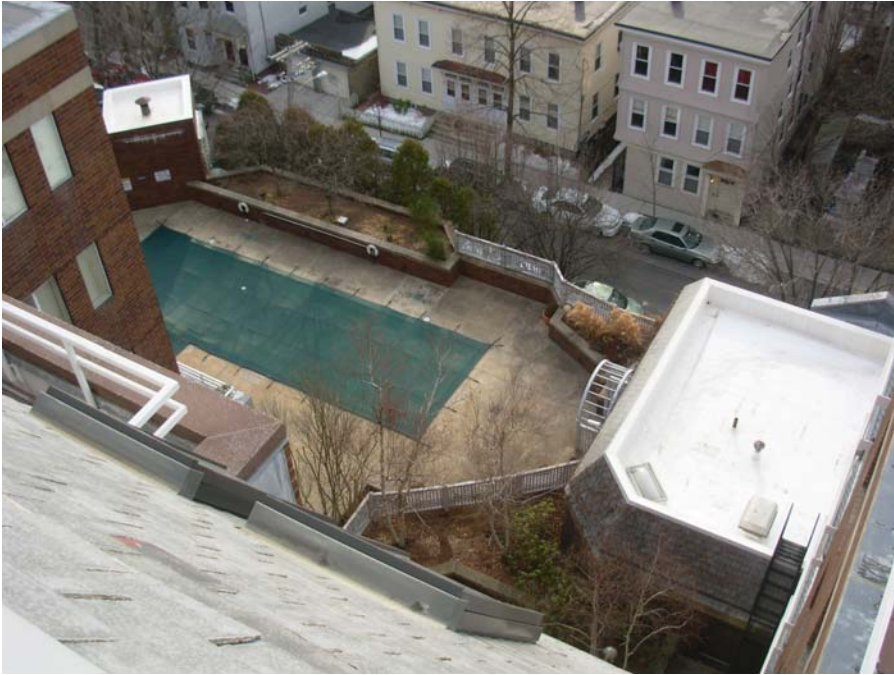
2. ***Courtyard Areas, Planters, Walks, Pool Deck*** - Two courtyard areas (the front Mass. Ave. courtyard and the rear south facing courtyard and pool area) provide exterior common areas for the residents. The front courtyard area along Mass. Ave. has a network of concrete walks that display minimal cracking and spalling. Periodic repair allowances are shown in the plan. The south courtyard and pool deck areas have several garden planters that are bordered by low brick retaining walls. These south courtyard and pool deck areas are located above the parking garage below. At least one of the planters is allowing water to infiltrate down into the garage spaces. Per discussions with site staff, deconstruction and re-building of the suspect planter structure is anticipated in 2011, and budgeted costs are shown accordingly. Future allowances for addressing anticipated garden planter water infiltration problems are shown in Years 5, 13, and 17. Brick pavers and concrete in the south courtyard area and concrete decking surrounding the pool/spa are included for repair, as needed, as part of the anticipated future planter work.

1. Overhead view of pool area and south courtyard. Note planters.

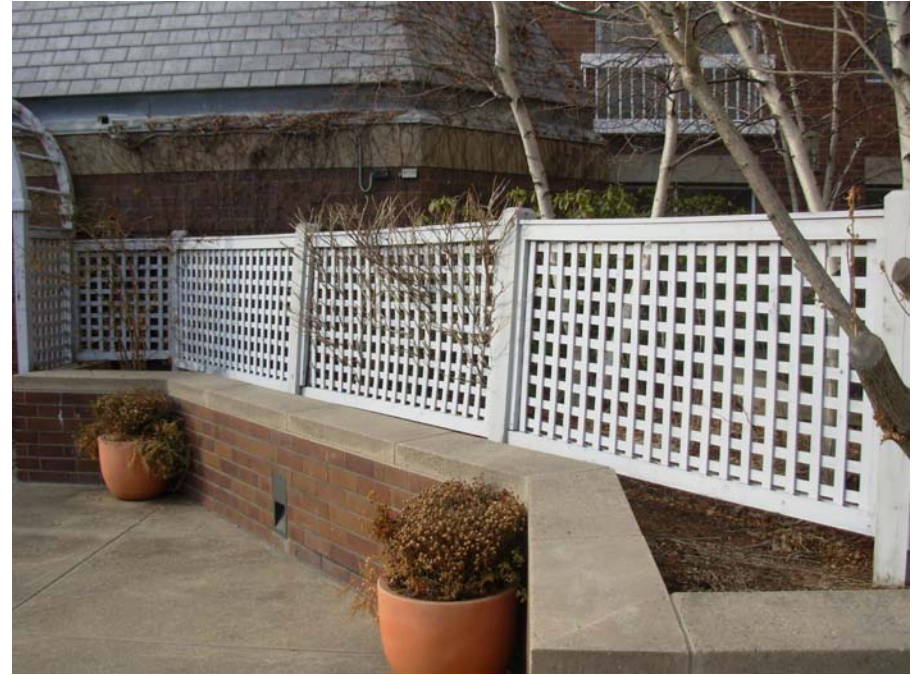
3. ***Fencing*** - Wood basket weave fencing partitioning the pool area from the south courtyard area is in deteriorating condition. Some leaning and damage were observed. Repairs and painting are handled from operations. Costs to replace this fencing are shown in Year 1. PVC privacy fencing was recently installed at the Green Street unit patio areas. Repair and powerwashing of this fencing would be handled from operations. Future replacement is shown in Year 18.

2. Deterioration and leaning of pool area fencing.

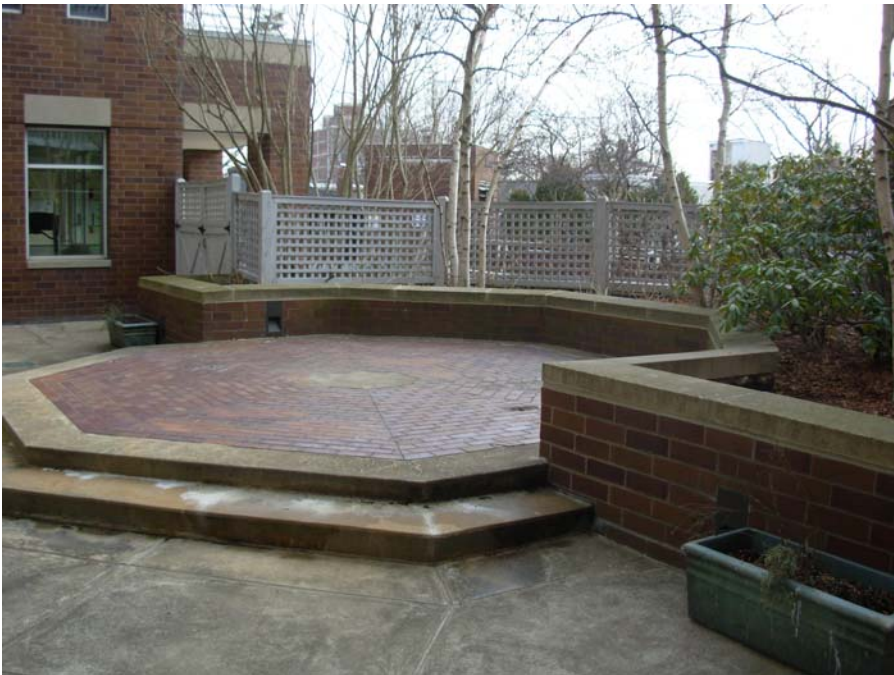
3. South courtyard platform and planters, source of leak concerns.

Retaining Walls	75 lf	_____	\$0	23	30+	_____	Wall along Bay Street - recently re-pointed. Monitor.	
	7 ea	Preliminary Bid Costs	_____	_____	_____	_____	South courtyard garden planters - 1 planter to be re-built in Yr 1 to address water infiltration into garage. Future allows.	
Garden Planters	1 ls	70000.00	\$70,000	23	30+	1 /5 /13 /17 in 1 Year	Wood basket weave fencing and gates at pool area.	
		High Costs per Mgmnt.	_____	_____	_____	_____	Spot deterioration, leaning, damage. Repaired - Optg. Replace.	
Fencing (Wood)	115 lf	130.43	\$15,000	23	20+	1 in 1 Year	Metal fencing along perimeter of Mass. Ave. courtyard.	
Fencing (Metal)	175 lf	_____	\$0	23	50+	_____	Good overall conditions. Repair and painting - operating.	
Fencing (PVC)	110 lf	37.50	\$4,125	1	15+	18 in 1 Year	PVC privacy fencing, recently installed at patios along Green St. Interim repair and powerwashing - operating. Future replace.

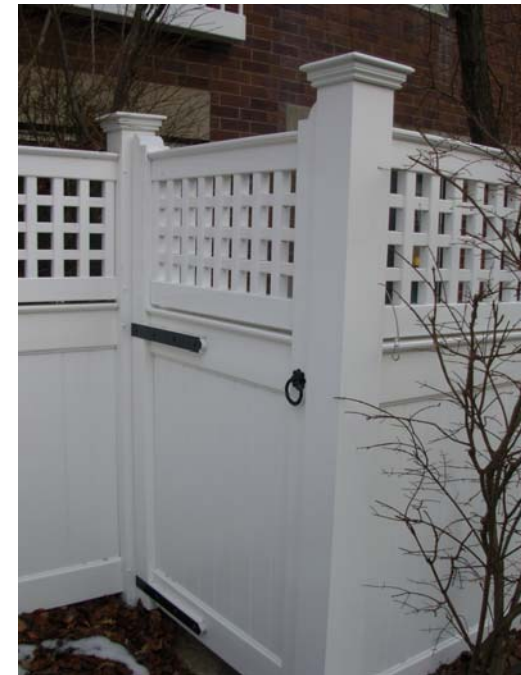
4. PVC privacy fencing at Green Street patios.

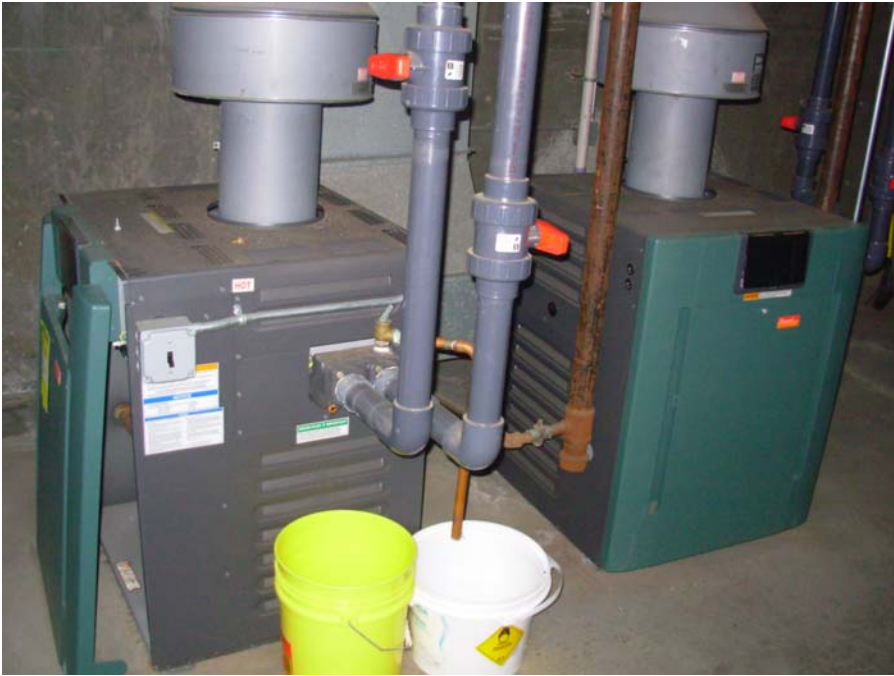
5. RayPak heating boilers serving the pool and spa.

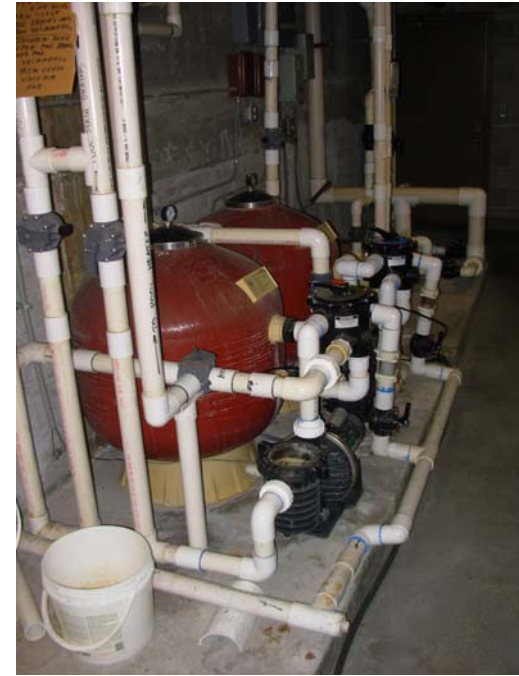
12. **Sauna and Pool/Spa Equipment** - The restroom/locker facility sauna heaters have recently been replaced. Future costs for replacement are shown in Year 13. The pool and spa filtration, autochlorination, and pumping equipment were replaced in 2005. This equipment is maintained as an operating expense. Future equipment replacement is shown in Year 10.

6. Pool and spa filtration and pumping equipment.

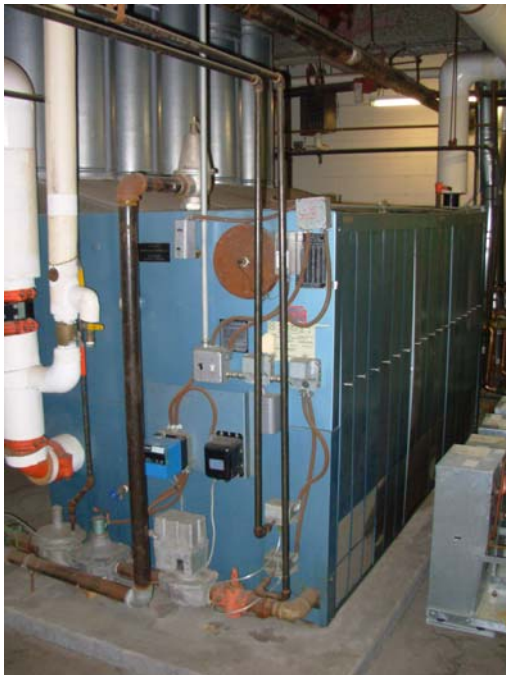
9. **Heating Boilers** - The RayPak swimming pool and spa heating boilers were recently replaced. Future costs for replacement are shown in Year 17. The building's primary heating is provided by an H.B. Smith boiler, located in a rooftop mechanicals penthouse. This boiler, rated at 3,825 MBH, is maintained under a service and maintenance contract. Future replacement/updating of this boiler plant, including replacement of the heating/cooling loop's heat exchanger and the system's controls, is shown in Year 10. The expansion/pressurization tank which hangs from the ceiling in the boiler room, was observed to be leaking, and site staff anticipates replacement in the near future. Costs for replacement are shown in Year 1.

7. H.B. Smith heating boiler plant.

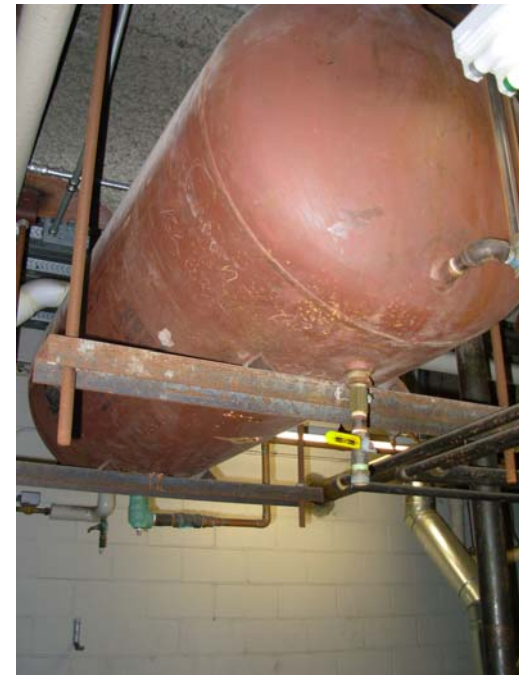
8. Expansion-pressurization tank leaking, to be replaced.

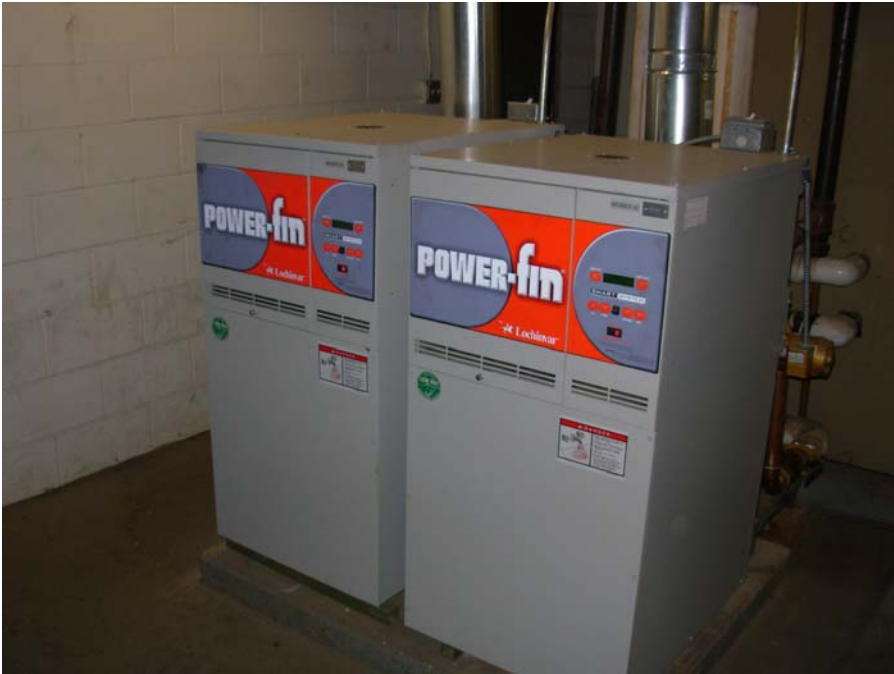
11. **Domestic Hot Water Equipment** - Domestic hot water (DHW) for the facility is produced by two Lochinvar boilers, rated at 500 MBH each. These were recently replaced, and future costs for replacement are anticipated in Year 17. The original, Lochinvar DHW storage tank was reportedly re-lined in 2008. Future allowances to inspect, clean, and re-line this storage tank are shown in Years 7 and 17.

9. Lochivar DHW boilers, recently installed.

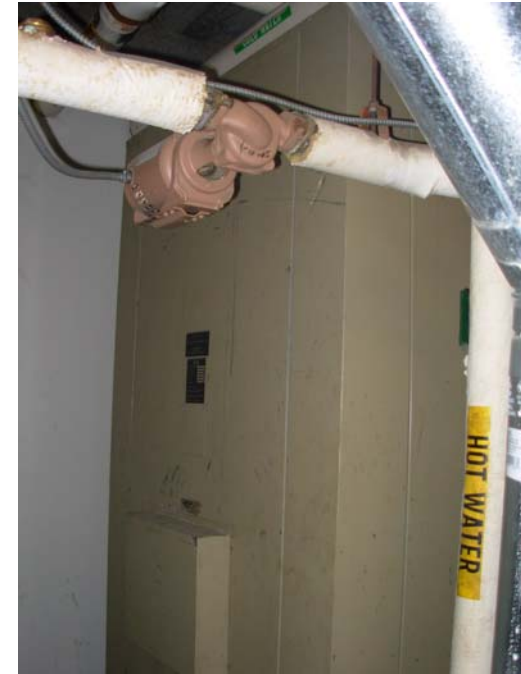
10. Lochivar DHW storage tank, recently re-lined.

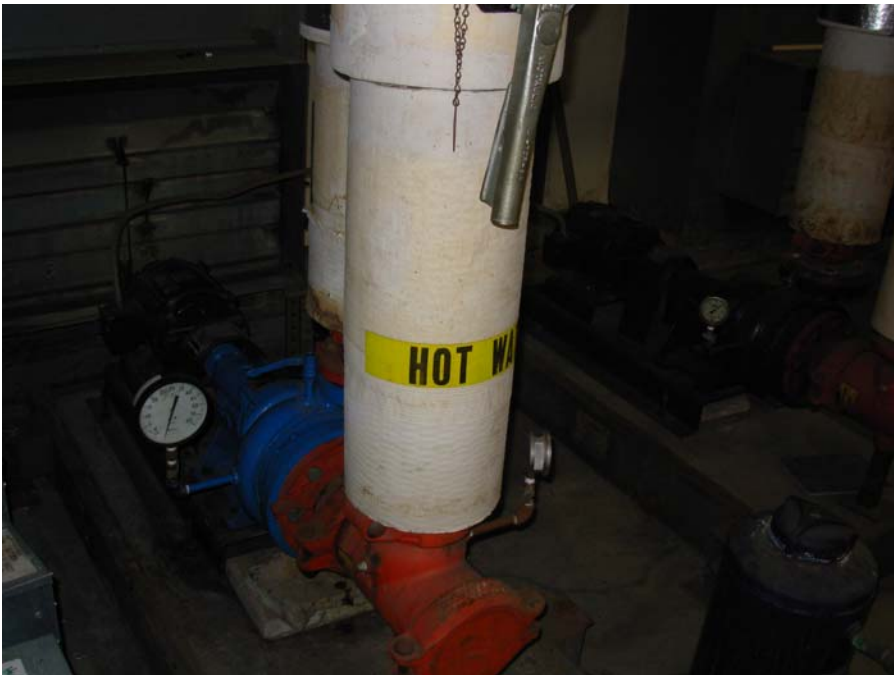
11. Hot water circulation pumps, to be replaced.

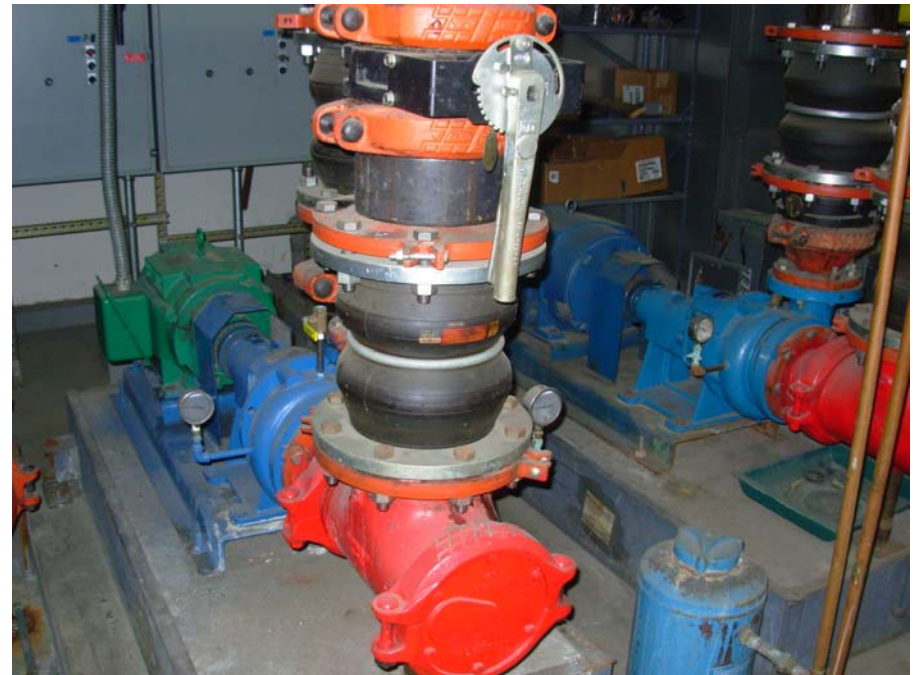
10. **Pumps** - Several pumps that serve the building's heating/cooling loop, circulate cooling tower water, and circulate hot water throughout the facility vary in age. These pumps are generally re-built, as needed, as operating expenses. Site staff noted that the two 5HP hot water circulation pumps are to be replaced in the near future, and costs for this work are shown in Year 1. Periodic allowances for replacement of the higher horsepower pumps serving the building are shown, as needed, throughout the plan. Site staff noted that variable frequency drives (VFDs) may be installed to help moderate overall usage of the higher horsepower pumps, helping control the motors serving these pumping systems. Electricity savings are the desired goal of this possible installation. Costs are shown, pending discussion at client review, for VFD installations. The Syncro-Flo cold water pressure tank and pumps are maintained as operating expenses. Future tank replacement is shown in Year 10.

12. Heating-cooling loop circulation pumps.

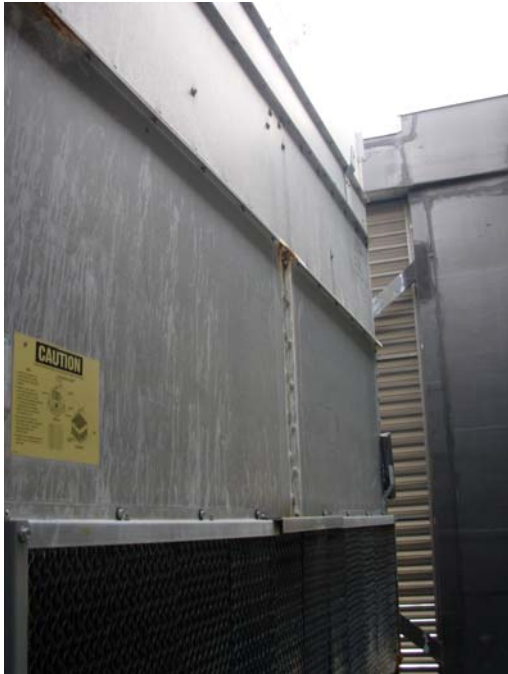
19. *Rooftop Cooling Tower / HVAC Units* - The rooftop cooling tower, which provides air conditioning to most of the facility, is original equipment, displaying spot rusting. This cooling tower is maintained under a service contract, and it is exceeding its expected useful life. Costs for replacement are shown in Year 2 of the plan. The packaged make-up air HVAC units that serve the common hallways have recently been replaced. Future replacement costs are shown in Year 14.

13. Rooftop cooling tower structure.

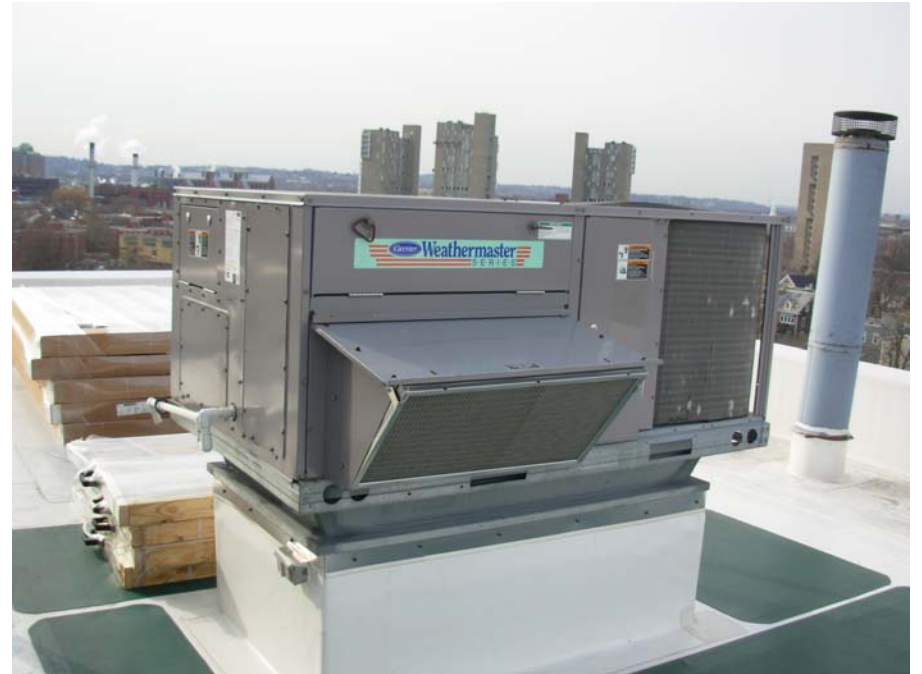
14. Rooftop make-up air packaged units serving common hallways.

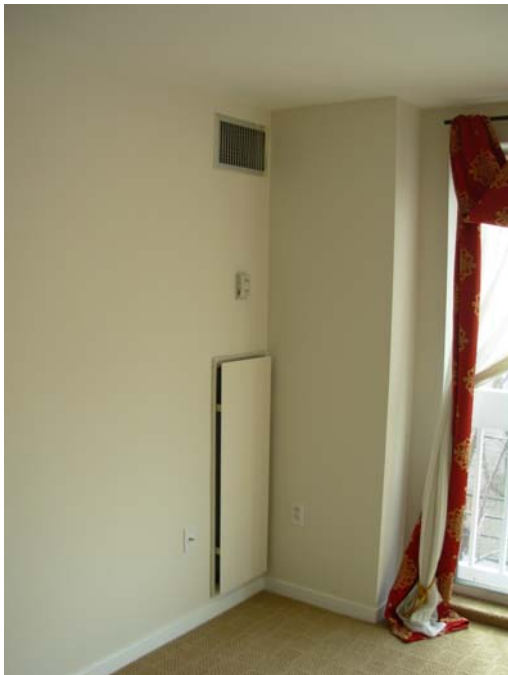
18. *Whalen/Fan Coil Units* - The building's heating/cooling distribution system is tied to Whalen heating/cooling units in the condominiums and in some common areas. Site staff reported that approximately forty of the Whalen unit wall assemblies have been replaced, as they have failed. Costs to continue this replacement work are shown in Years 1-13, with future allowances for those models replaced starting once again in Year 14 of the plan.

15. Whalen units serving condos. and common areas.

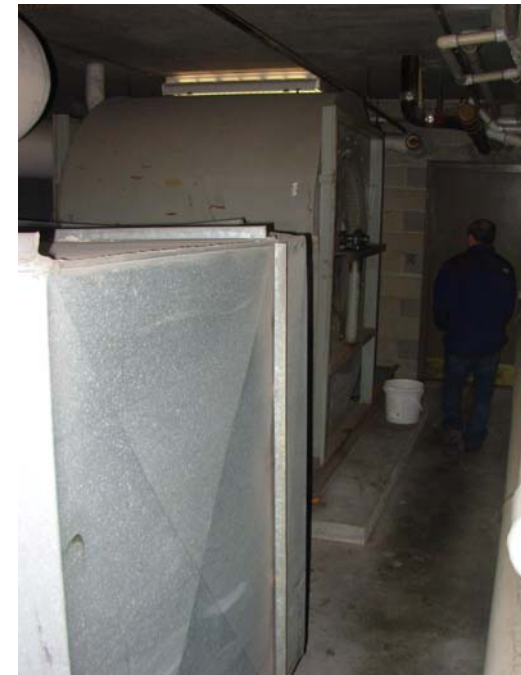
16. Garage intake and exhaust fans.

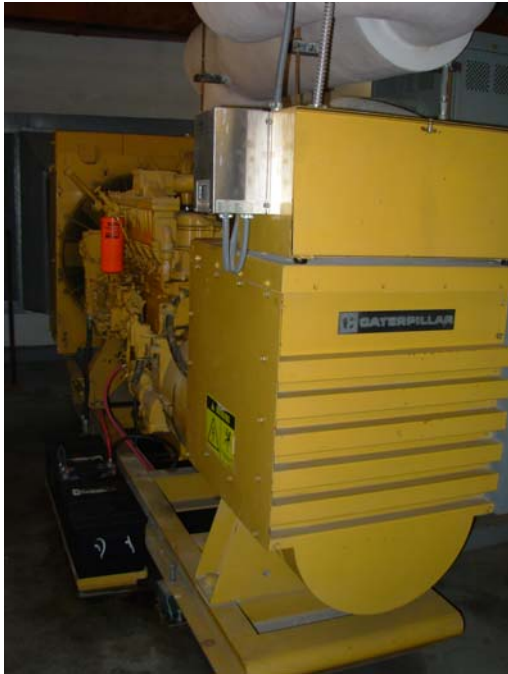
- 21. Building Electrical & Emergency Generator** - The building's electrical switchgear and panels are primarily GE equipment. Infrared scanning of the building's electrical equipment discovered few problems, which have been addressed by the building's electrician. The Caterpillar emergency generator, rated at 300 kW and 375 kva, is located in the rooftop penthouse, and it is protected from the weather elements. The generator is maintained under a service contract, and it is tested regularly. An engine re-building allowance is shown in Year 7. Future replacement of the generator is shown in Year 17 of the plan.

17. View of the Caterpillar emergency generator.

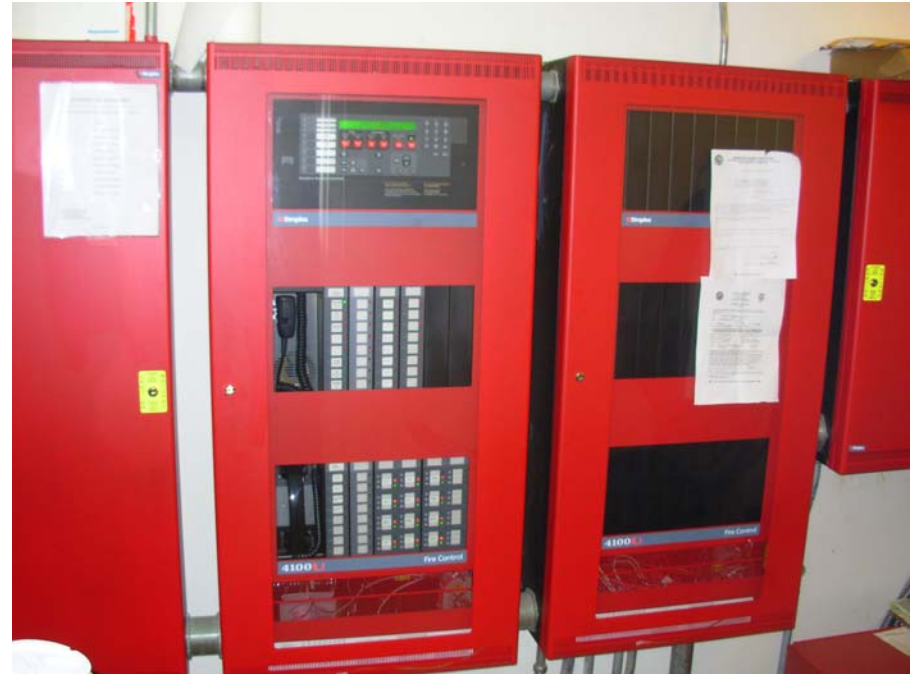
18. Building's main fire detection system monitoring panel.

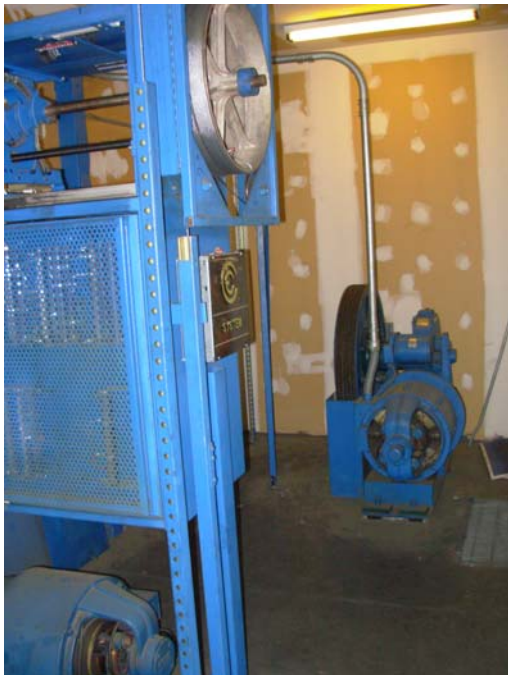
- 24. Elevators** - The building's east and west elevators provide access to each floor of the building, including the garage levels. The original Dover hoist-type equipment is maintained under a full service contract with Advance Elevator. Site staff reported that cab panel and button updates were done in 2005. An evaluation of the elevators by Elevator Consulting Associates recommends updating/upgrading these elevator systems in the near future. Costs for this work are shown in Years 3 and 4 of the plan. The work would include elevator cab upgrades. Future allowances for cab upgrades are shown in Year 18.

19. Elevator machine room equipment.

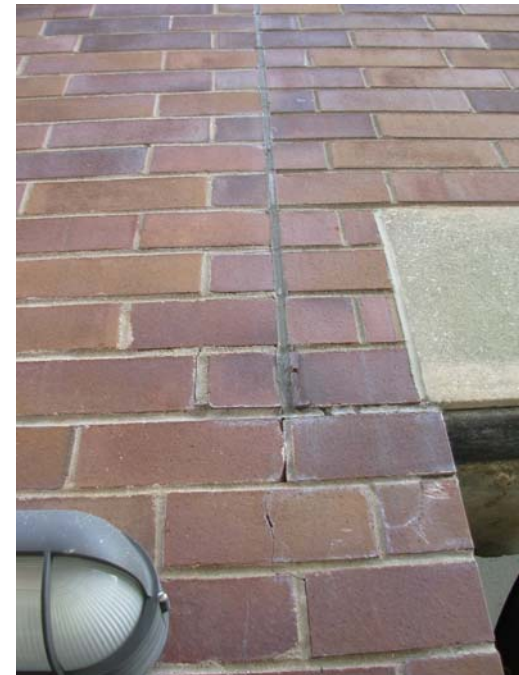
20. Minimal masonry cracking and mortar deterioration.

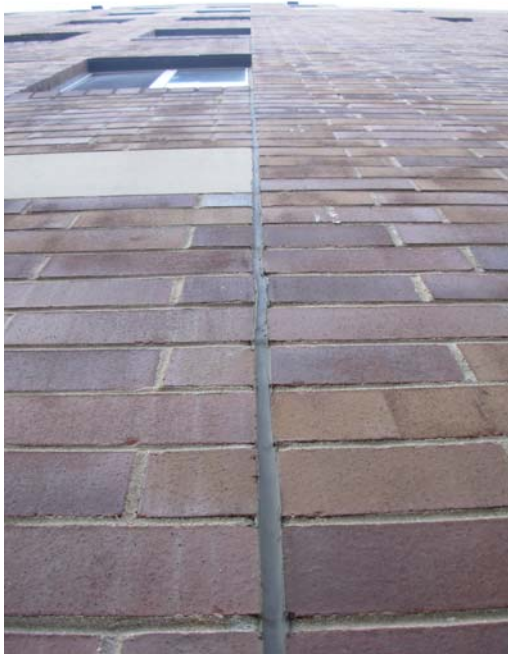
- 29. Building Envelope** - The building's exterior is primarily clad in brick. Sealant filled control/expansion joints were observed around the building. Management representatives noted that the building's envelope was addressed in 2005. This work included spot masonry pointing and replacement of all sealant joints. Good overall conditions were observed, and site staff reported no water infiltration problems. Future costs for inspecting the building envelope, making necessary masonry repairs, and replacement of the sealant joints are shown in Year 14 of the plan. The pergola structure at the south facing courtyard was recently installed, and maintenance is seen as an operating concern.

21. Sealant-control joints recently replaced.

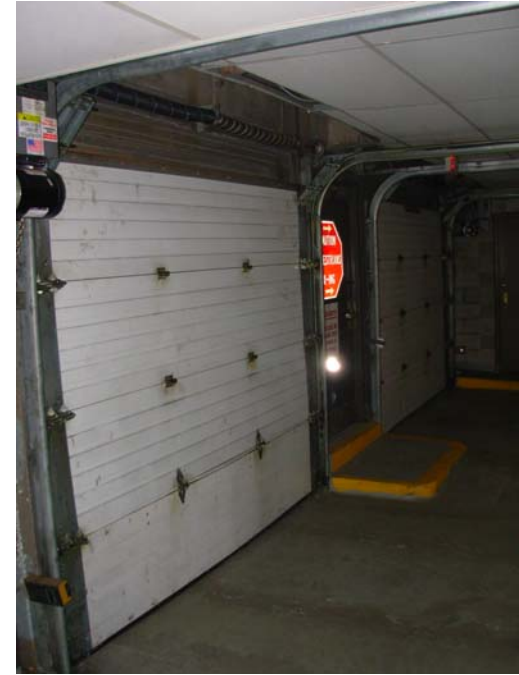
22. Overhead doors serving garage egress and entrances.

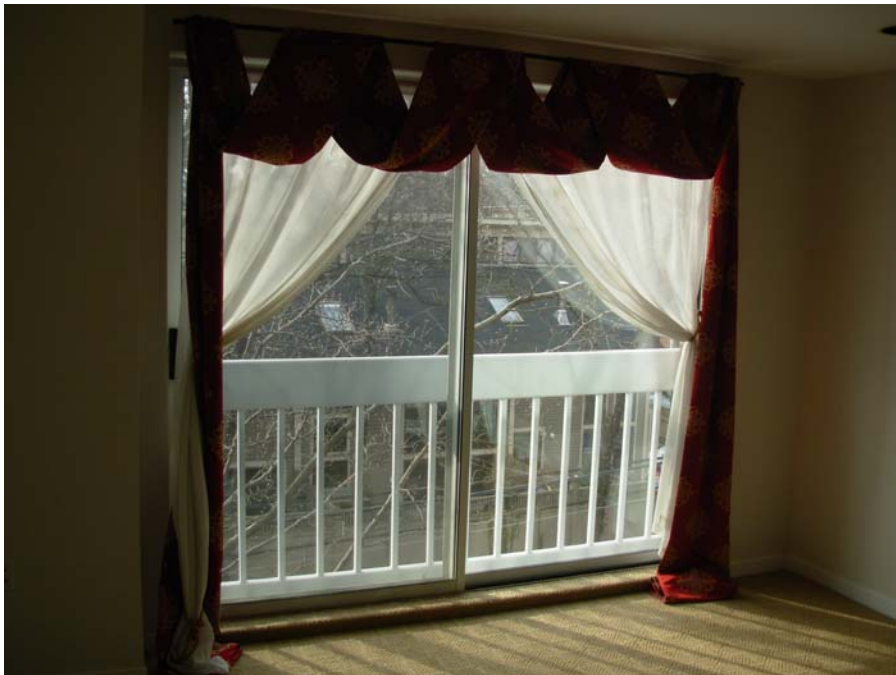
23. Unit sliding glass doors, being replaced over time.

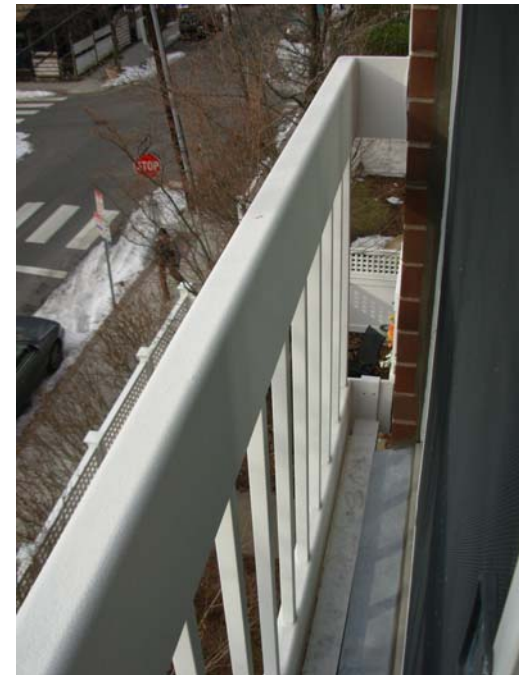
- 30. Railings & Balconies** - Railings at many of the units' sliding glass doors have recently been refinished with the Rhinoshield ceramic coating system. This finishing system is reported to have a lifetime warranty. However, the long-term condition of this finishing system may be questionable. Future allowances for refinishing these railing systems are shown in Years 17-20. There are several unit balconies and patios at the upper floors of the building. The penthouse level balconies have recently had their underlying membrane systems replaced concurrent with the main roofing work. Future replacement is shown in Year 20. The Mass. Ave. roof deck/balcony reportedly had its membrane system replaced concurrent with the building envelope work in 2005. Future costs are shown in Year 14. The south facing lower roof deck/balcony, with an extensive network of pavers, was reportedly addressed in 1999 when the decks were installed. Future membrane replacement is shown in Year 8.

24. Railings recently refinished with Rhinoshield system.

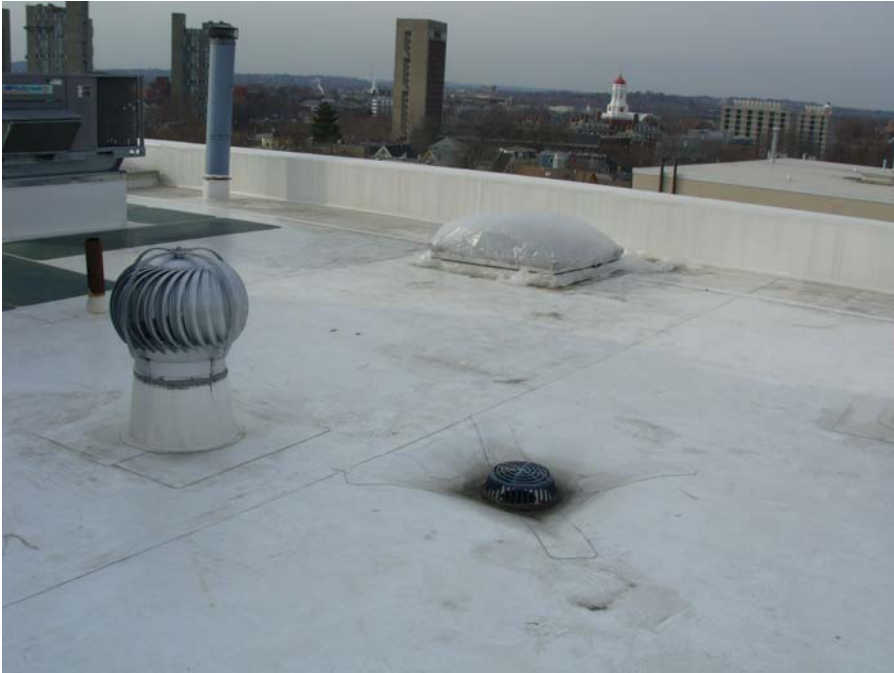
- 32. Roof Coverings** - The main (upper) roof surface was recently replaced with a Sarnafil PVC membrane system. Spot ponding and ice build-up were observed on this roof surface. The roofing system reportedly has a twenty year warranty, and repairs would be addressed through the warranty. Future replacement of this main roof area is anticipated near the end of the plan, and costs are shown in Year 20 accordingly. The south facing lower roof and ventilation tower roofing surfaces have similar PVC membrane systems to that of the main roof. Future replacement is shown in Year 17 of the plan. The pitched mansard type roofing system is covered with a cementitious (faux slate) type roofing shingle system, some of which displays shingle slippage, shifting, and displacement. Periodic allowances for inspection and repair of these pitched roofing surfaces are shown throughout the plan. Roof drainage systems are cleaned and maintained as an operating concern.

25. Main roofing surface, recently replaced.

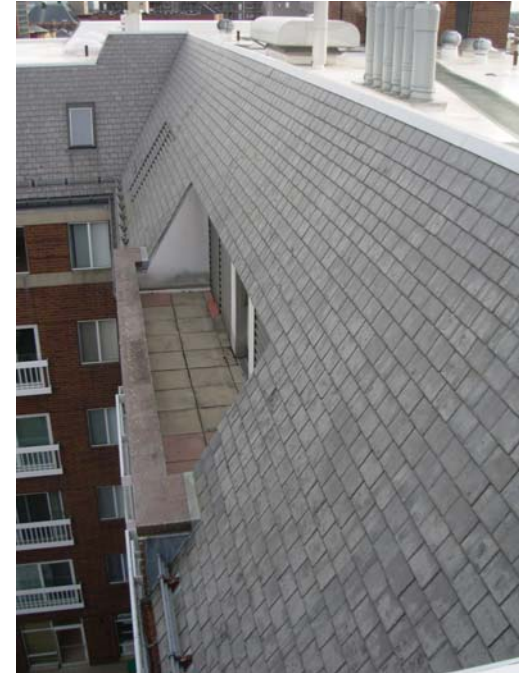
26. Mansard roofing sections.

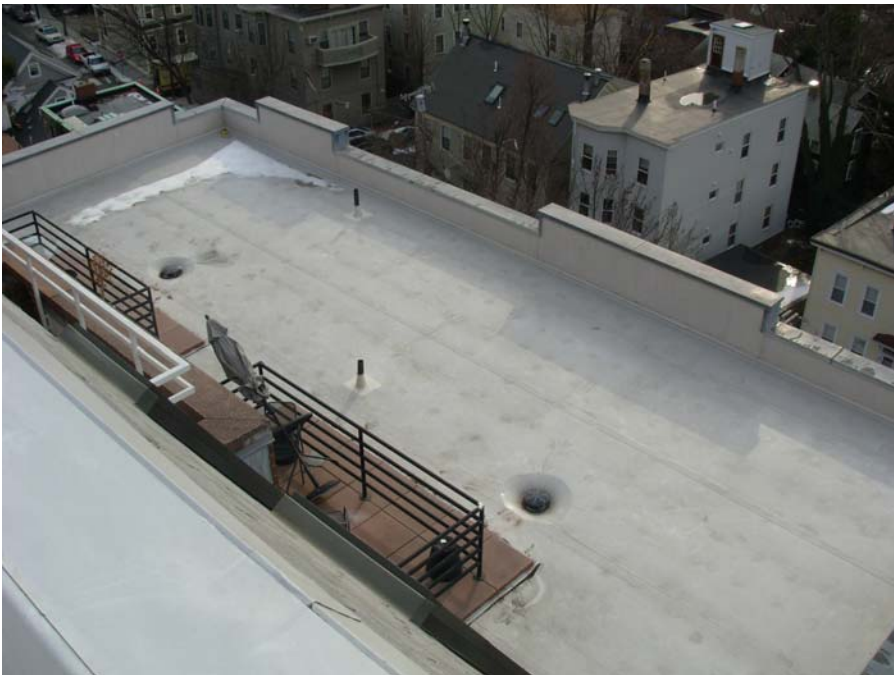
27. Lower roof with unit patios.

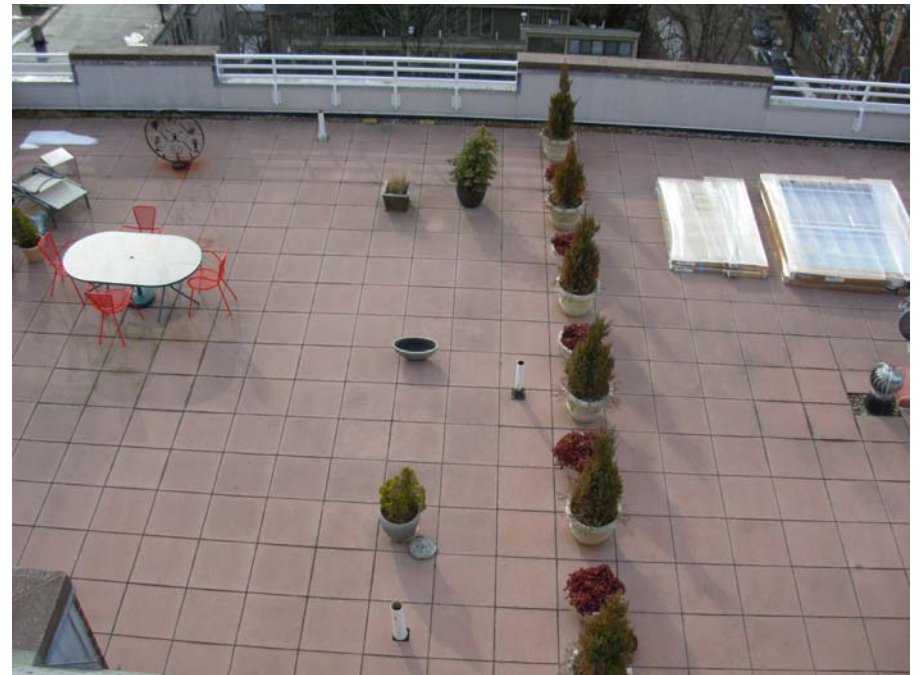
28. South facing unit roof deck with pavers.

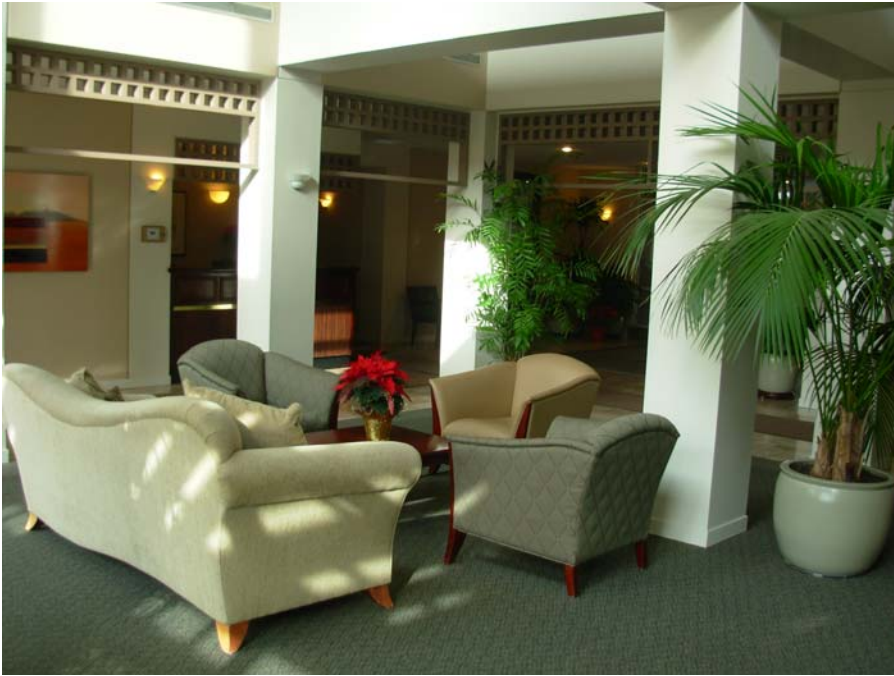
29. View of the lobby and sitting area finishes and furnishings.

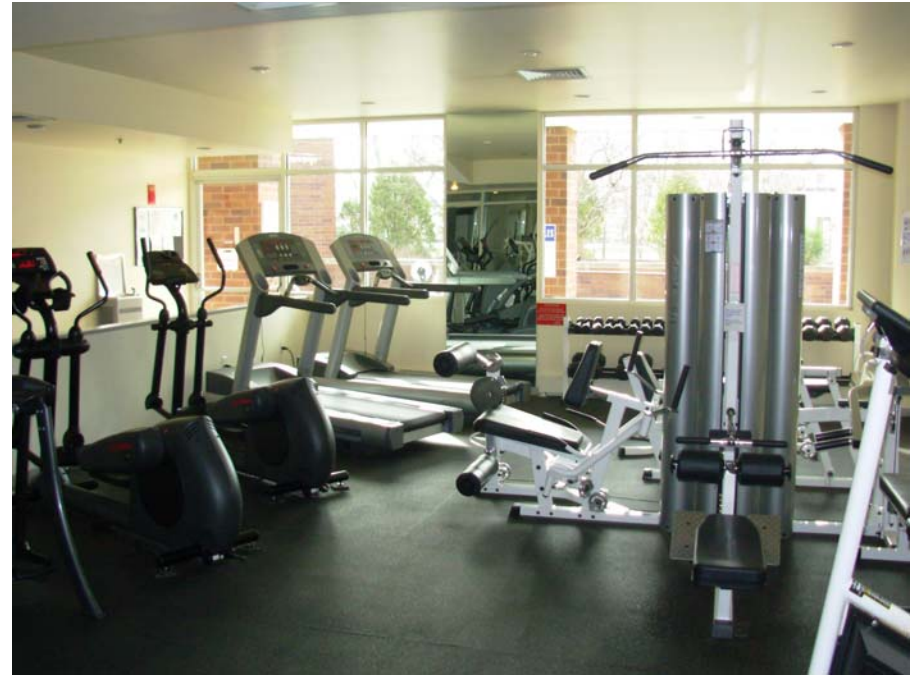
30. View of the fitness center finishes and equipment.

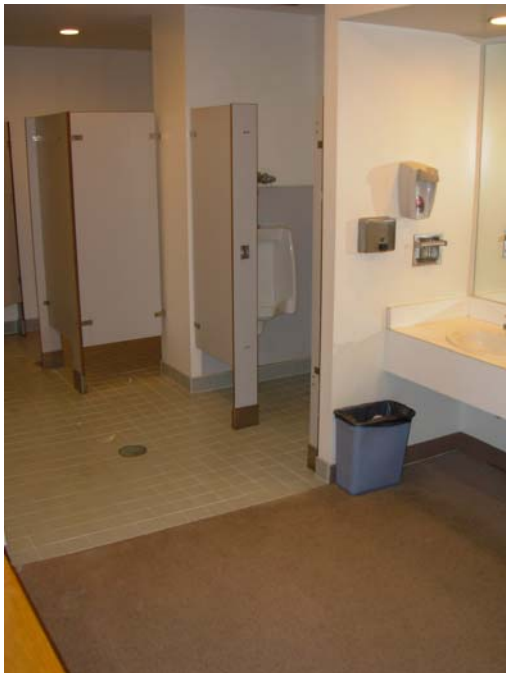
31. View of the restroom - locker room facilities, to be renovated.

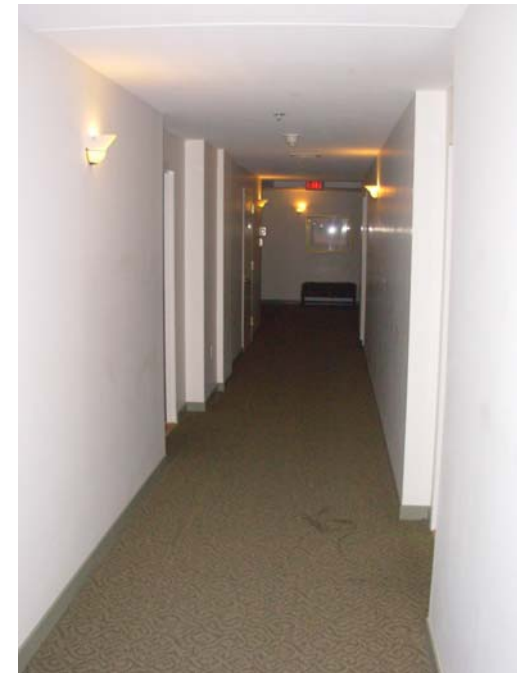
32. Common hallway finishes. Note minimal carpet staining.
