# *Condominium* Capital Needs Assessment and Replacement Reserve Analysis

Bay Square  
Cambridge, MA

March 25, 2016

*Final Report (v.3)*

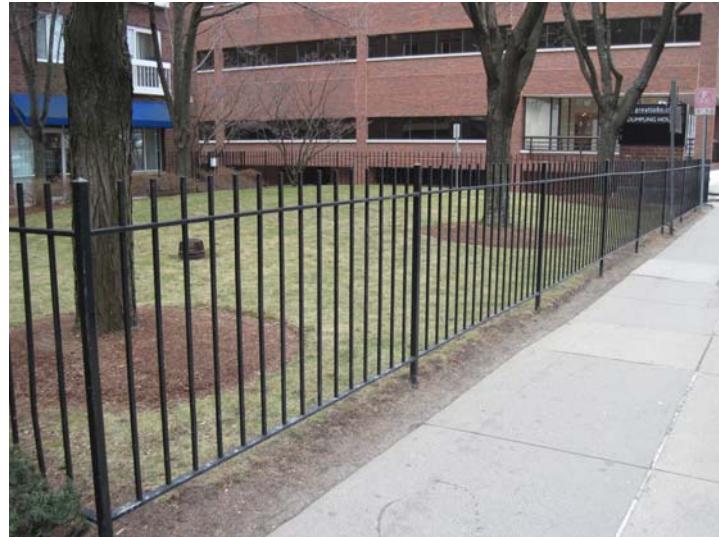
The painted metal fence bordering the front park exhibits overall age and weather-related paint failure; in need of sanding priming, and painting.

6. General paint failure, flaking, and chipping is evident along the entire length of the front courtyard painted metal fence. Costs to sand, prime, and paint the fence are shown in Year 1, with a future refurbishment shown in Year 16.

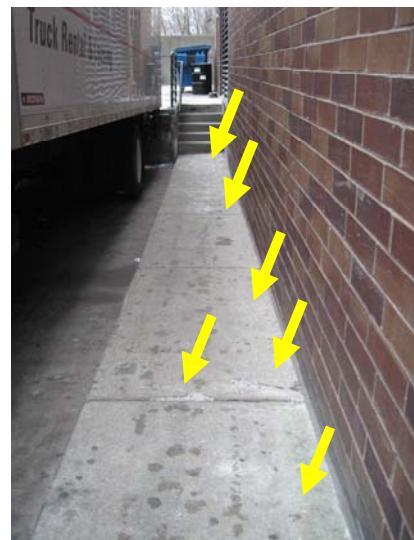
View of the loading and trash removal dock at the building east elevation. Note general surface deterioration and cracking visible at several locations along the walkway.

- 1. Costs for the development's site related elements total \$263,499 or \$2,635 per % of B.I. in inflated dollars.**
2. The east elevation driveway concrete surface, adjacent walkway, and loading dock exhibit age and use related wear with several large sections of deterioration in need of repair. Costs to sectionally repair and resurface the drive and loading dock are shown in Year 1. Costs to apply a protective epoxy coating to the loading dock platform are shown in Year 1, with a re-application shown in Year 11.
3. Costs to remove and re-pour the elevated concrete walkway adjacent to the loading dock driveway are shown in Year 1.
4. The concrete pool deck and rear courtyard surface is in generally good condition with some localized deterioration noted. Periodic costs for as-needed sectional repairs and resurfacing are shown every five years starting in Year 1.

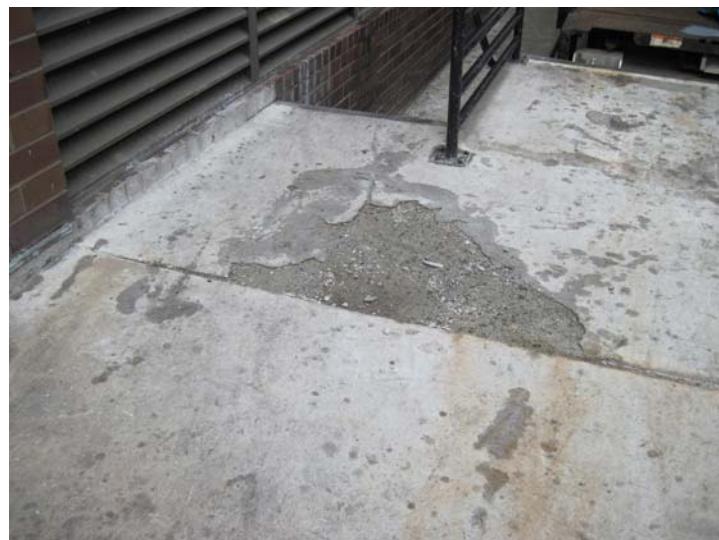
Sectional concrete deterioration and cracking is visible on the loading dock surface as well.

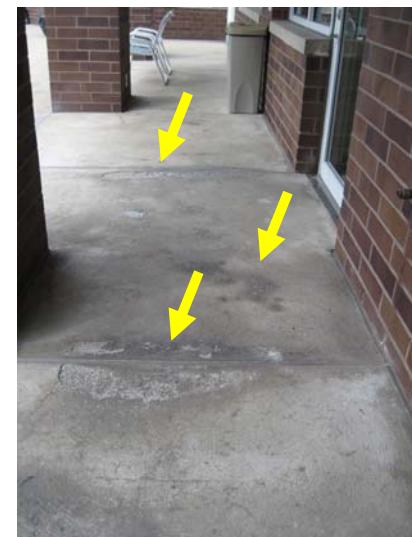
Sectional concrete surface deterioration is visible at the pool area and rear courtyard; in need of sectional repair/resurfacing.

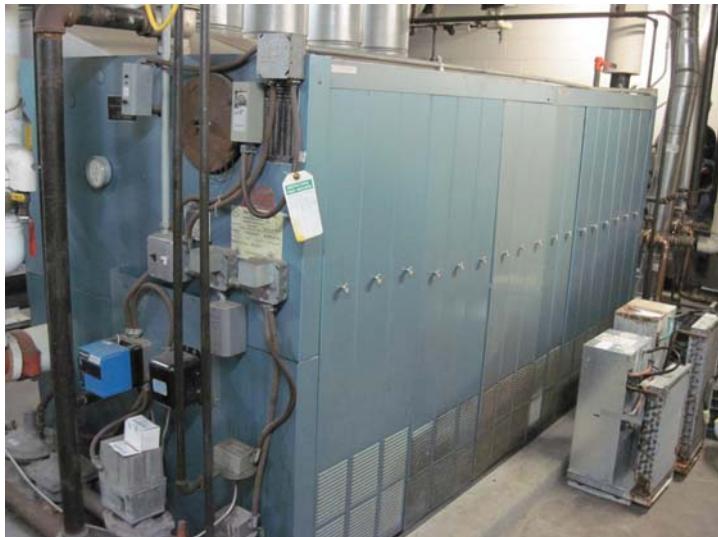
13. No operating issues related to the H.B. Smith cast-iron boiler were reported during the assessment; however this original equipment is approaching the end of its expected useful service life of thirty years. Replacement of the current setup with a series of high-efficiency, natural gas-fired condensing boilers of equal capacity is shown in Year 2.

View of the 3,825 MBH, H.B. Smith sectional cast-iron natural gas-fired hot water boiler serving the two-pipe fan coil unit system.

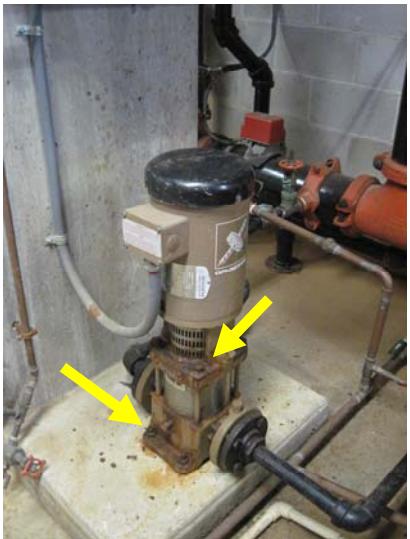
27. Although operational, the aging jockey pump exhibits considerable corrosion at its flange and base; and replacement is shown in Year 1.

The ageing 2-horsepower fire-suppression system jockey pump shows signs of leaking and corrosion at its flange and base. Due for replacement in 2016.

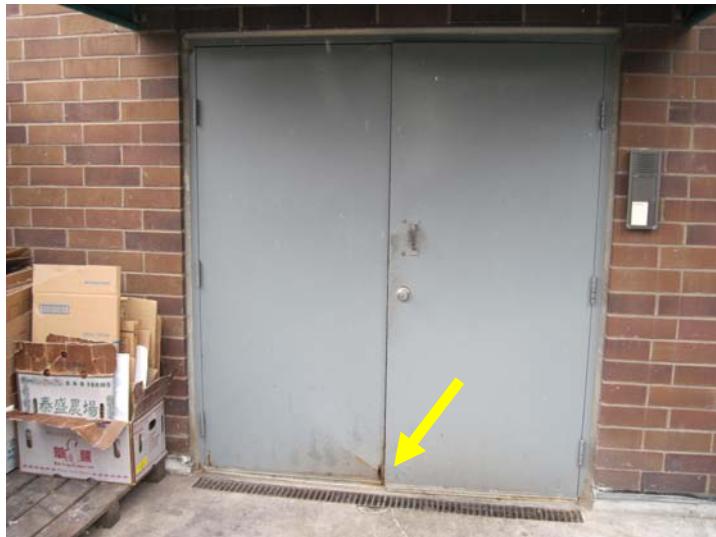
The aging loading dock flush metal service doors is corroding at the base and in need of replacement in the near term.

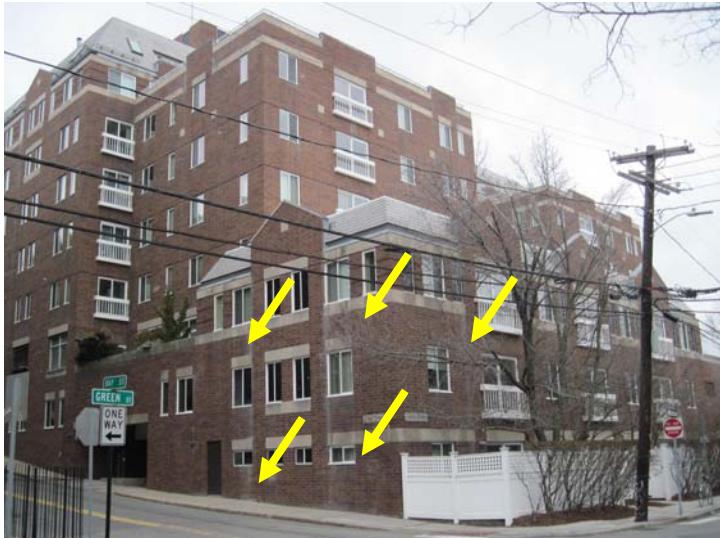
View of the rear (south) Green Street elevation.  
Note visible efflorescence at southwest corner.

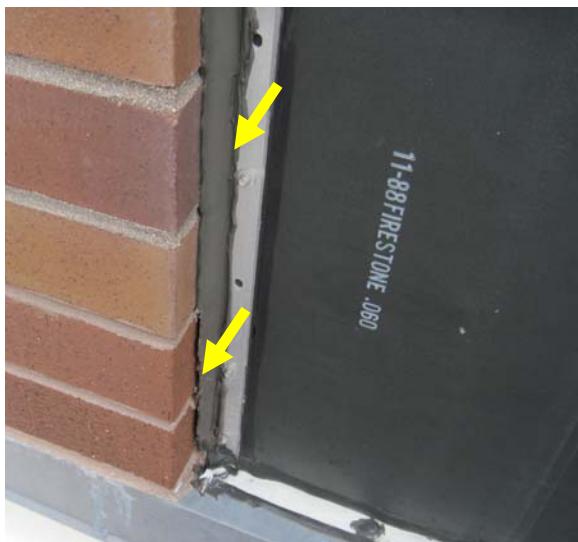
Door and control joint caulk exhibit age-related cohesion failure many locations. In need of replacing.

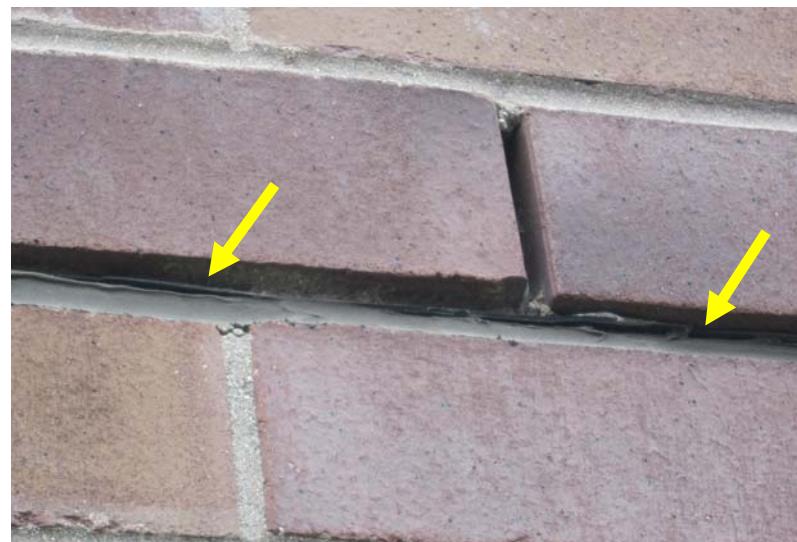
Close-up of control joint cohesion failure.

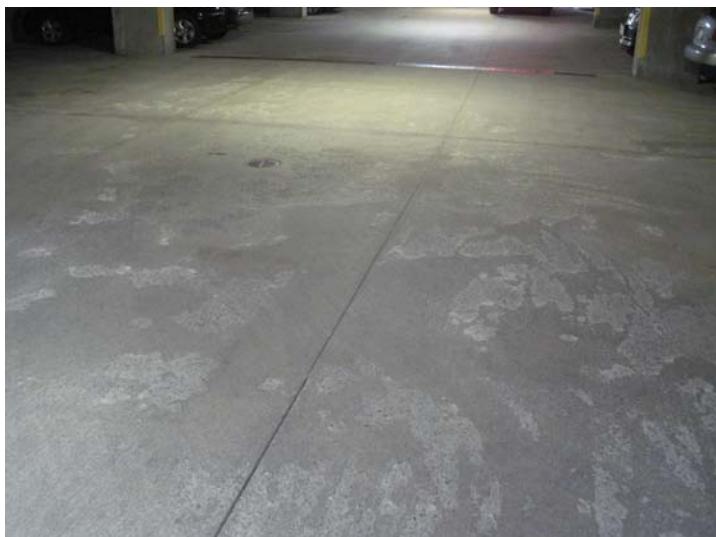
44. The lower garage retains its original bare concrete surface with several areas of age, use, salt, and moisture related surface deterioration visible throughout. Costs to repair, resurface, clean, etch, and then epoxy-coat the lower garage surface are shown in Year 1. Future costs to clean and re-apply the epoxy coating are shown in Year 11.

The lower garage concrete deck exhibits areas of surface deterioration. In need of repair, resurfacing, and an epoxy deck coating.

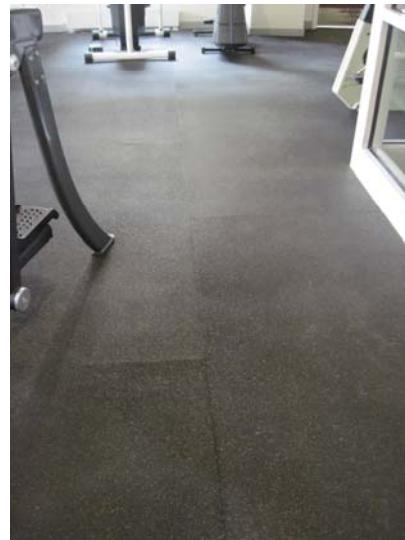
The fitness room rolled rubber flooring is showing signs of age and use related wear.
