# Capital Needs Assessment and Replacement Reserve Analysis

## Bay Square Condominium

Cambridge, MA

October 19, 2021

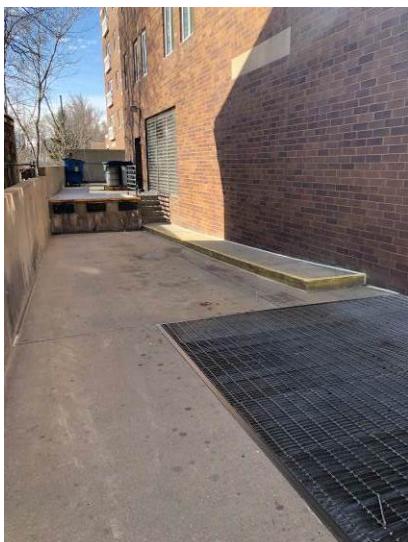
View of the loading dock driveway and sidewalk at the right. The loading dock platform was repaired and sealed in 2016.

- 1. Costs for the development's site and pool related elements total \$942,674 or \$9,427 per % BI in inflated dollars.**
2. The east elevation driveway concrete surface and adjacent walkway exhibit age and use related wear. The loading dock was repaired and sealed in 2016 and remains in good condition. Costs to reapply a protective epoxy coating to the loading dock platform are shown Years 5 and 15.

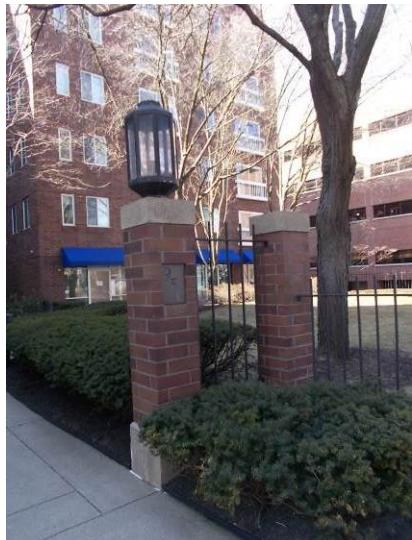
View of the original pier lighting at the front entry walkways.

6. The bollard light fixtures along the pedestrian walkways at the front courtyard and the lights on the two brick piers are believed to be original and are shown being replaced in Year 1.

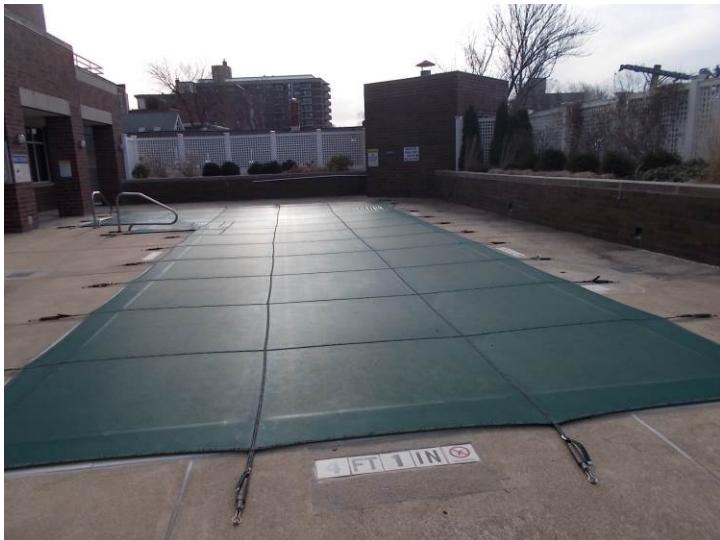
View of the pool and spa. Note the brick and stone planters were refurbished in 2017-2018 and the cover was replaced in 2015.

10. The pool and spa were covered on the day of the assessment; however, both were reported to be in good condition. The pool and spa were last resurfaced in 2015; and future resurfacing costs are shown in Years 4 and 14. The caulking around the pool and the pool deck was replaced in 2018; future costs are shown in Year 12 after fifteen years of use.

11. The pool/spa spring-anchored mesh safety cover was replaced in 2015. Future replacements are shown in Years 4 and 14.
12. No issues regarding the various pool mechanical equipment – sand filters, separators, chlorinators, pumps, etc. – were reported during the assessment, and periodic allowances for as-needed replacements and upgrades are shown every five years beginning in Year 1.

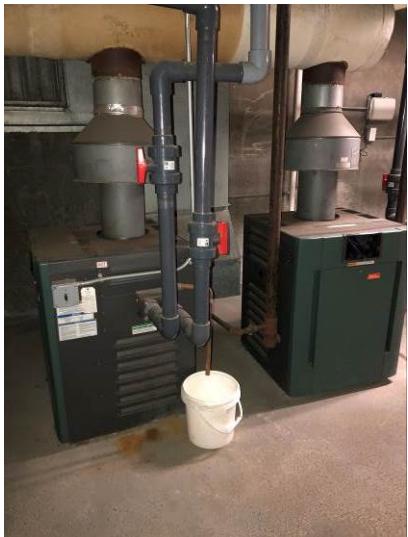
RayPak 399-MBH natural gas-fired boilers used to heat the pool water, both were installed in 2008.

13. The pool and spa water are heated by a pair of 399-MBH RayPak natural gas-fired boilers located in the pool mechanical room. These were installed in 2008 and remain in reportedly good operating condition. Future replacement of both boilers is shown in Year 12, after twenty-five years of use.

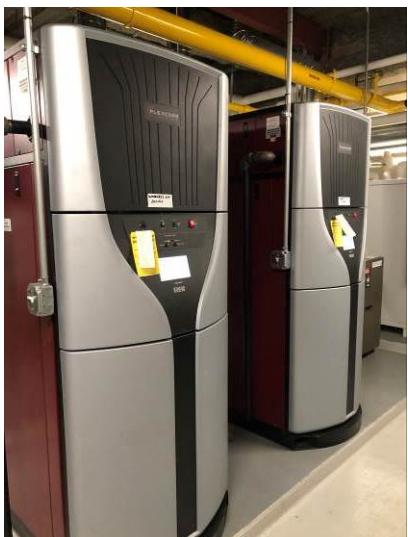
View of the RBI Flexcore condensing boilers, each with an input rating of 1500-MBH serving the two-pipe fan coil unit system.

15. The heating boilers date to 2016 and are in good current condition with no operational problems reported during the course of the assessment. Replacement of the 1,500-MBH RBI Flexcore condensing boilers the smaller 300-MBH RBI, high-efficiency boiler is shown in Year 15, based on a 20-year expected useful service life. Costs shown reflect the actual 2016 costs increased for inflation.

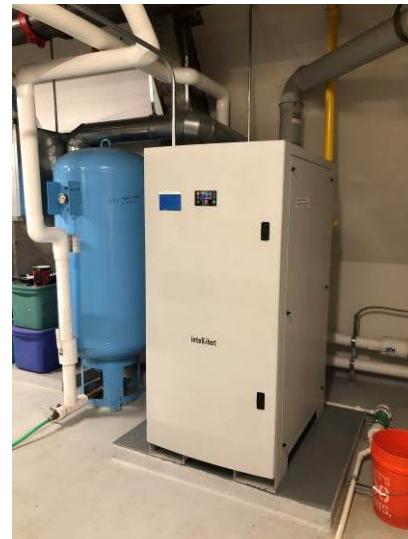
View of one of two Intellihot, natural gas-fired, 1001-MBH domestic hot water boilers. Both boilers were installed in 2016 and are in good current condition.

21. Domestic hot water (DHW) is generated via a pair of dedicated 1001-MBH Intellihot, natural gas fired boilers installed in 2016. Future replacement is shown in Year 15 after twenty years of use.

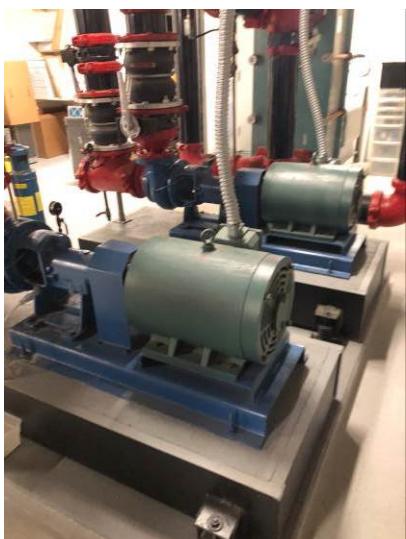
View of the Leeson WattSaver 30-hp, base-mounted service loop pumps.

18. The 30-hp service loop pump motors were replaced in 2011; and future replacement of both motors is shown in Year 10, based on a twenty-year expected useful service life. The service loop pumps are rebuilt approximately every fifteen years; and alternating rebuild costs are shown in Years 1, 8, and 16.

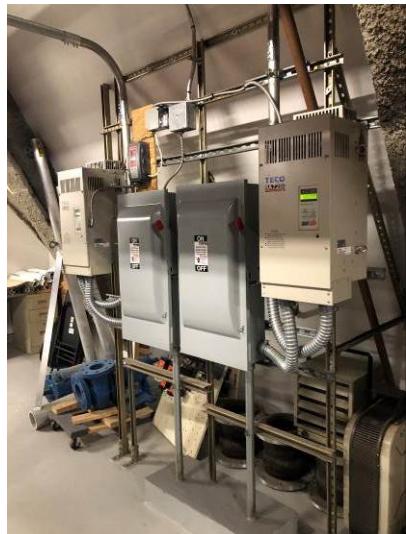
Teco MA7200 variable frequency drives (VFD) were installed in 2014 on each service loop pump.

19. The Teco service loop pump VFD's were newly installed in 2014. Replacement of these units is shown in Year 8, after fifteen years of use.
20. The cooling tower was newly installed in 2012 and remains in good observable condition with no reported operating issues. Future replacement is shown in Year 16, after twenty-five years of use. Rebuilding of the cooling tower loop pumps and motors are shown in Years 1, 8, and 16 of the plan.

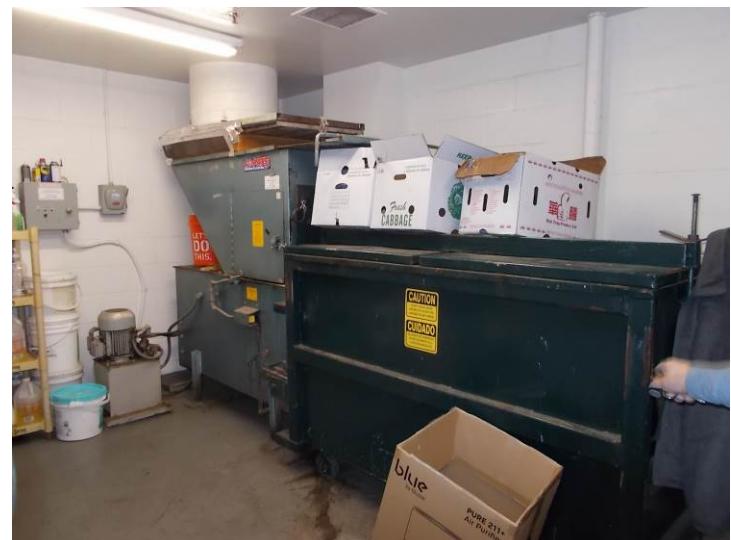
View of the chut-fed, hydraulic compactor and two-cubic yard rolling trash containers.

24. Building waste management is facilitated by an original chute-fed, forward-feed, hydraulic compactor with two rolling containers. The compactor has been maintained in good operating condition over the years; however, it has surpassed standard life assumptions and replacement is shown in Year 1. The rolling waste containers are currently replaced as-needed and are shown throughout the plan being maintained from operating accounts.

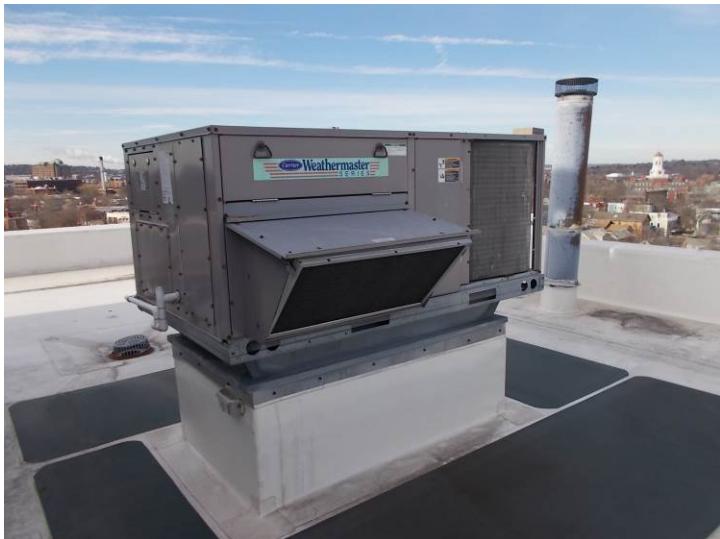
One of two, Carrier WeatherMaster, 4-ton, single-package rooftop units serving the common hallways.

- 28. The building has two, Carrier WeatherMaster 4-ton units, which provide fresh and conditioned air to the common hallways. The units are located on the roof and are shown for replacement in Year 4 after twenty years of service.

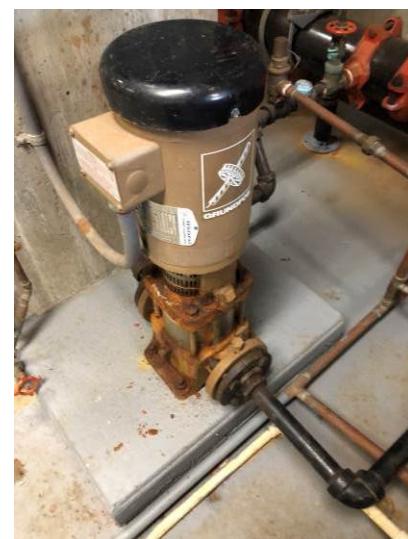
The ageing 2-horsepower fire-suppression system jockey pump shows signs of leaking and corrosion at its flange and base.

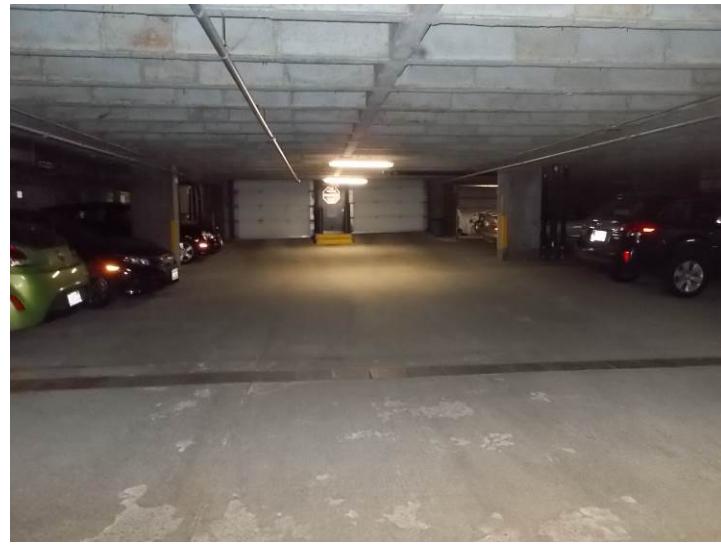
The lower garage concrete deck exhibits areas of surface deterioration.

46. The lower garage and the townhouse unit garage both have original bare concrete surfaces with areas of age, use, salt, and moisture related surface deterioration visible throughout. Costs to repair, resurface, clean, etch, and then epoxy-coat the lower garage surface are shown in Year 1. Future costs to clean and re-apply the epoxy coating are shown in Year 11.

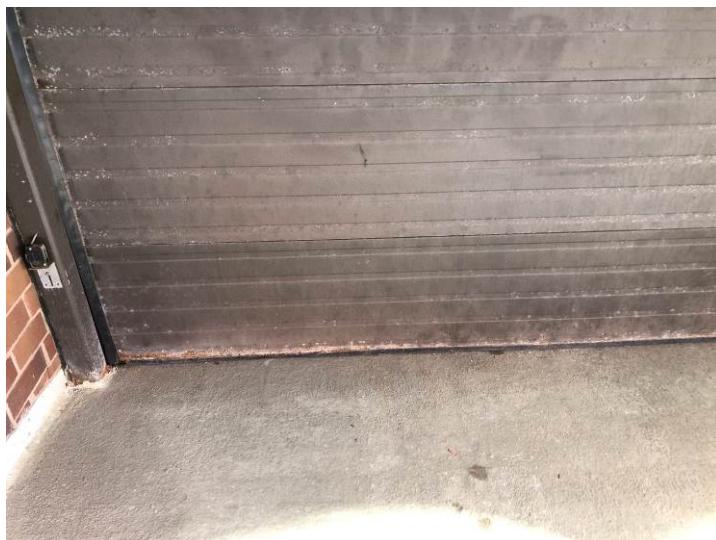
Rusting and surface deterioration was observed on many of the garage doors.

47. Access to the garage is by fiberglass segmented panel overhead doors powered by  $\frac{1}{2}$ -horsepower hoist operators of various manufacturer and age. Costs to replace the garage door are shown over five years beginning in Years 1 and 16. Periodic replacement costs for the door operators are shown every three years throughout the plan.

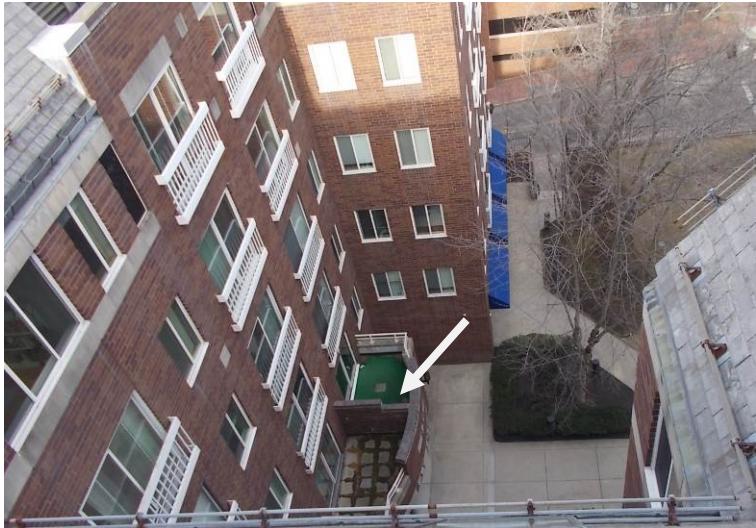
The EPDM membrane at the front entry private terrace is planned for replacement in 2021.

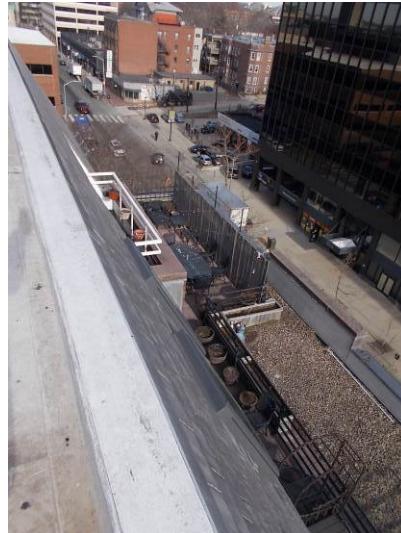
The EPDM membrane at the front 6th-Floor private terrace is planned for replacement in 2021.

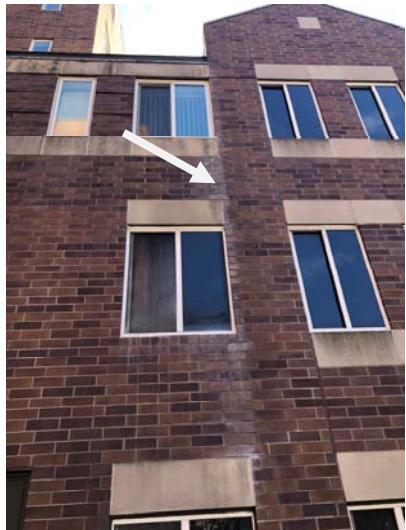
Visible efflorescence noted at various elevations of the building.

- 52. Exterior bricks and mortar appeared to be generally good condition from available vantage points. Management has reported an ongoing infiltration issue within the courtyard, based on discussions with the Board, an allowance is shown in Year 1 to address this façade. An allowance for a professional review and as-needed brick repointing and repair of the remainder of the building is shown in Years 2 and 17.

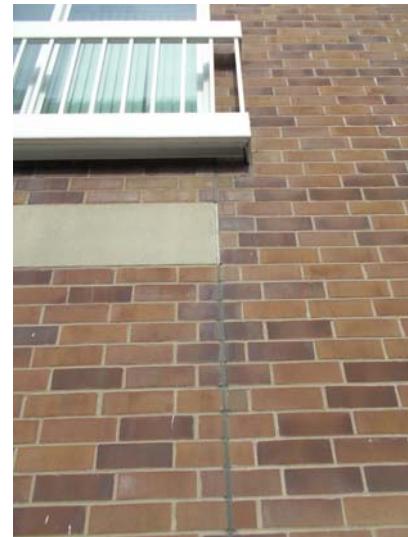
The Juliet balcony railings were painted with RhinoShield ceramic coating in 2010. The control joint caulking was spot repaired and replaced in 2005; some seam separation and cracking was observed.
