CopelandBEC Engineering Study Addenda, Notes, and Errata

Bay Square Condominiums

950 Massachusetts Avenue
Cambridge, MA

Building Condition Assessment

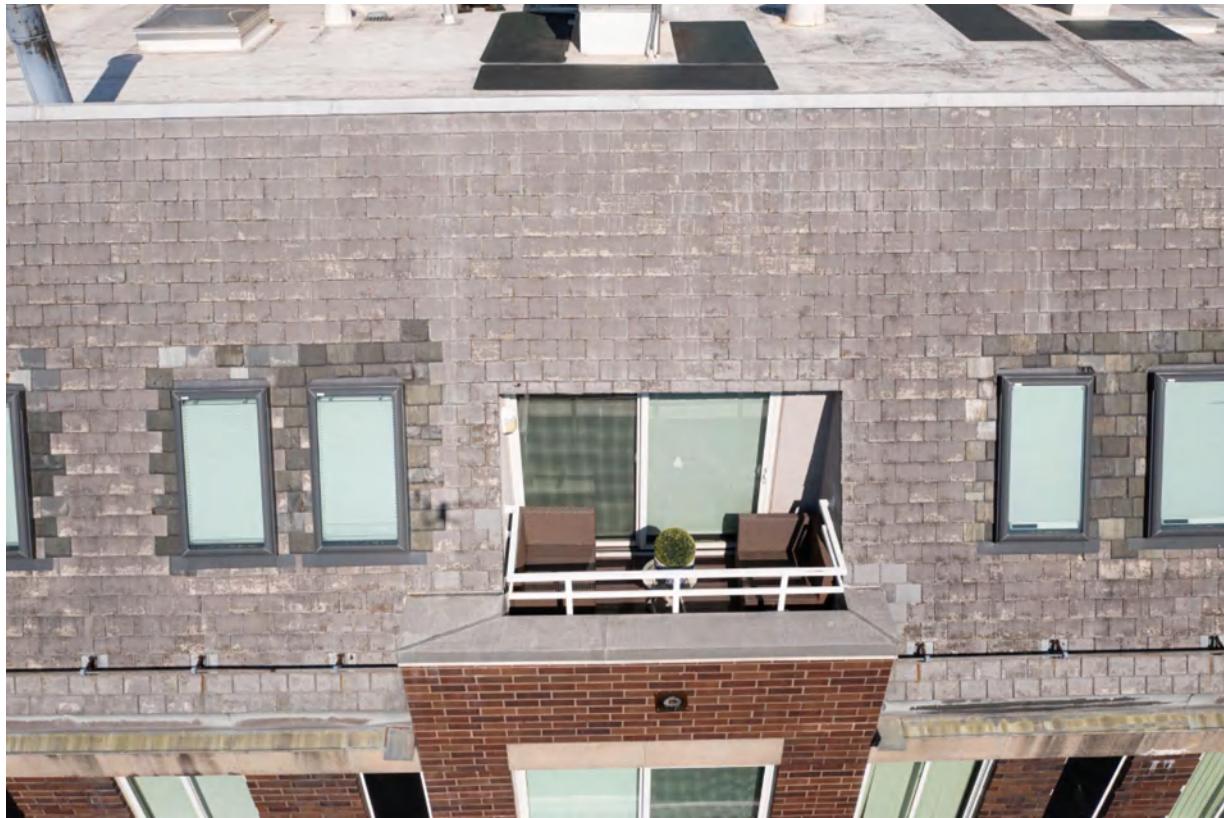
Photo 9: mansard style steep sloped roof

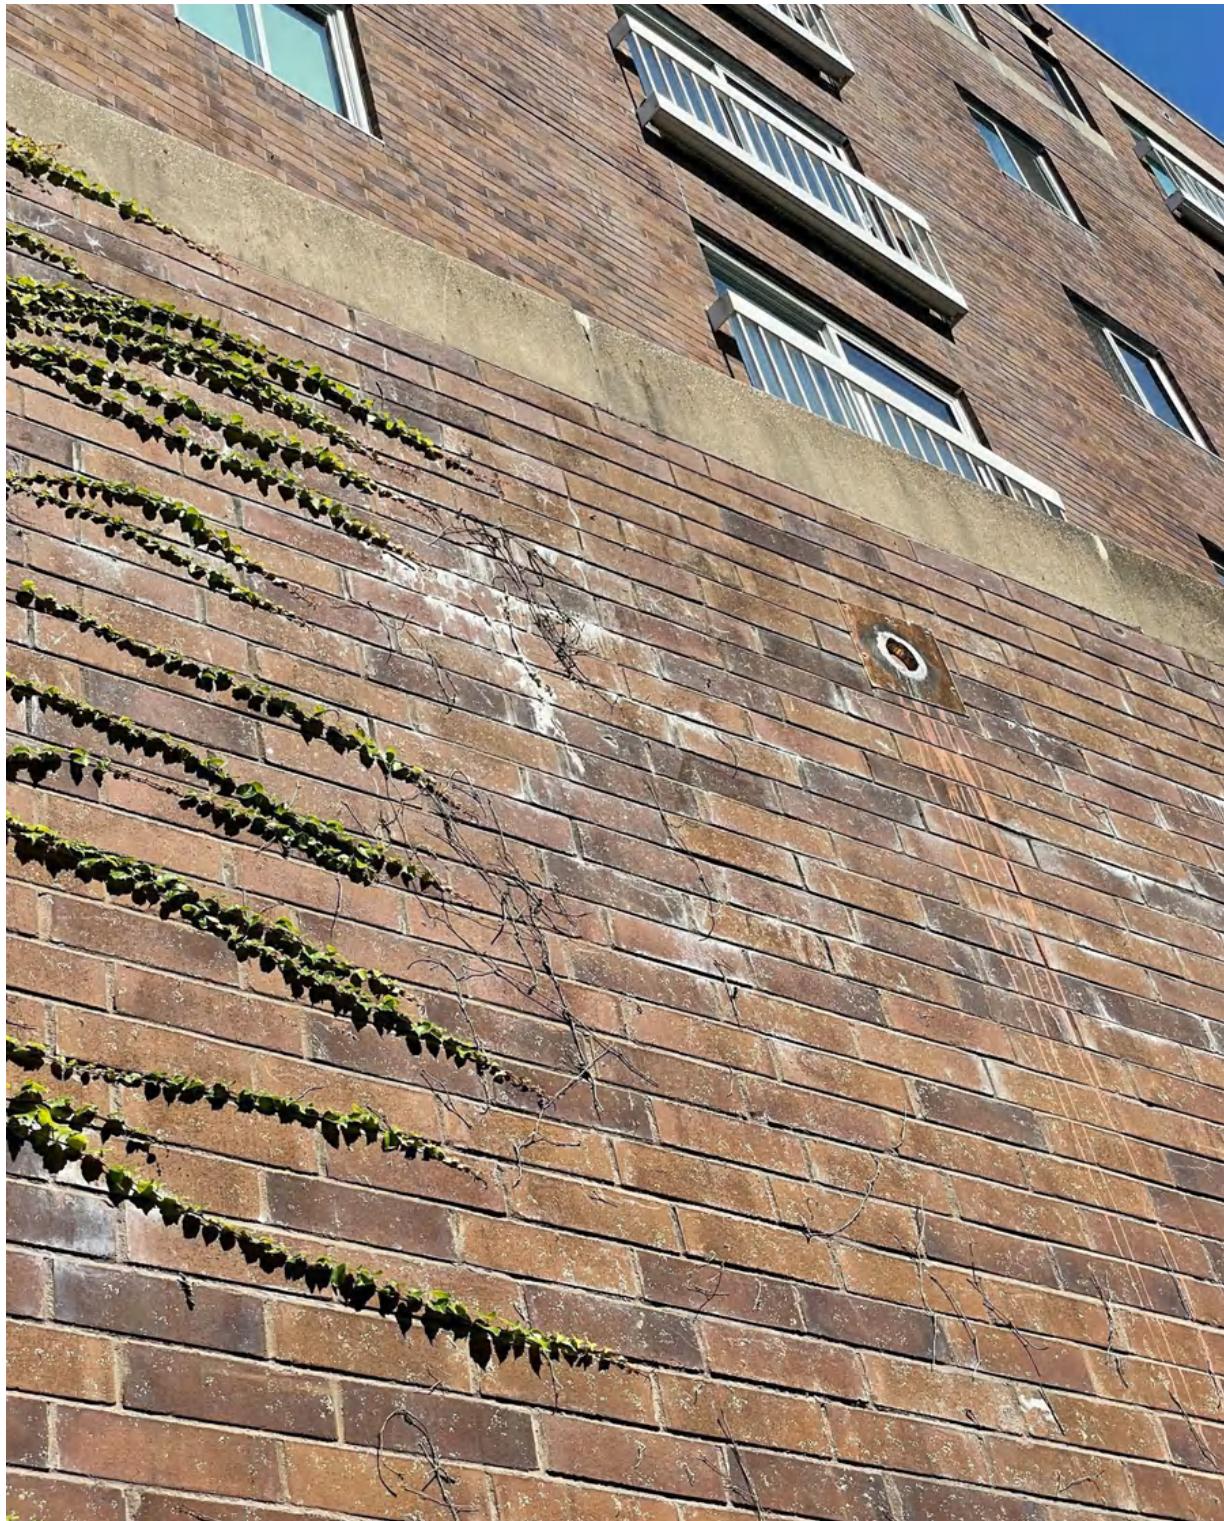
Photo 16: wall trellis' installed promoting additional ivy growth on the masonry wall

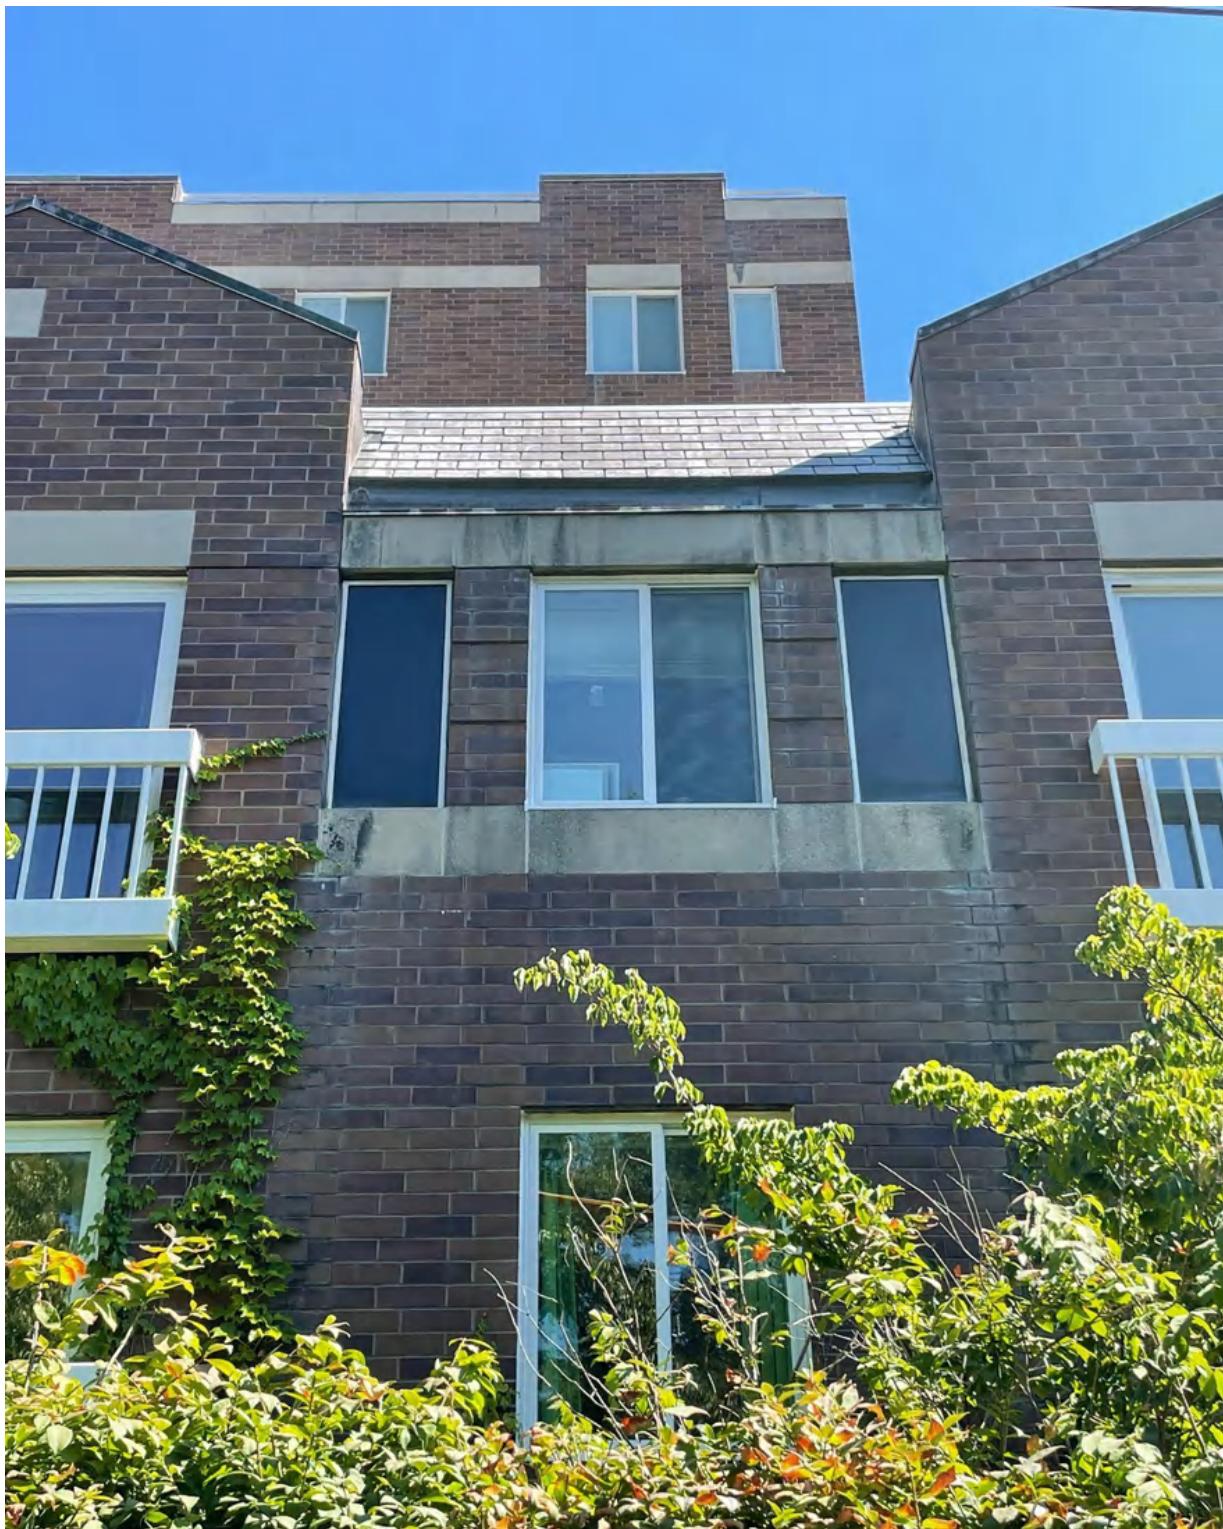
Photo 19: areas of heavy carbonate and efflorescence staining on brick veneer wall, at the pool planter wall

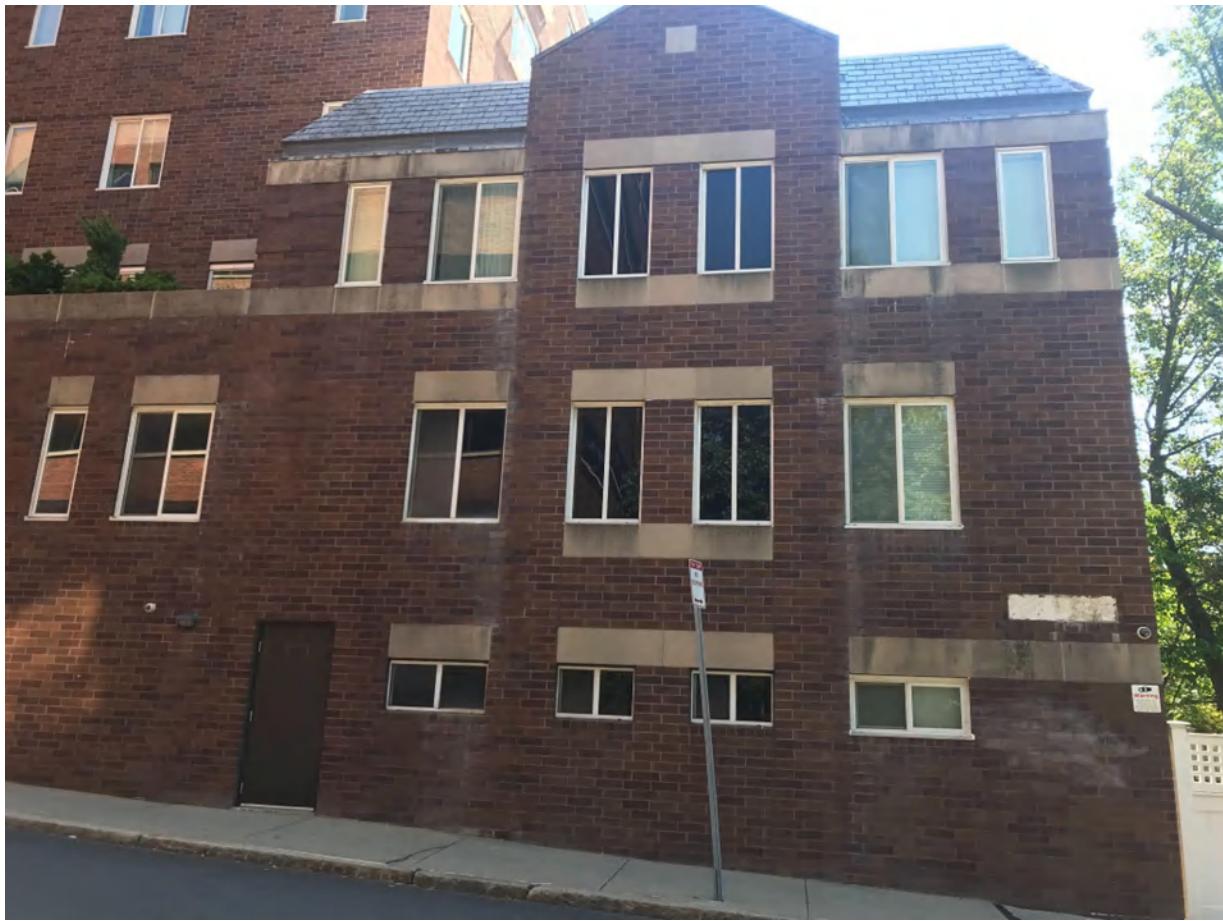
Photo 20: staining on brick veneer wall and cast stones directly below mansard roof edge/dormer rising wall interface areas - roof edge without gutters

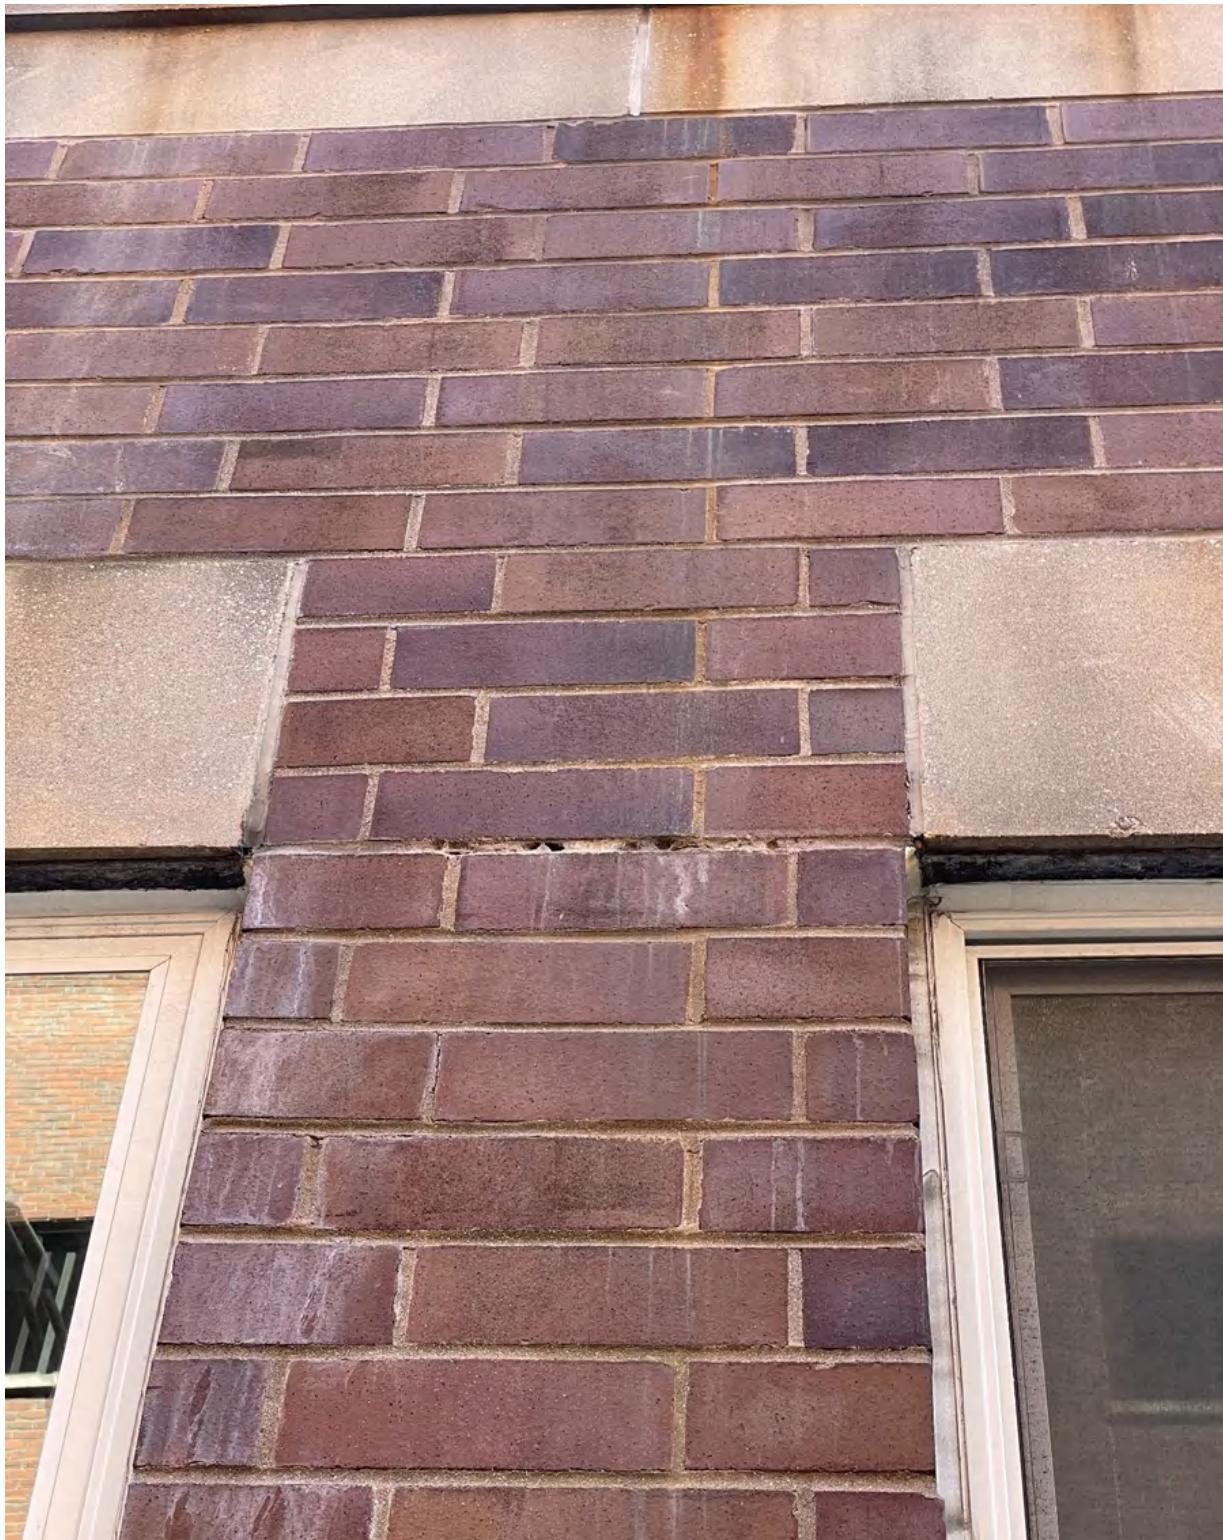
Photo 21: brick and cast stone staining at areas directly below mansard roof edge/dormer rising wall interface areas and below roof edges without gutters

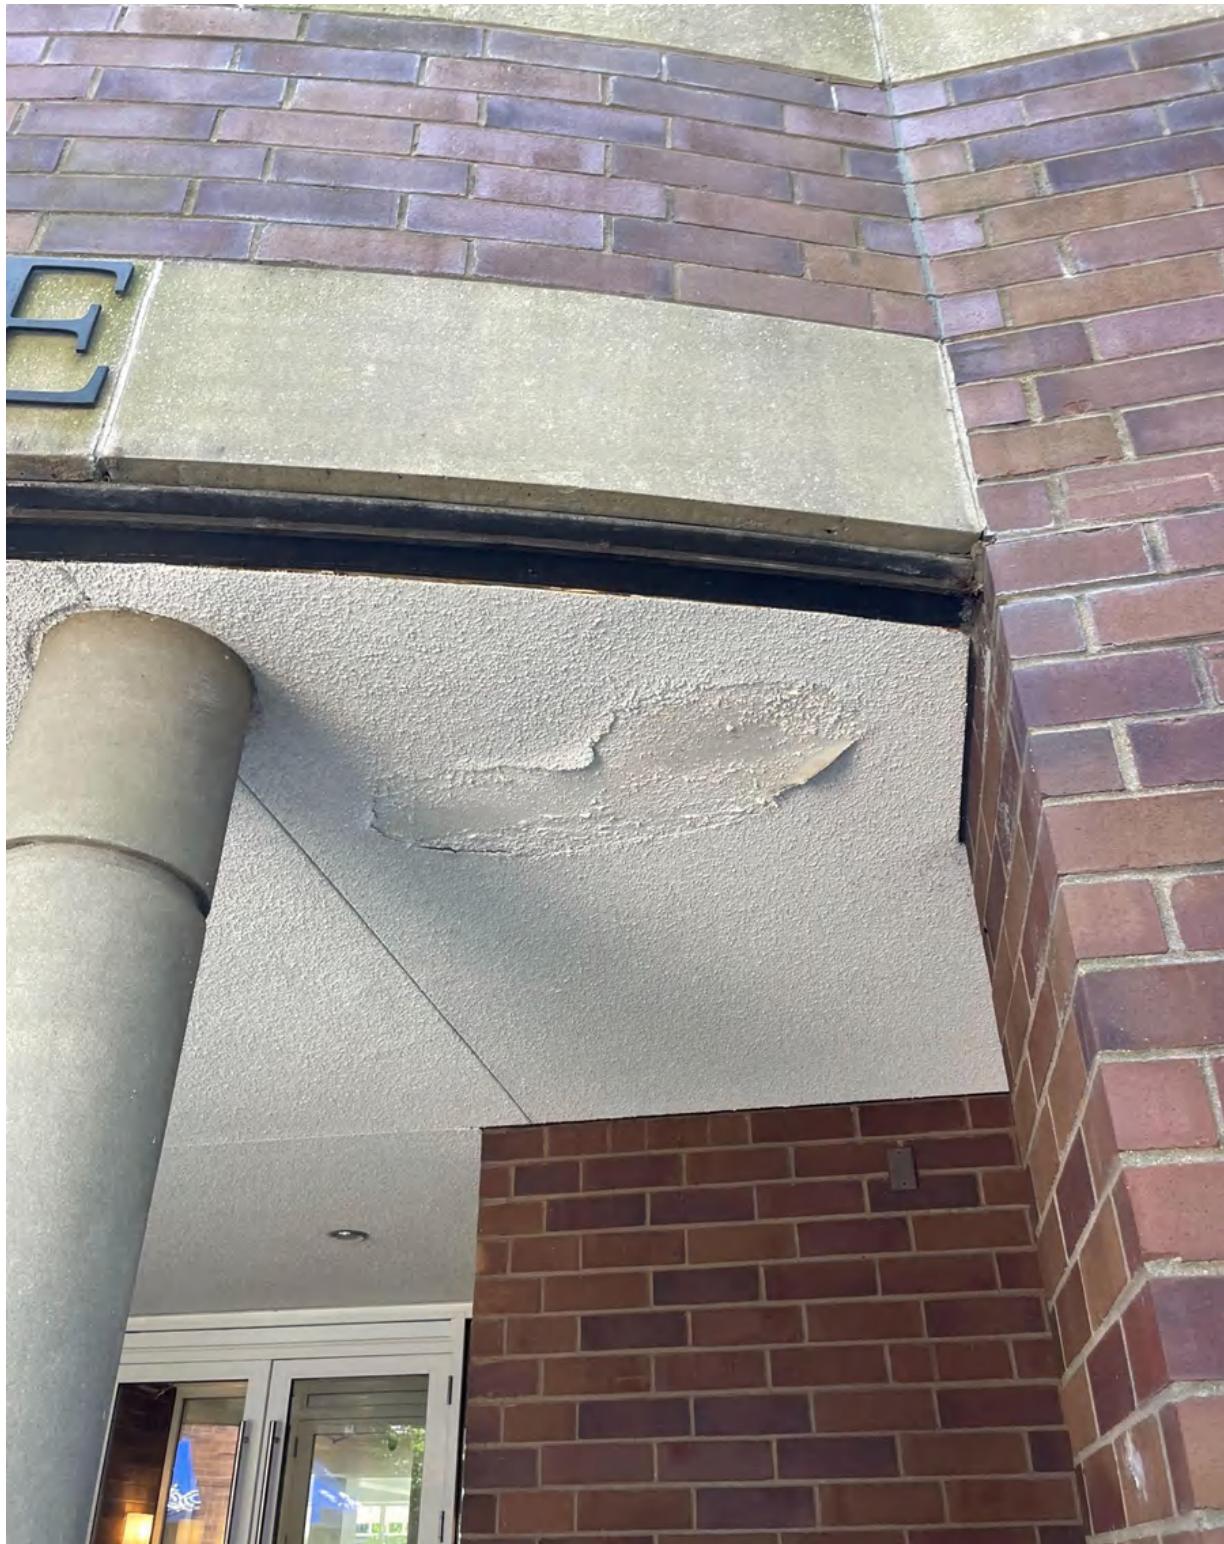
Photo 22: exposed areas of the galvanized steel relieving angles over the windows and failing joint sealant

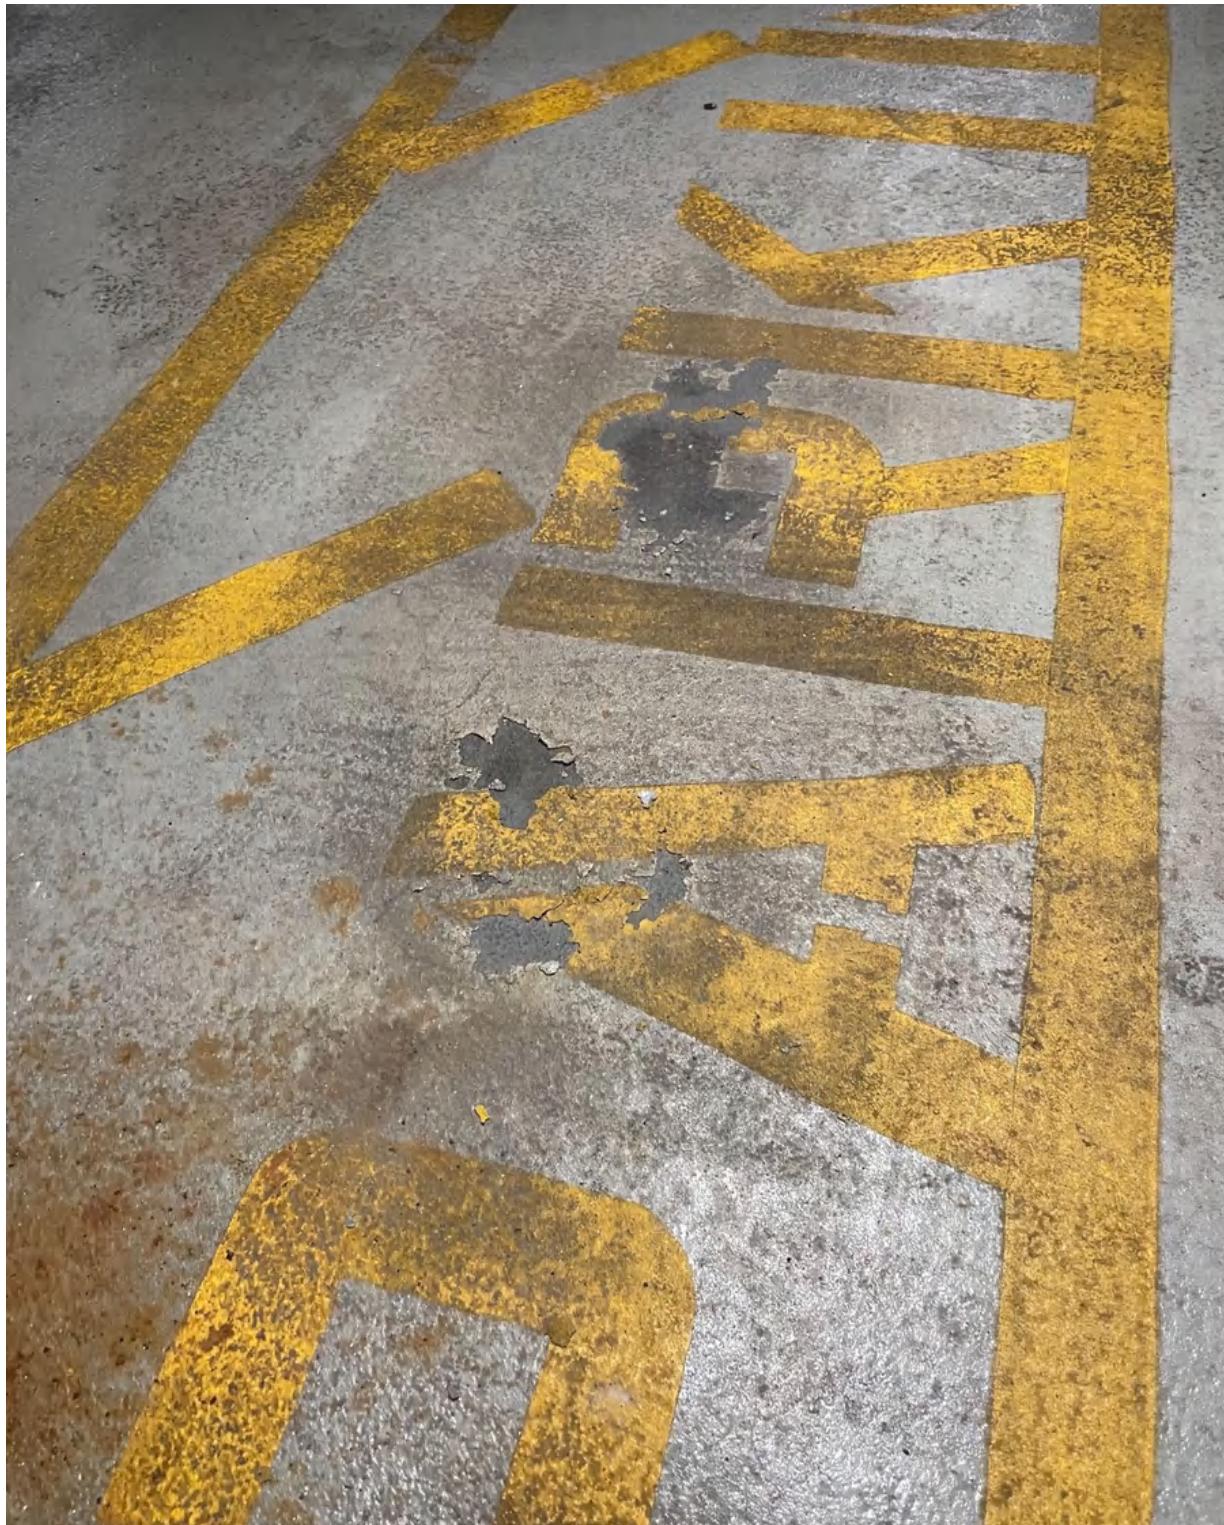
Photo 37: delaminated urethane traffic coating at the upper level garage

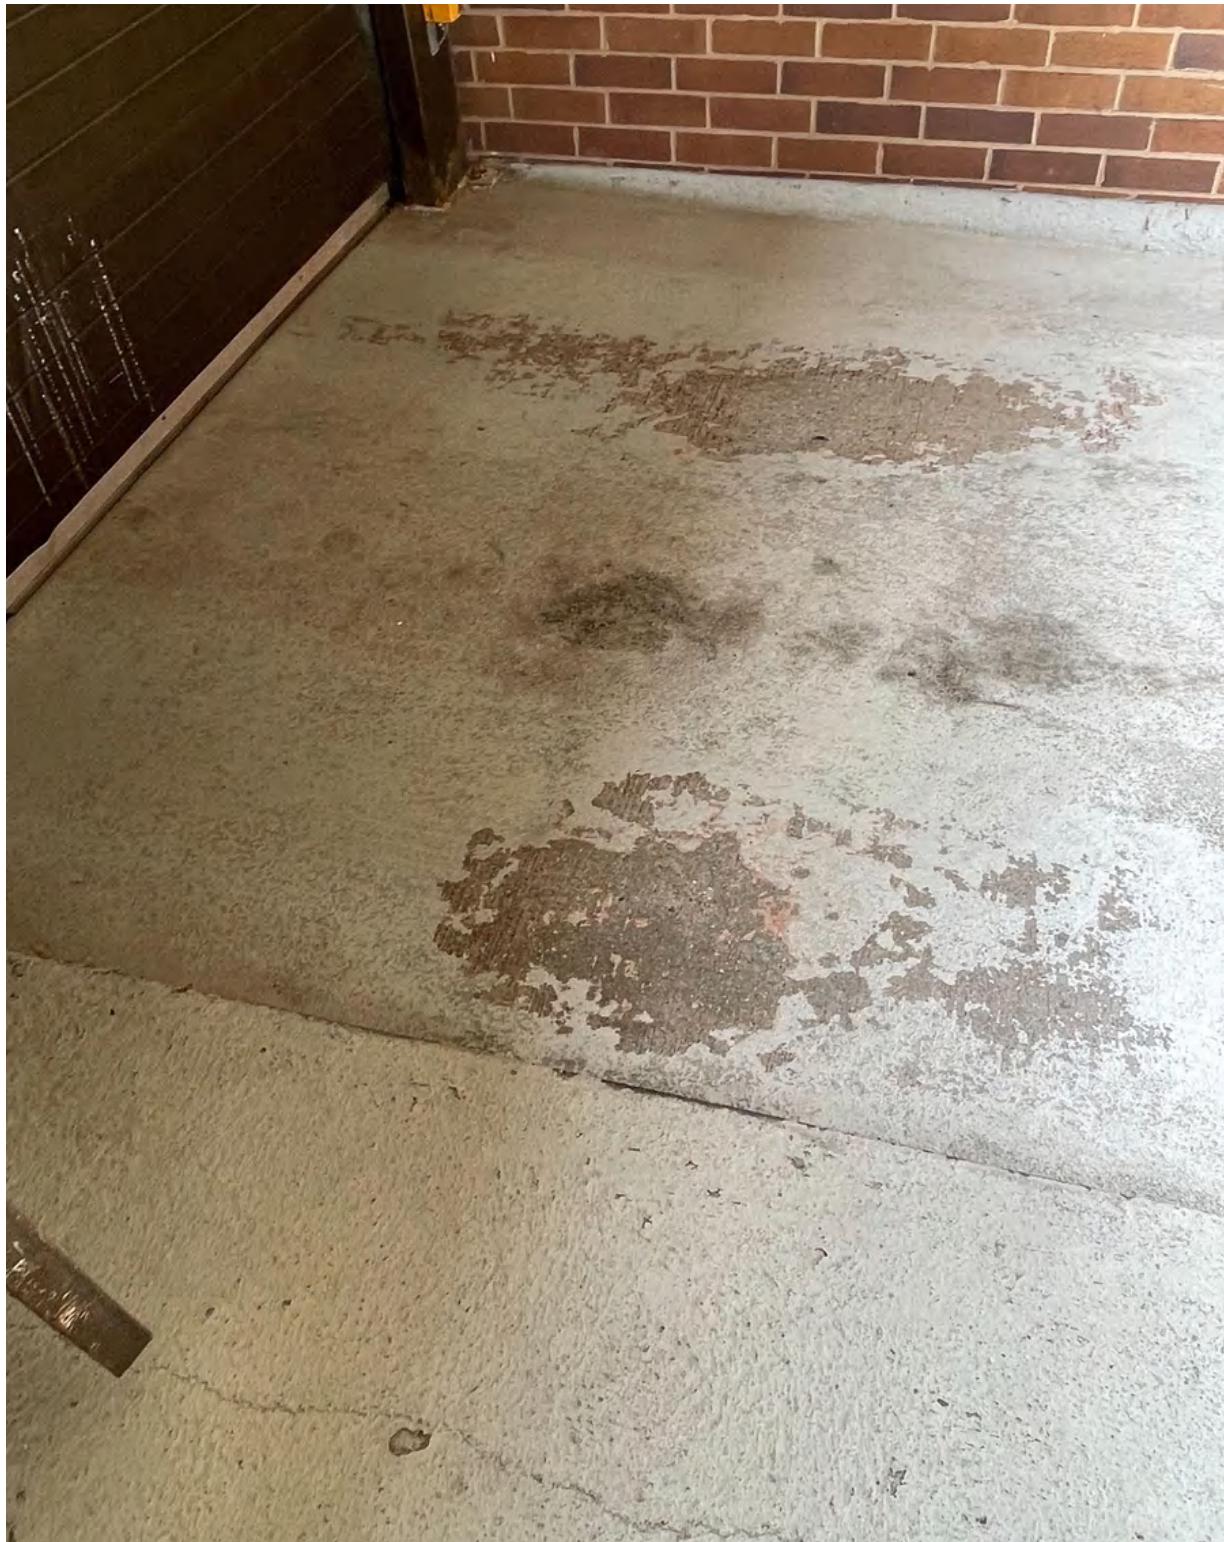
Photo 38: worn out/delaminated urethane traffic coating at upper level garage parking stall

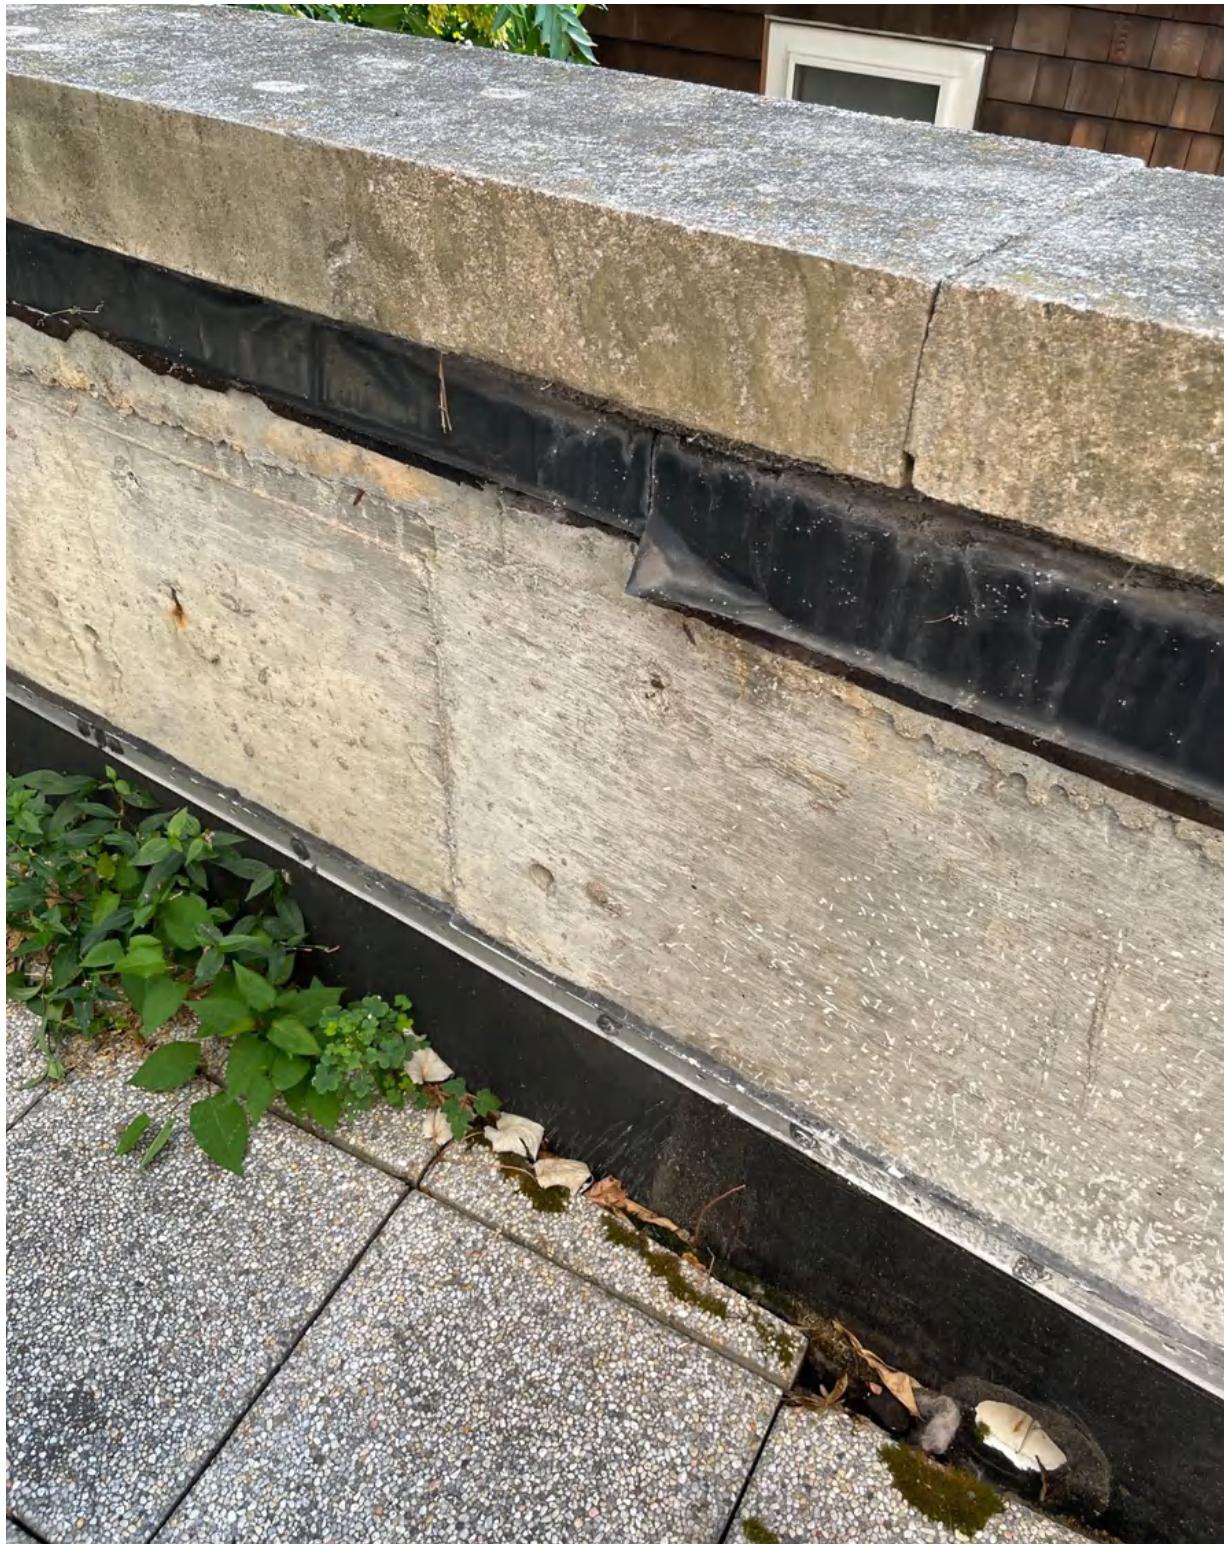
Photo 43: failed sealant at continuous aluminum termination bar (without counterflashing)

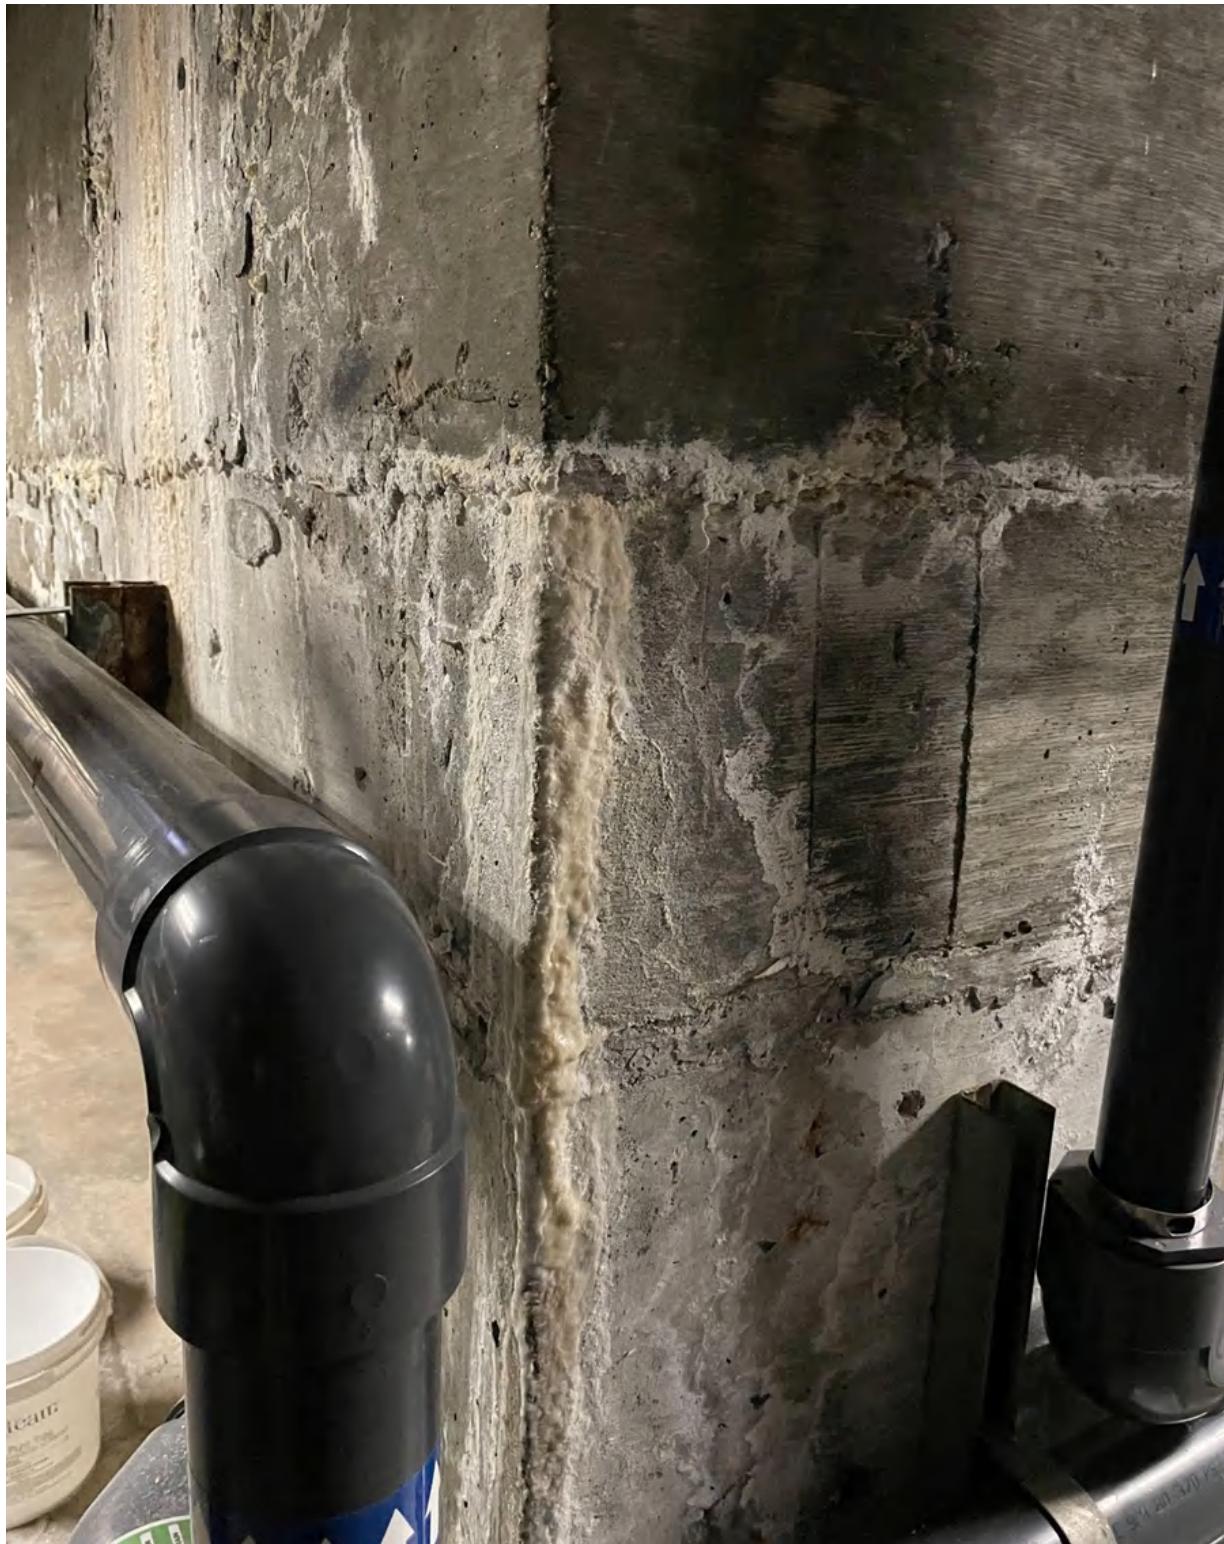
Photo 46: heavy carbonate staining on concrete pool wall and leak diverters attached to the wall directing active leak to collection bucket

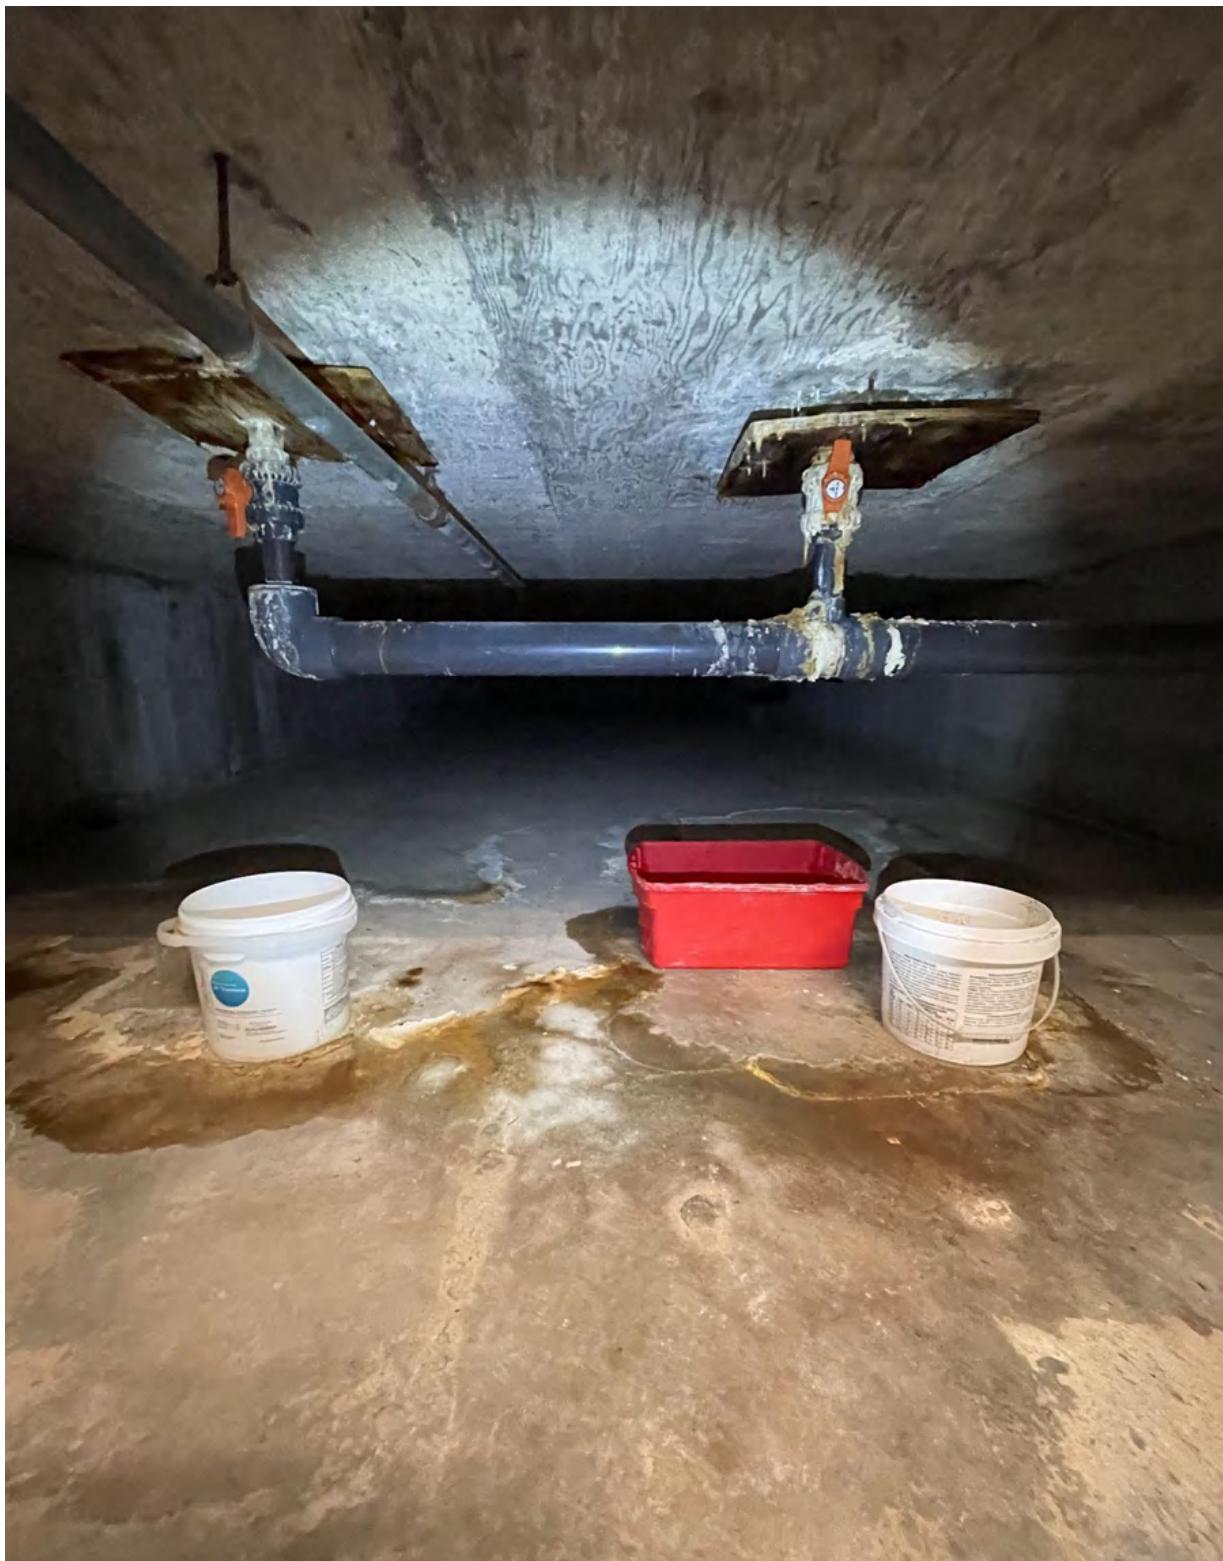
Photo 47: leak source appears to be from cold joint at the pool wall and lower slab
