February 2, 2024  
*Revised: February 27, 2024*

## **BUILDING ENVELOPE STUDY – BAY SQUARE CONDOMINIUMS**

Bay Square Condominiums  
950 Massachusetts Avenue  
Cambridge, MA 02139

BRS/Building RECON Services  
A BRS/Building Restoration Services Corp entity  
371 Dorchester Avenue  
Boston, MA 02147

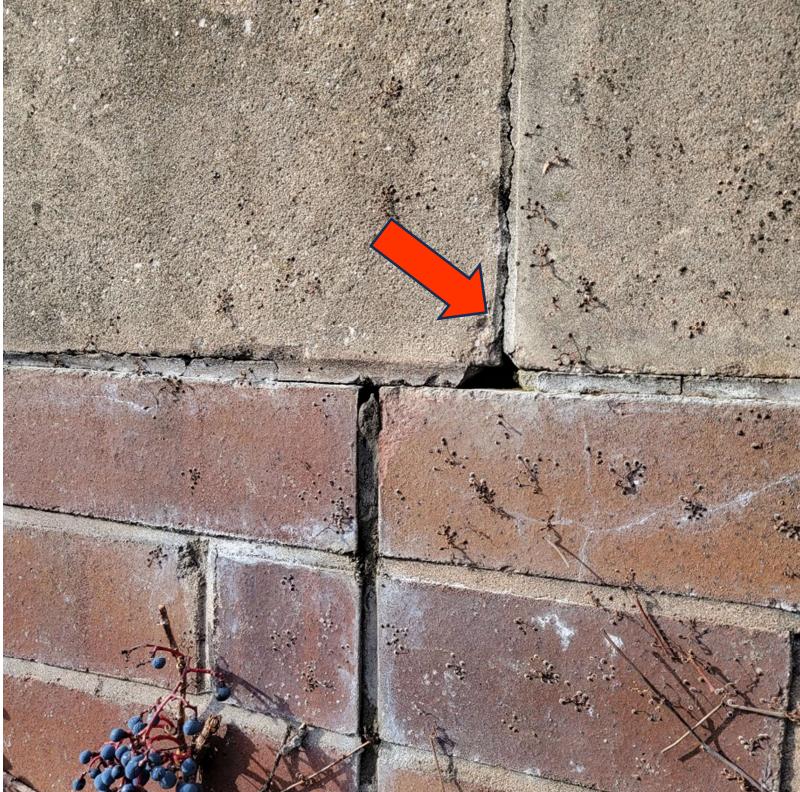
1. Cracked, deteriorated, open, and missing mortar at the cast stone coping and brick masonry veneer on the east exterior wall of the parking garage (Photos 4 – 5).

<p><b>Photo 4:</b> Failed mortar joints at east wall coping stone and brick masonry veneer.</p>

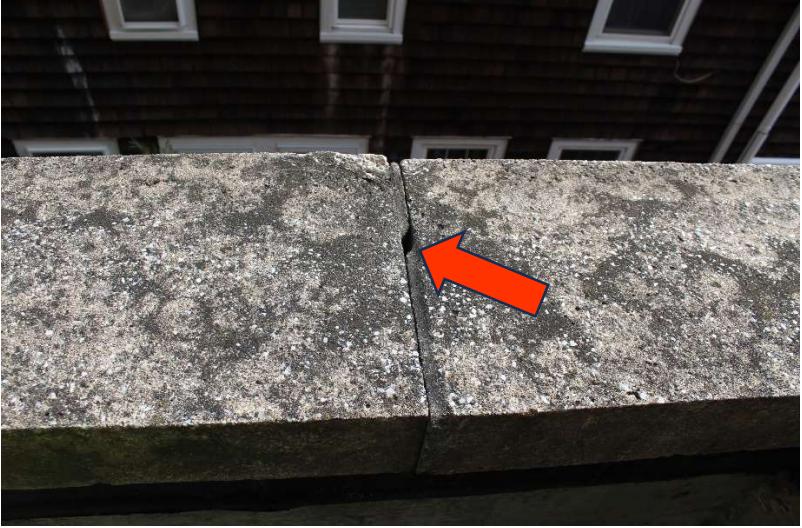
<p><b>Photo 5:</b> Failed coping stone mortar joints at east wall.</p>

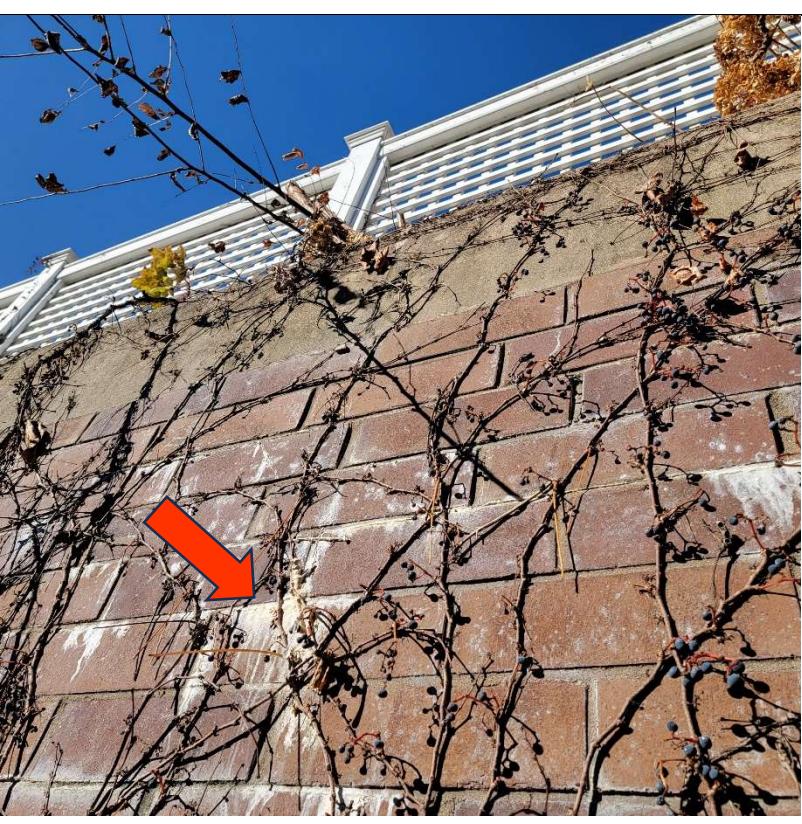
2. Efflorescence and widespread ivy covering the two-story brick masonry wall at the east exterior wall of the parking garage (Photo 6).
3. Cracked and spalled cast stone coping on south exterior wall of the parking garage with failing surface-applied sealants (Photo 7).

<p><b>Photo 6:</b> Ivy and efflorescence on east wall of parking garage.</p>

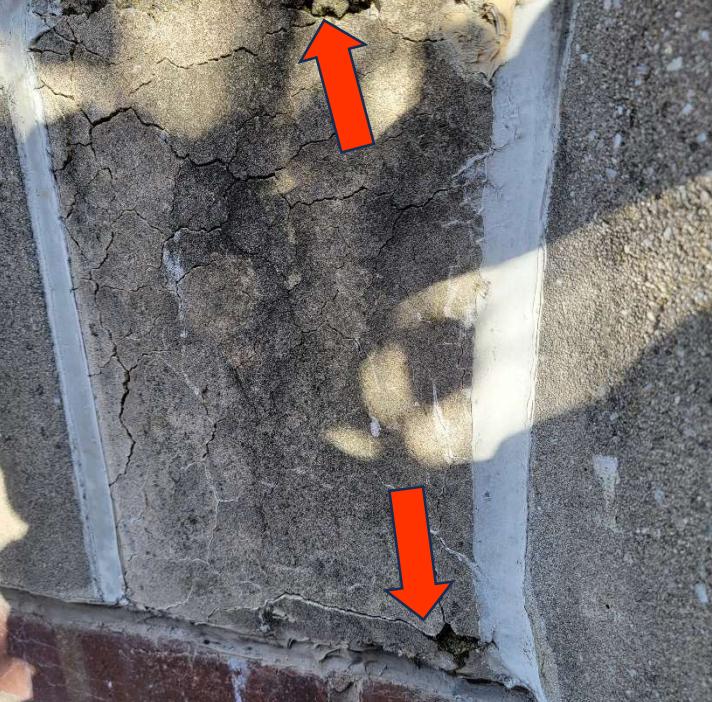
<p><b>Photo 7:</b> Spalled/damaged coping stones at south elevation of parking garage.</p>

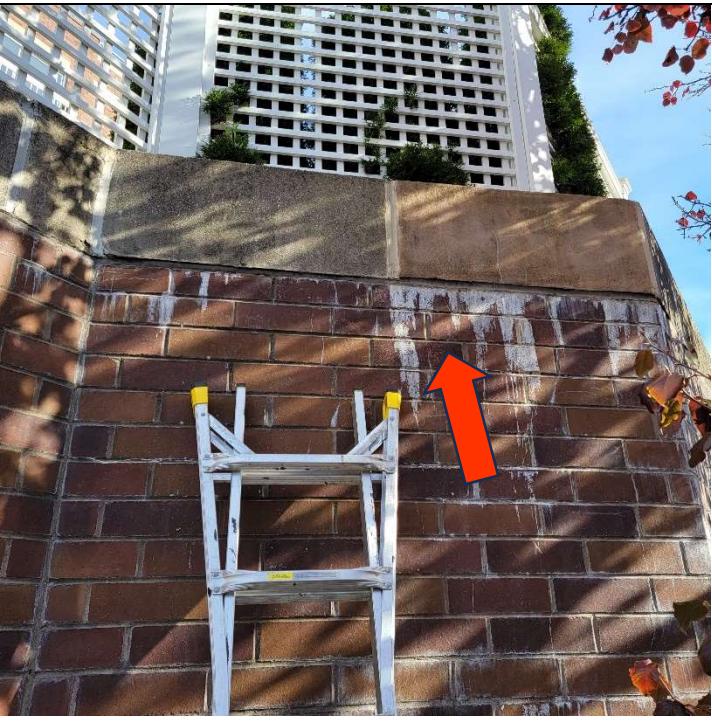
4. Cracked, deteriorated, open, and missing mortar as well as displaced brick masonry veneer and efflorescence on the south exterior wall of the parking garage (Photos 8 - 9).

<p><b>Photo 8:</b> Cracked, deteriorated, open, and missing mortar and efflorescence on the south exterior wall of the parking garage.</p>

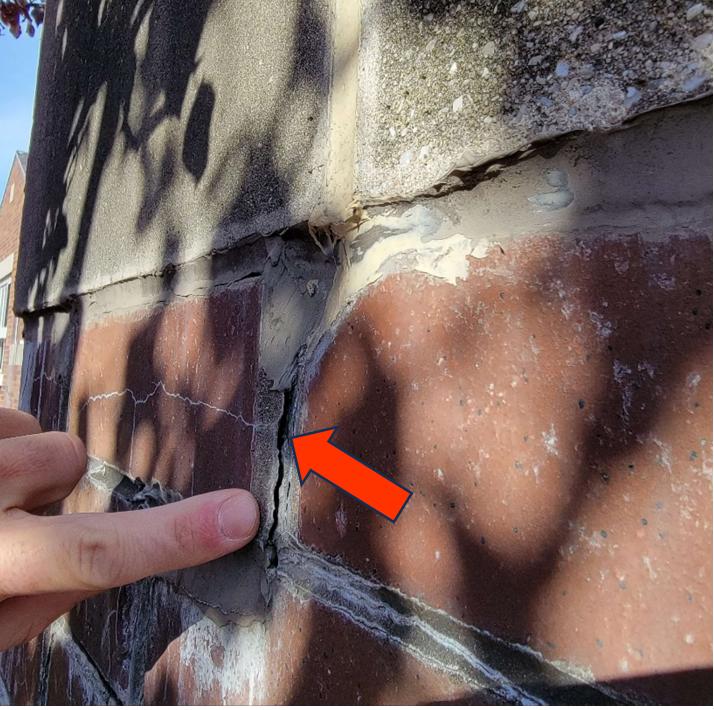
<p><b>Photo 9:</b> Cracked, deteriorated, open, and missing mortar as well as displaced brick masonry veneer and efflorescence on the south exterior wall of the parking garage.</p>

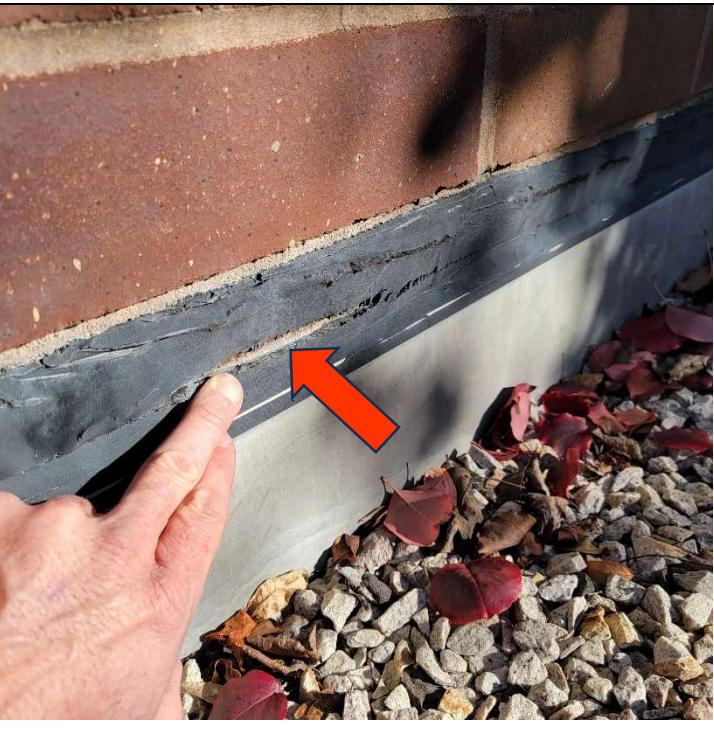
5. Failing mastic coatings along the metal counter flashings at the south exterior wall of the parking garage (Photo 10).
6. Cracked and open mortar joints at the cast stone coping and brick masonry veneer as well as efflorescence on the pool headhouse structure (Photos 11 - 12).

<p><b>Photo 10:</b> Failing mastic coatings along the metal counter flashings at the south exterior wall of the parking garage</p>

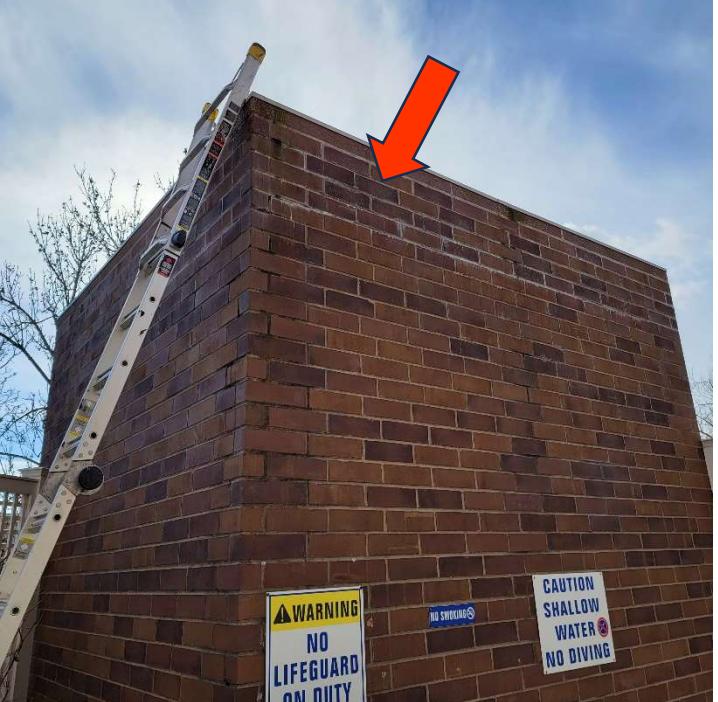
<p><b>Photo 11:</b> Cracked and open mortar joints at the cast stone coping and brick masonry veneer as well as efflorescence on the pool headhouse structure</p>

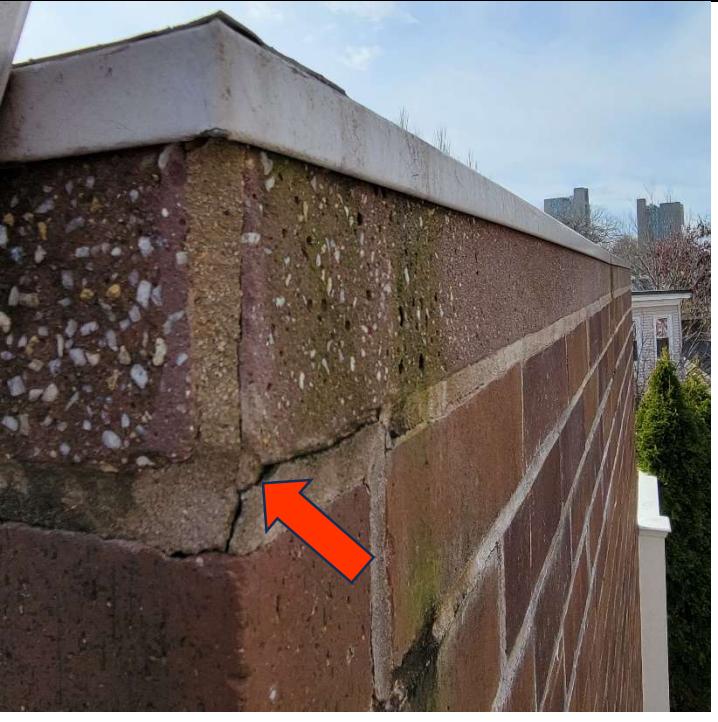
<p><b>Photo 12:</b> Cracked and open mortar joints at the cast stone coping and brick masonry veneer as well as efflorescence on the pool headhouse structure</p>

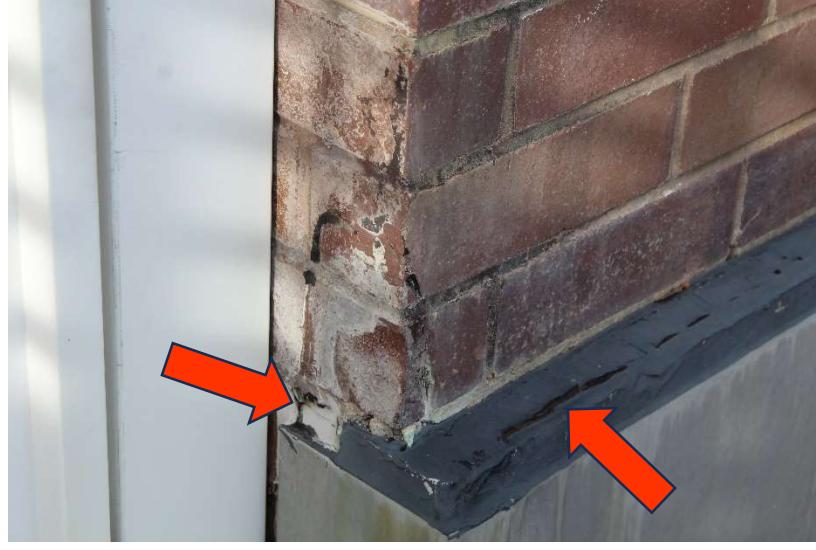
7. Failing mastic coatings along the metal counter flashing and damaged/open masonry on the east exterior wall of the building at the terrace on the first-floor level (Photo 13).

<p><b>Photo 13:</b> Failing mastic coatings along the metal counter flashing and damaged/open masonry on the east exterior wall of the building at the terrace on the first-floor level</p>

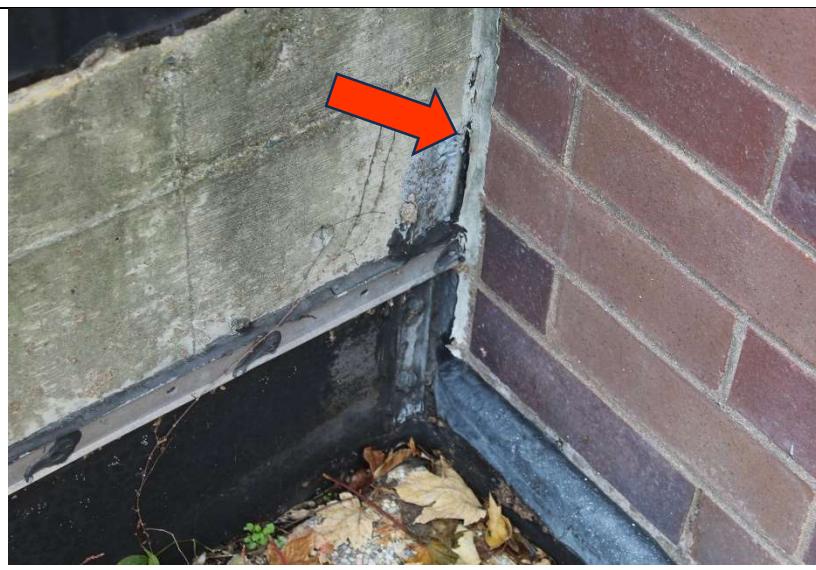
<p><b>Photo 14:</b> Failed sealants and open mortar joints at the Unit 106 terrace on the first-floor level.</p>

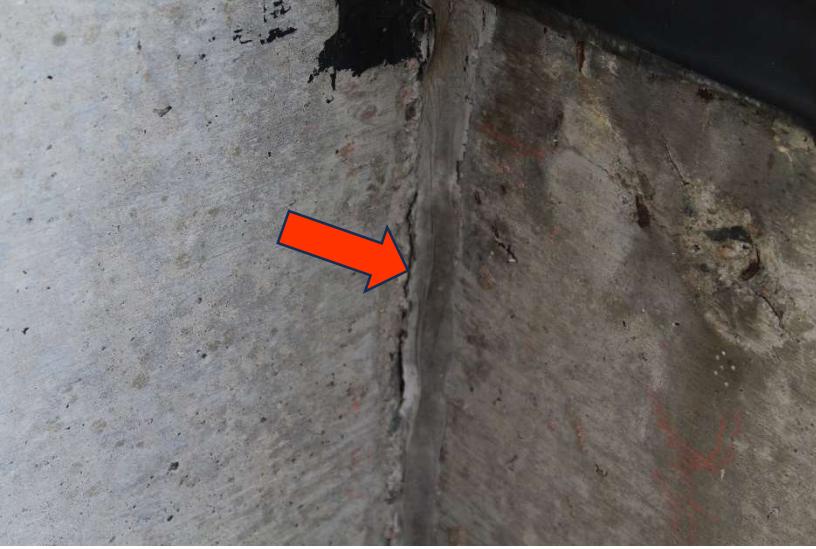
8. Failed sealants at concrete-to-concrete wall joints at the Unit 106 terrace on the first-floor level (Photos 14 and 15).
9. Failing surface-applied sealants along the roof membrane termination and termination bar at the Unit 106 terrace on the first-floor level (Photo 16).

<p><b>Photo 15:</b> Failed sealants at concrete-to-concrete wall joints at the Unit 106 terrace on the first-floor level.</p>

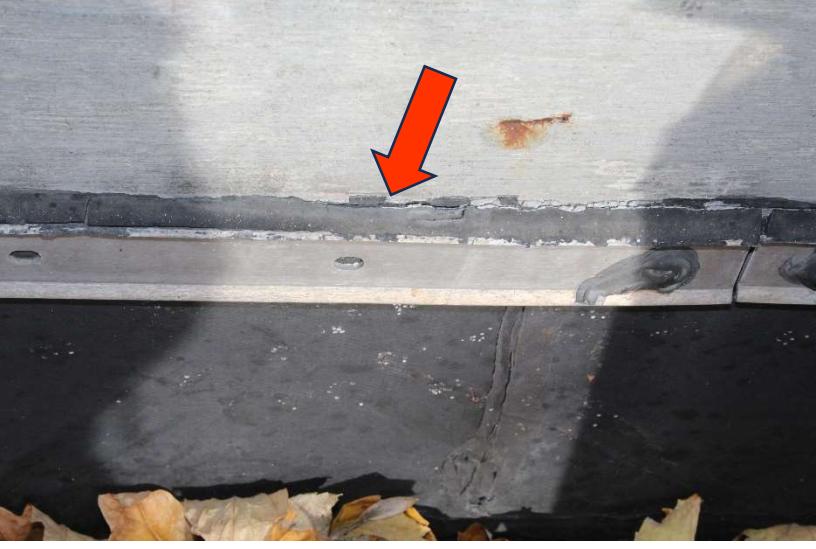
<p><b>Photo 16:</b> Failing surface-applied sealants along the roof membrane termination and termination bar at the Unit 106 terrace on the first-floor level</p>

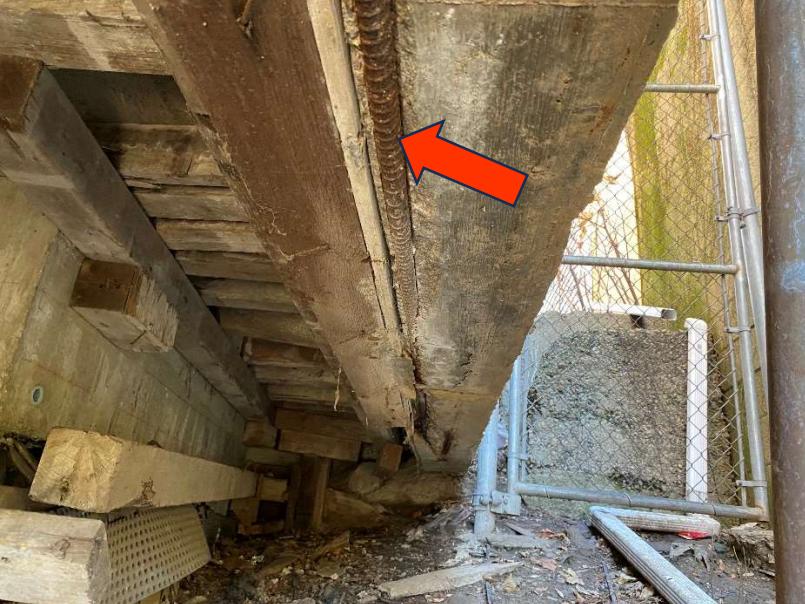
10. Deteriorated and spalled concrete structure beneath the loading dock platform at the east side of the building with exposed, deteriorated, and corroded steel reinforcing steel (Photo 17).

<p><b>Photo 17:</b> Deteriorated and spalled concrete structure beneath the loading dock platform at the east side of the building with exposed, deteriorated, and corroded steel reinforcing steel</p>

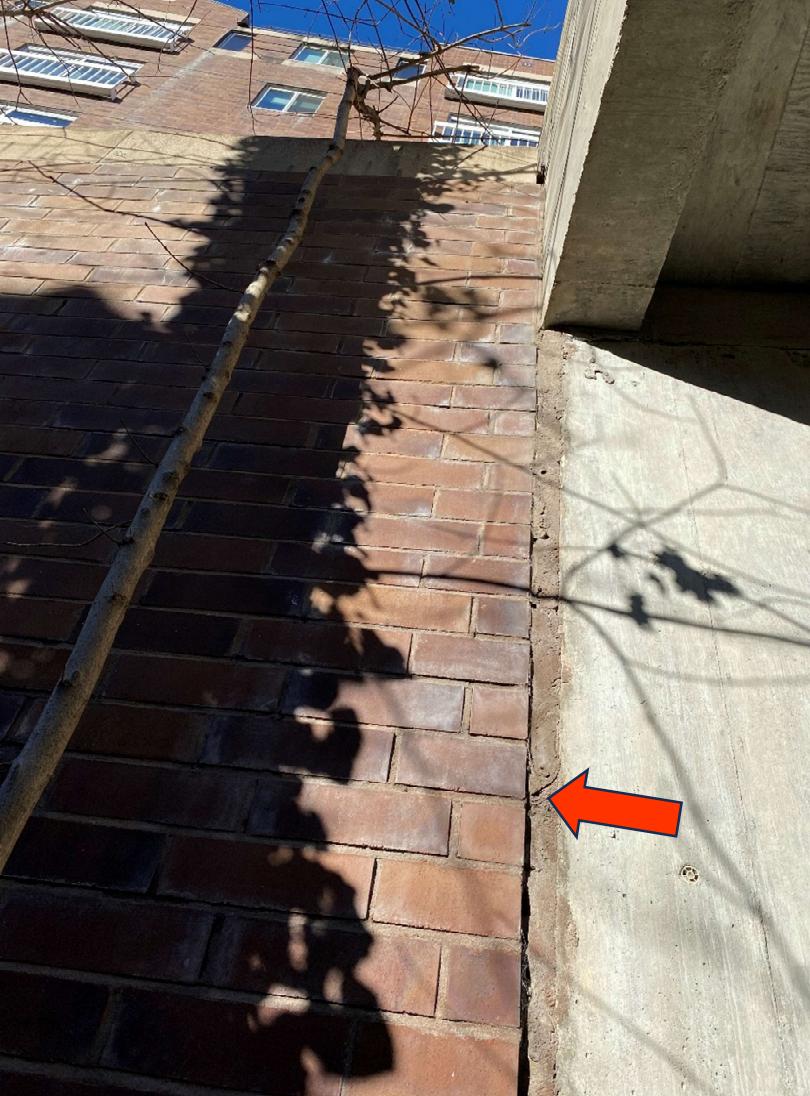
11. Open/failing joint between the brick masonry and concrete wall at the east elevation of the parking garage (Photo 18).

<p><b>Photo 18:</b> Open/failing joint between the brick masonry and concrete wall at the east elevation of the parking garage</p>

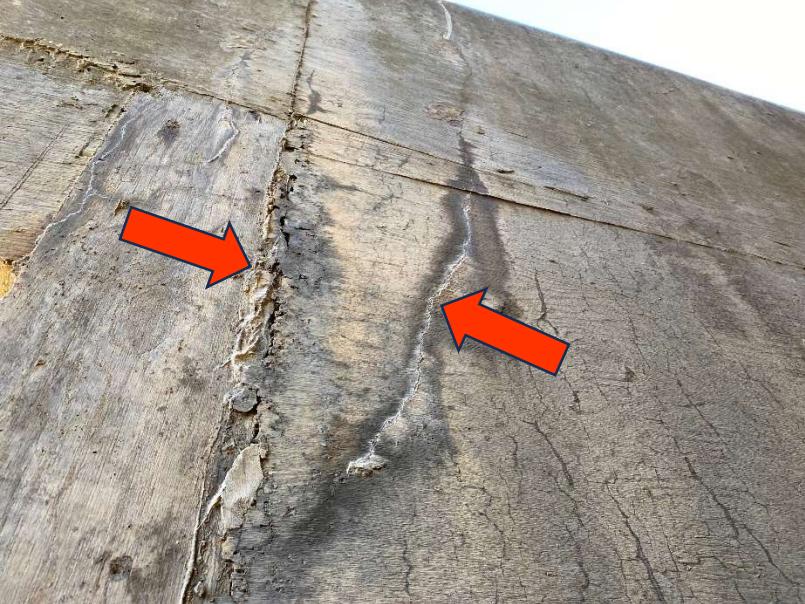
12. Gaps, honeycombs, and cracks in the exterior concrete wall at the east side of the loading dock (Photo 19).
13. Holes in the concrete foundation wall at the front of the loading dock, constructed by others. We were told that water leaked out of these holes, once constructed (Photo 20).

<p><b>Photo 19:</b> Gaps, honeycombs, and cracks in the exterior concrete wall at the east side of the loading dock</p>

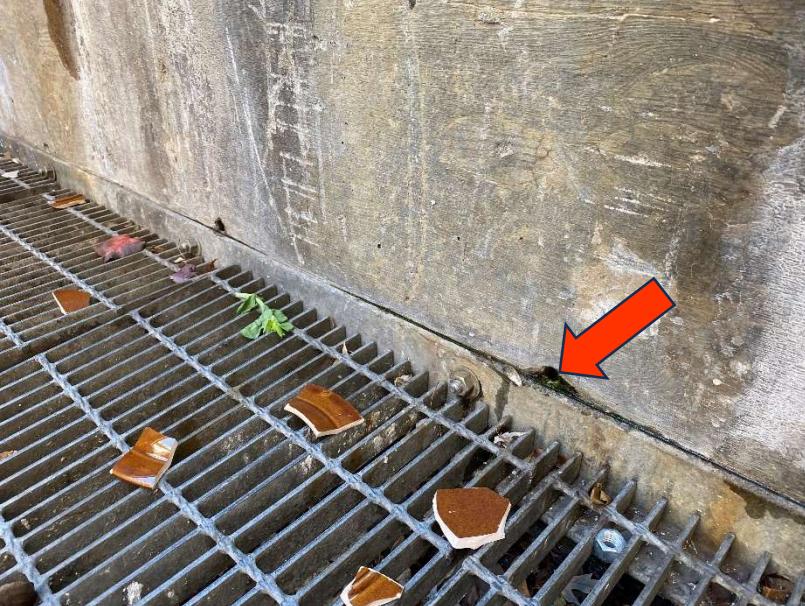
<p><b>Photo 20:</b> Holes in the concrete foundation wall at the front of the loading dock, constructed by others. We were told that water leaked out of these holes, once constructed.</p>

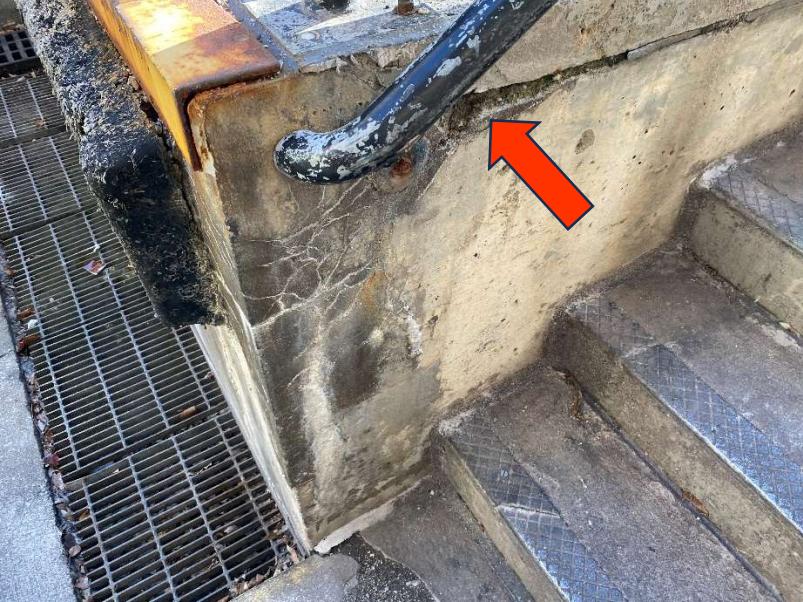
14. Spalls concrete at the loading dock slab and stairs (Photos 21 - 22).
15. Missing through wall flashings along the perimeter of the loading dock and at the side of the loading dock stairs (Photo 22).

<p><b>Photo 21:</b> Spalls concrete at the loading dock slab and stairs</p>

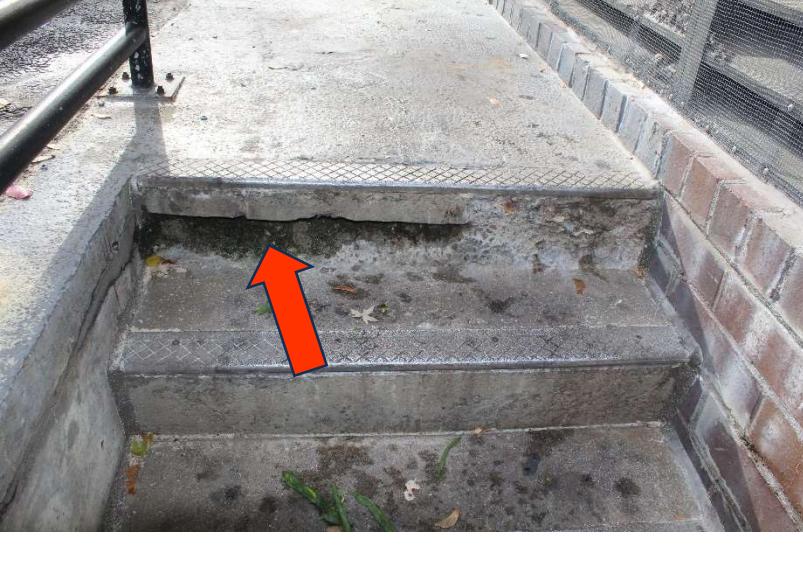
<p><b>Photo 22:</b> Spalls concrete at the loading dock slab and stairs</p>

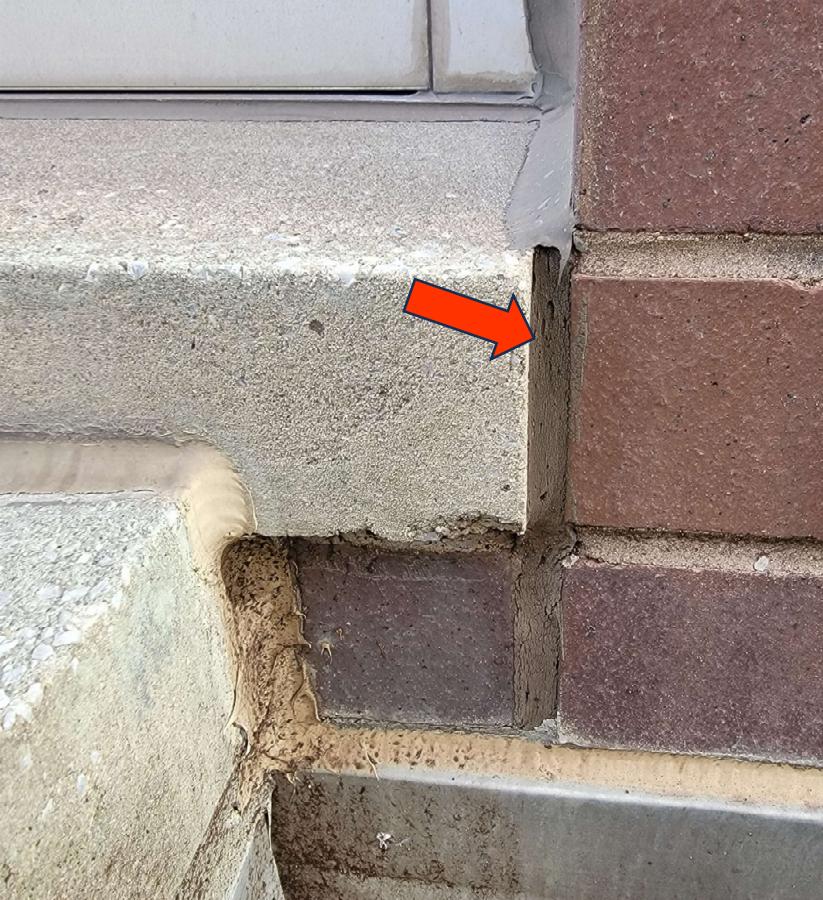
16. Failing surface-applied sealants along the loading dock ramp and stairs.
17. Perimeter sealants at the south brick masonry exterior wall of the first-floor common area that have passed their useful service life (Photo 23).

<p><b>Photo 23:</b> Perimeter sealants at the south brick masonry exterior wall of the first-floor common area that have passed their useful service life</p>

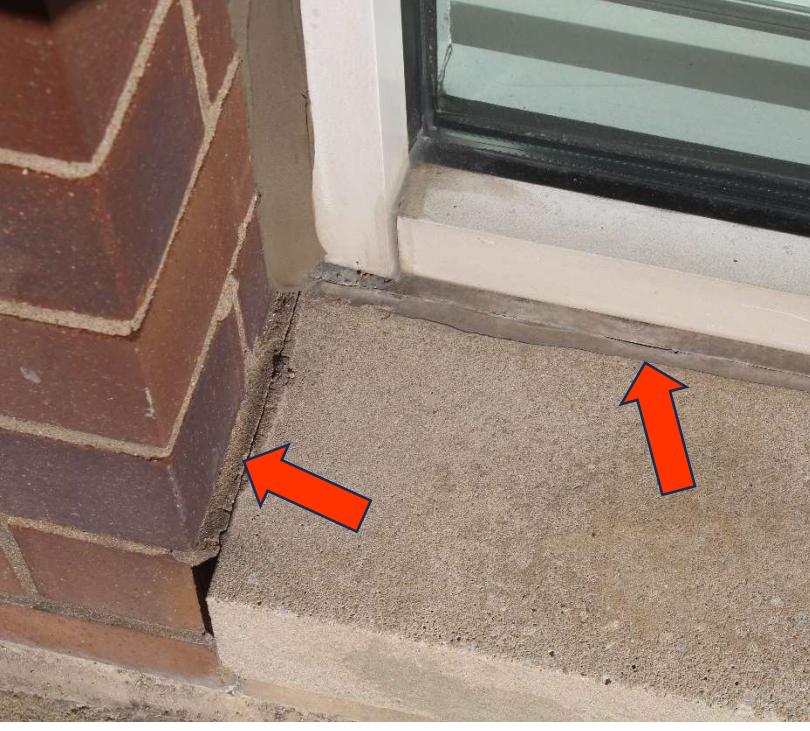
20. Open mortar and failed surface-applied sealants at the cast stone curbs beneath the storefront windows/doors at the south wall of the first-floor common area (Photo 24).

<p><b>Photo 24:</b> Open mortar and failed surface-applied sealants at the cast stone curbs beneath the storefront windows/doors at the south wall of the first-floor common area</p>

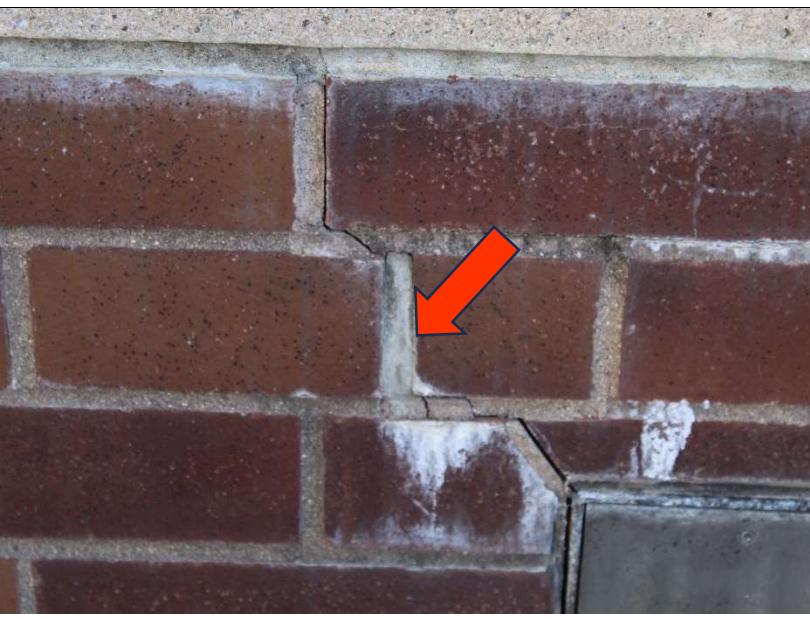
21. Surface-applied sealants at the planter walls on first floor common terrace that are open and have passed their useful service life.
22. Cracks within the brick veneer mortar and efflorescence on the brick masonry at the first-floor common terrace (Photo 25).

<p><b>Photo 25:</b> Cracks within the brick veneer mortar and efflorescence on the brick masonry at the first-floor common terrace</p>

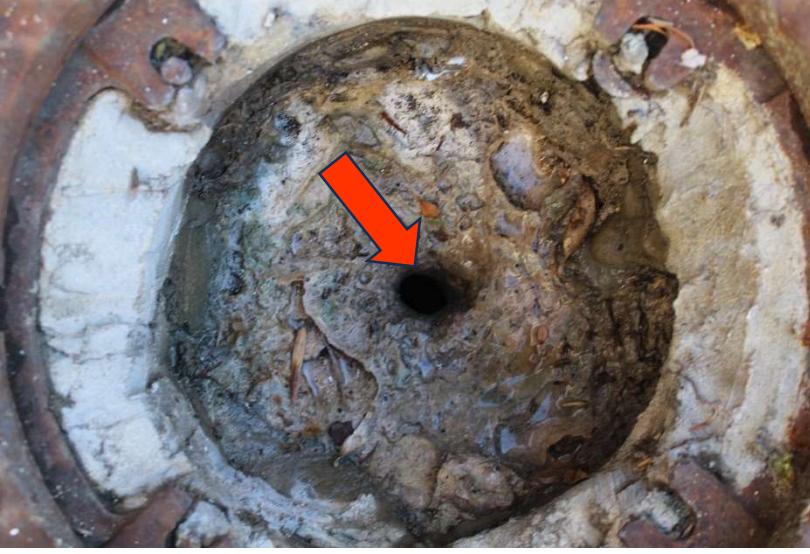
It is unclear if there is a waterproofing membrane and/or drainage mat between the slabs at these terraces. However, the terrace drains at this building do not allow water to discharge from the lower slab. Mortar was applied around the inside of the terrace drain bodies covering any weep holes or perforation in the drain bodies designed to evacuate the water. In addition, the mortar buildup has closed the opening of the drain piping reducing the discharge capacity of the drains. Therefore, any water that is directed from the cavity wall or from defects in perimeter sealants at the terrace becomes trapped in the interstitial space which becomes overwhelmed with water causing leakage at the interior. Also, standing water causes leaks in the slab through defects/cracks in the concrete that may not otherwise leak if the water could flow freely to the drains.

<p><b>Photo 26:</b> Surface drains at the terrace that have limited drainage due to mortar buildup at the drain opening and have mortar covering the weep holes around the drain bowl preventing water from evacuating from the split-slab construction</p>

To minimize the risk of further leakage into the parking garage, the terrace topping slab should be removed and replaced with a paver system over a new waterproofing system with new bi-level drains. However, we understand that this is costly, and a first approach may be to replace the bi-level drains to confirm whether that addresses all leaks.

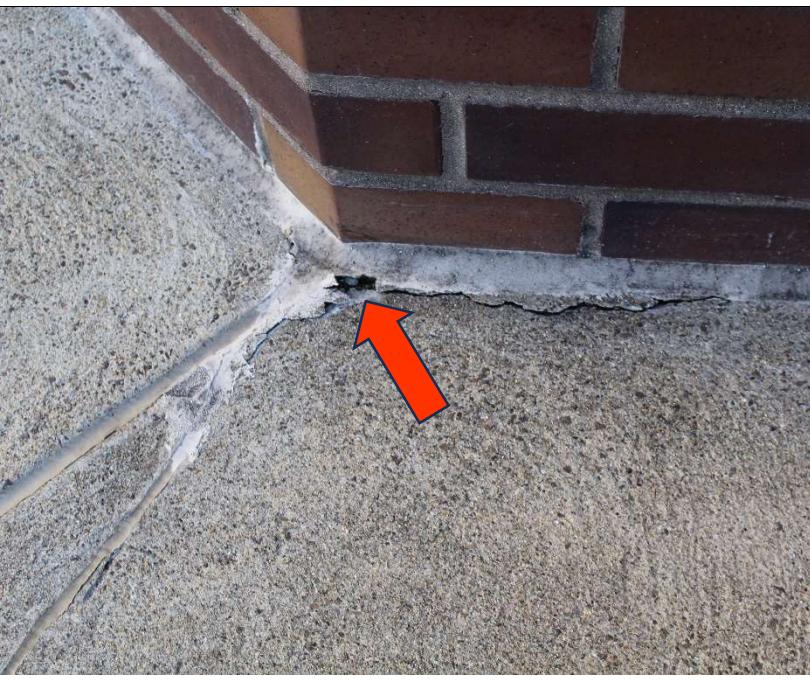
24. Surface-applied sealants at the pool area have failed allowing water to migrate into the split slab construction and possibly into the lower-level pool area through unsealed penetrations in the structural slab (Photo 27).

<p><b>Photo 27:</b> Surface-applied sealants at the pool area have failed allowing water to migrate into the split slab construction and possibly into the lower-level pool area through unsealed penetrations in the structural slab</p>

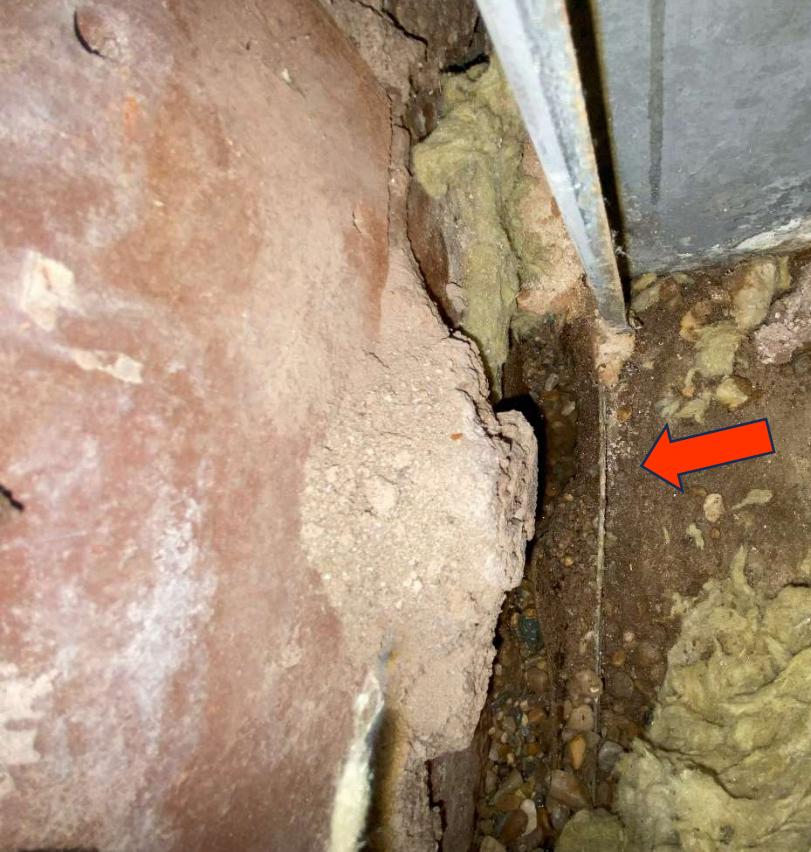
1. Moisture, corroded studs, and dirt within the exterior wall assembly at the south elevation of the first-floor common area (Photo 28).
2. Calcium carbonate build-up beneath pipe penetrations through the concrete foundation walls beneath the pool (Photos 29 - 30).

- Corroded steel studs and steel bottom track, wet insulation, deteriorated exterior sheathing, and water within the pea stone in the cavity (Photo 28).

<p><b>Photo 28:</b> Moisture, corroded studs, and dirt within the exterior wall assembly at the south elevation of the first-floor common area</p>

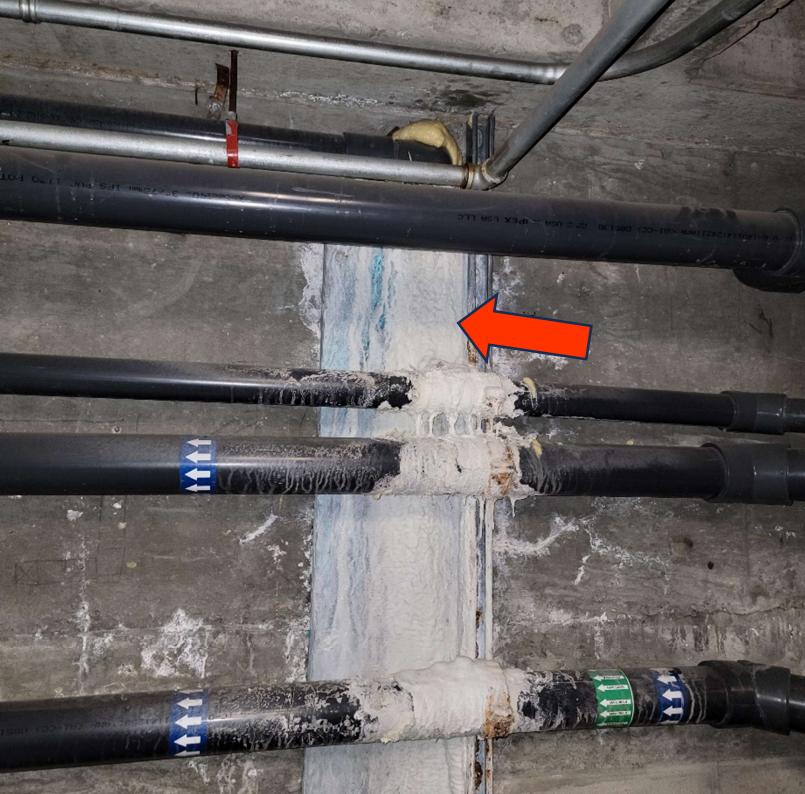
<p><b>Photo 29:</b> Calcium carbonate build-up beneath pipe penetrations through the concrete foundation walls beneath the pool</p>

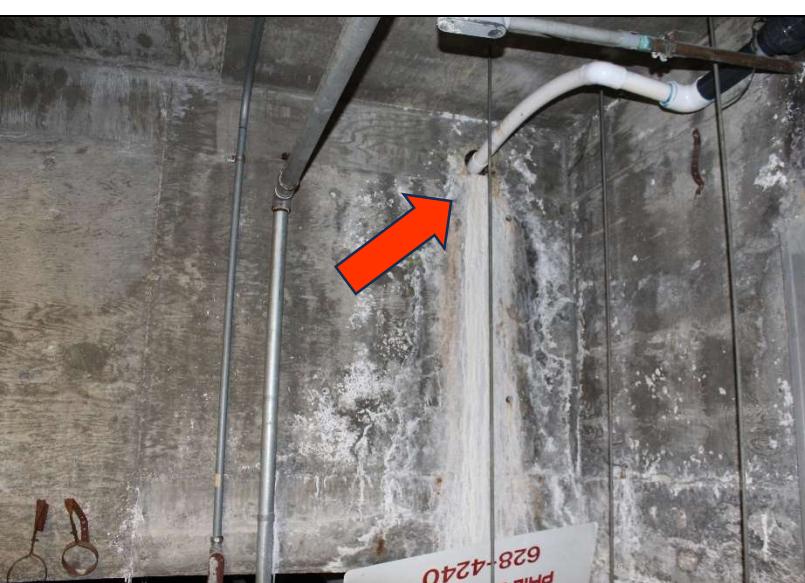
<p><b>Photo 30:</b> Calcium carbonate build-up beneath pipe penetrations through the concrete foundation walls beneath the pool</p>

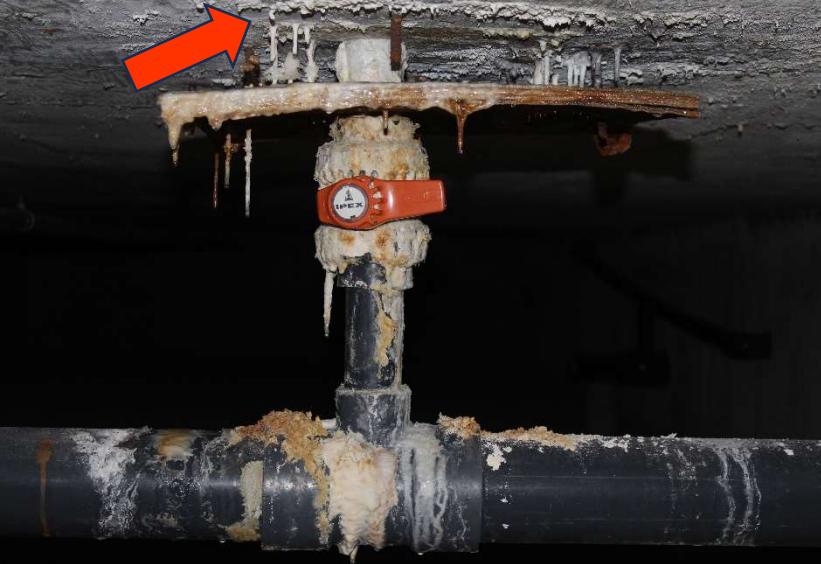
3. Calcium carbonate build-up around pipe penetrations through the concrete slab beneath the pool. Also, water/moisture on the concrete slab on grade beneath the pipe penetrations (Photo 31).

<p><b>Photo 31:</b> Calcium carbonate build-up around pipe penetrations through the concrete slab beneath the pool. Also, water/moisture on the concrete slab on grade beneath the pipe penetrations</p>

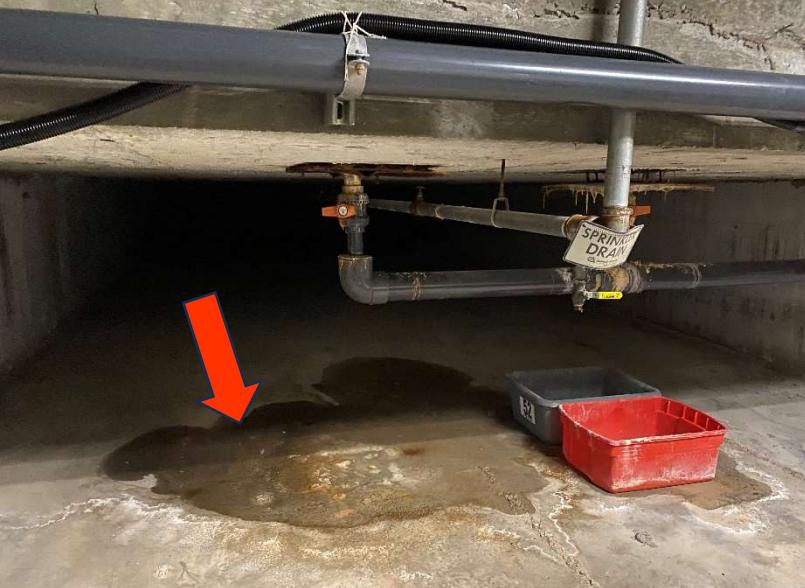
<p><b>Photo 31a:</b> Ponded water on the slab beneath the pool.</p>

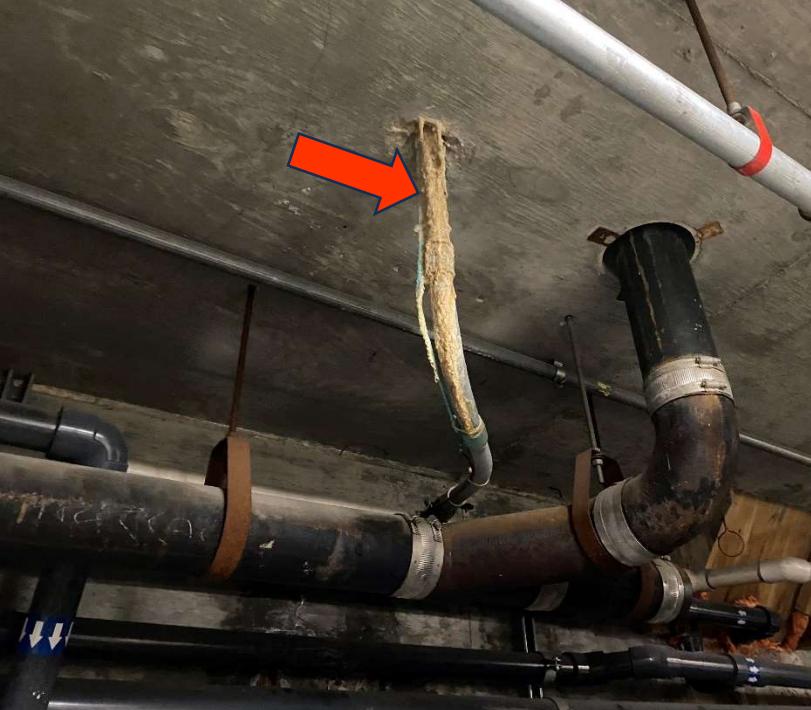
A photograph showing a network of pipes and conduits in an underground or semi-underground space. A vertical metal conduit is visible, with a significant amount of yellowish-brown calcium carbonate build-up around its base and where it penetrates the surrounding concrete. A red arrow points to this build-up. The surrounding area is made of concrete, and other pipes are visible in the background.	<p><b>Photo 32:</b> Calcium carbonate build-up around conduit and conduit penetrations beneath the pool terrace</p>

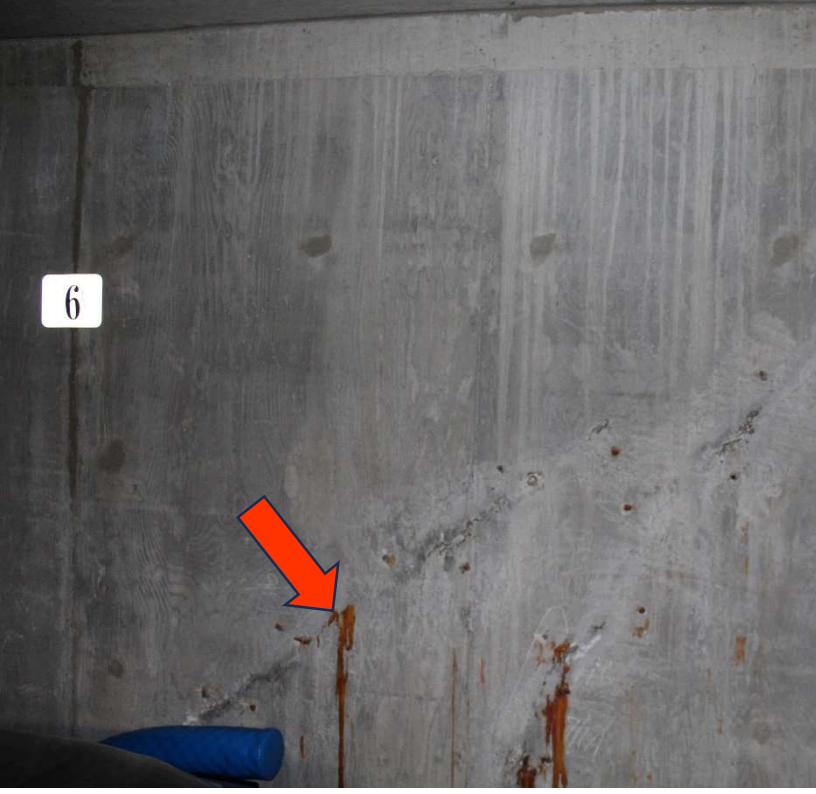
6. Cracks and previous injection repairs at the east foundation wall in the parking garage (Photo 33).
7. Cracks and previous injection repairs at the underside of the concrete slab/ceiling beneath the east terrace, in the upper-level parking garage (Photo 34).

<p>6</p>	<p><b>Photo 33:</b> Cracks and previous injection repairs at the east foundation wall in the parking garage</p>

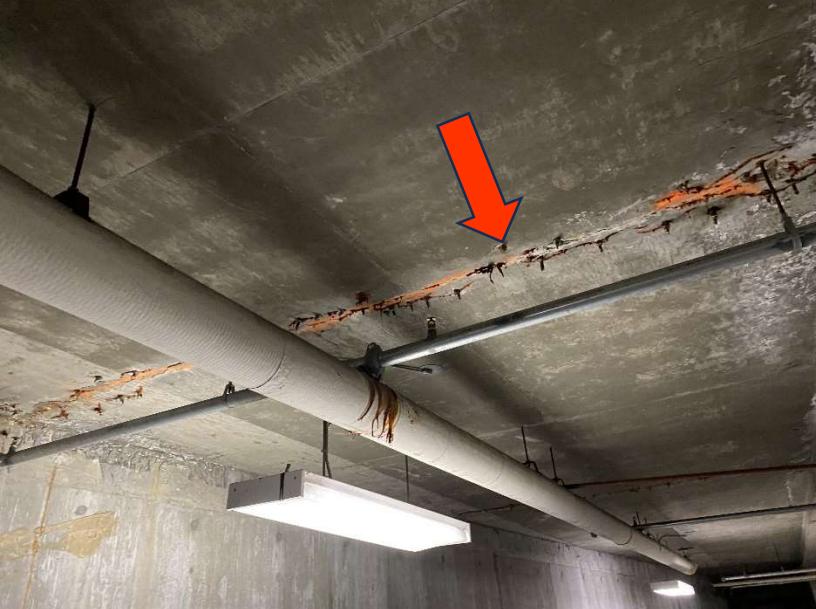
<p><b>Photo 34:</b> Cracks and previous injection repairs at the underside of the concrete slab/ceiling beneath the east terrace, in the upper-level parking garage</p>

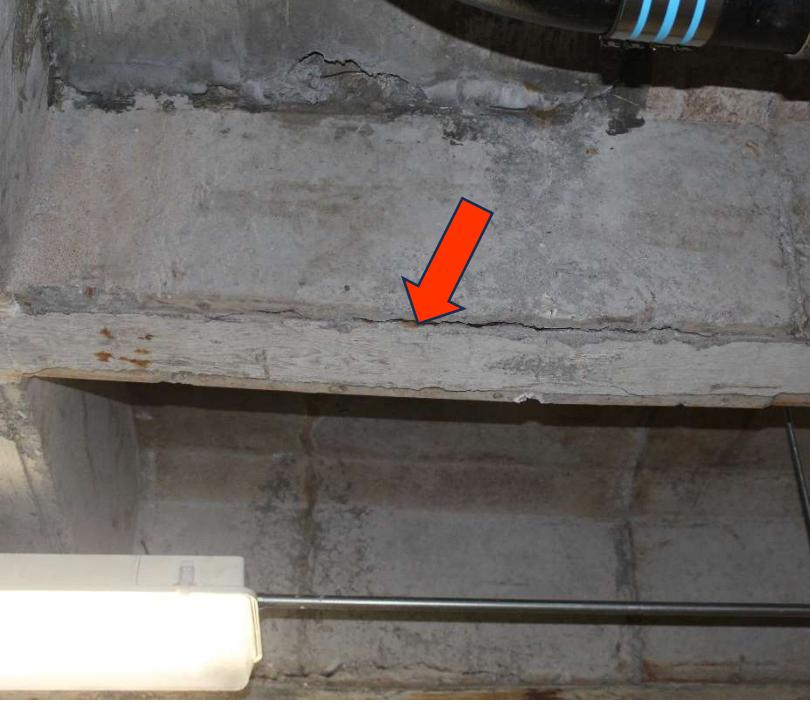
8. Cracks in concrete beams at ceiling in the garage (Photo 35).
9. Delaminated concrete beams with exposed and corroded rebar at ceiling in the garage (Photo 36).

<p><b>Photo 35:</b> Cracks in concrete beams at ceiling in the garage</p>

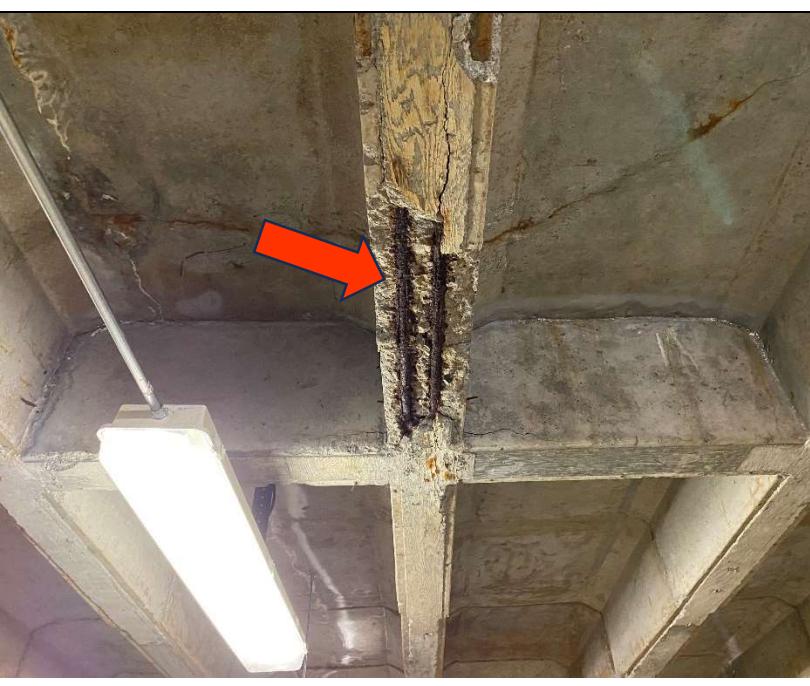
- Corroded reinforcing steel (Photo 36).
- Inadequate concrete cover over the reinforcing steel.

<p><b>Photo 36:</b> Delaminated concrete beams with exposed and corroded rebar at ceiling in the garage</p>

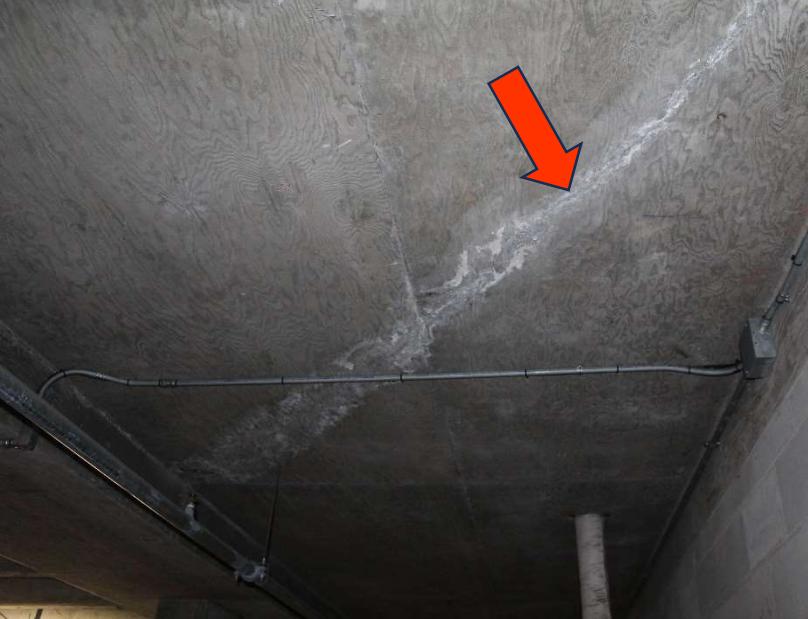
10. Hairline cracks in the underside of the concrete slab in the parking garage (Photo 37).
11. Cracks in the wearing surface of the parking garage slabs with failing repair sealants and water around drains (Photo 38).

<p><b>Photo 37:</b> Hairline cracks in the underside of the concrete slab in the parking garage</p>

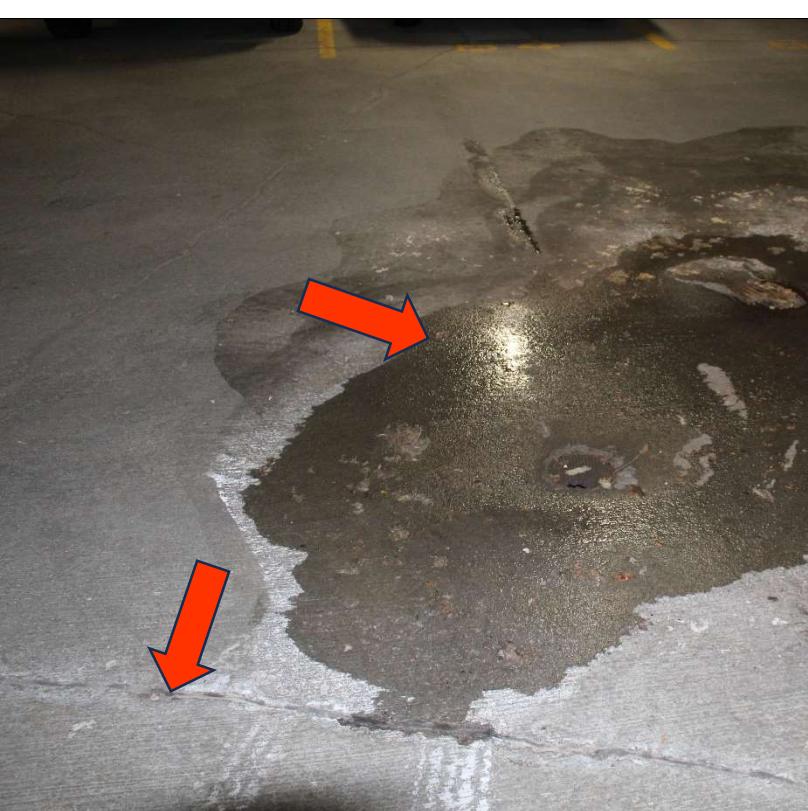
<p><b>Photo 38:</b> Cracks in the wearing surface of the parking garage slabs with failing repair sealants and water around drains</p>
