February 2, 2024  
*Revised: February 27, 2024*

## **BUILDING ENVELOPE STUDY – BAY SQUARE CONDOMINIUMS**

Bay Square Condominiums  
950 Massachusetts Avenue  
Cambridge, MA 02139

BRS/Building RECON Services  
A BRS/Building Restoration Services Corp entity  
371 Dorchester Avenue  
Boston, MA 02147

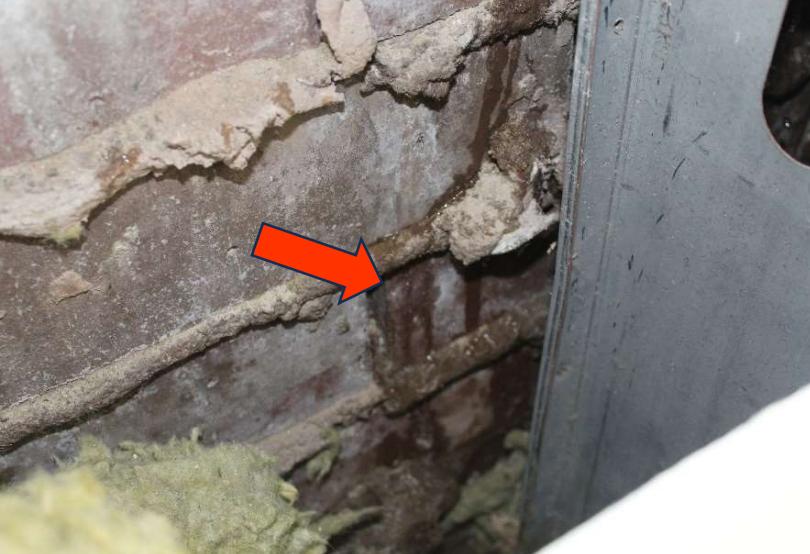
<p><b>Photo 39:</b> Water was applied to the storefront windowsill for thirty minutes. Ten minutes after the test began, water was observed seeping through the brick. Water was also observed building up in the cavity at base of the wall.</p>

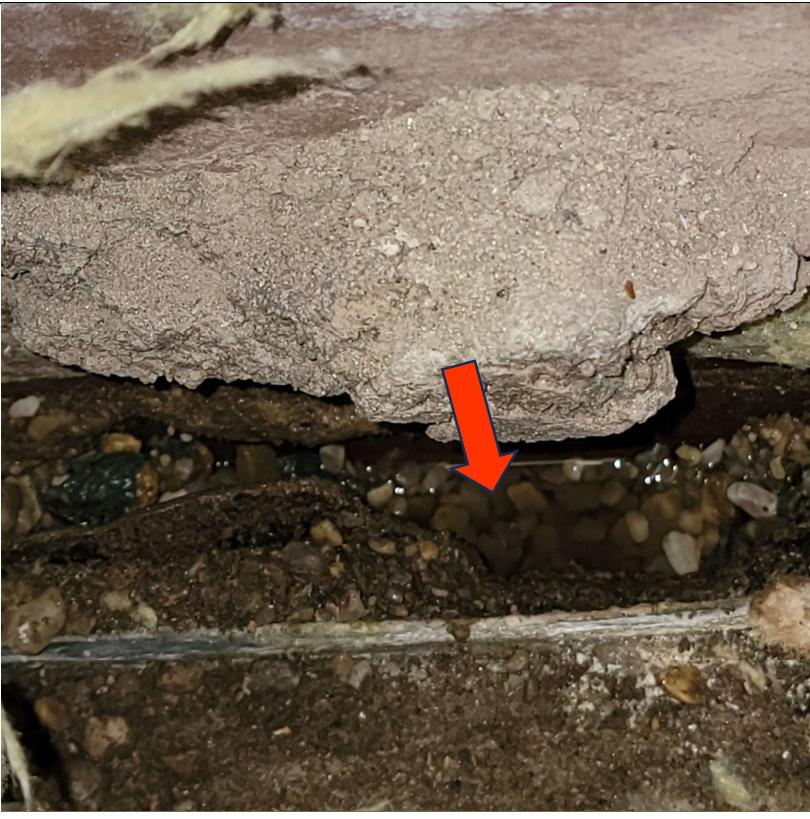
<p><b>Photo 40:</b> Water was applied to the storefront windowsill for thirty minutes. Ten minutes after the test began, water was observed seeping through the brick. Water was also observed building up in the cavity at base of the wall.</p>

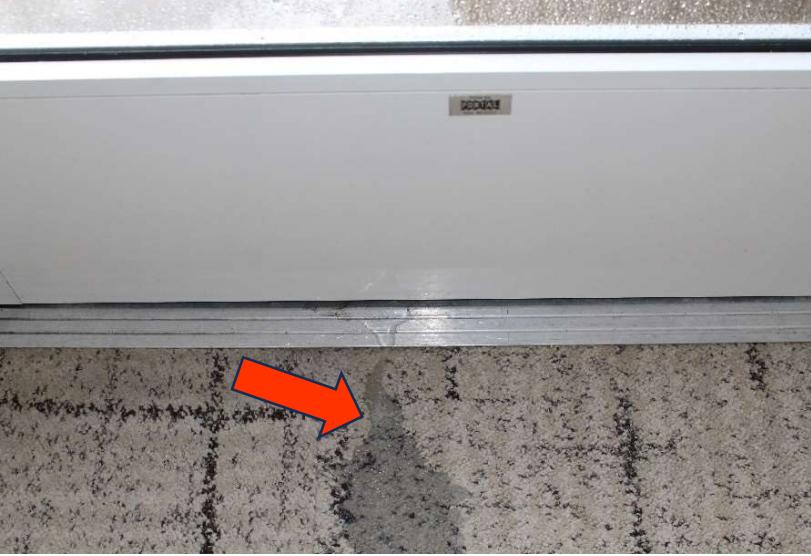
5	South elevation, exterior wall from lobby, courtyard, window & doorsill	AAMA Standard 501.2	Water was applied to the bottom of the entry door for twenty-five minutes. After fifteen minutes, water was observed seeping beneath the carpet and leaking over the threshold, beneath the entry door <b>(Photos 41 - 42)</b> .

<p><b>Photo 41:</b> Water was applied to the bottom of the entry door for twenty-five minutes. After fifteen minutes, water was observed seeping beneath the carpet and leaking over the threshold, beneath the entry door.</p>

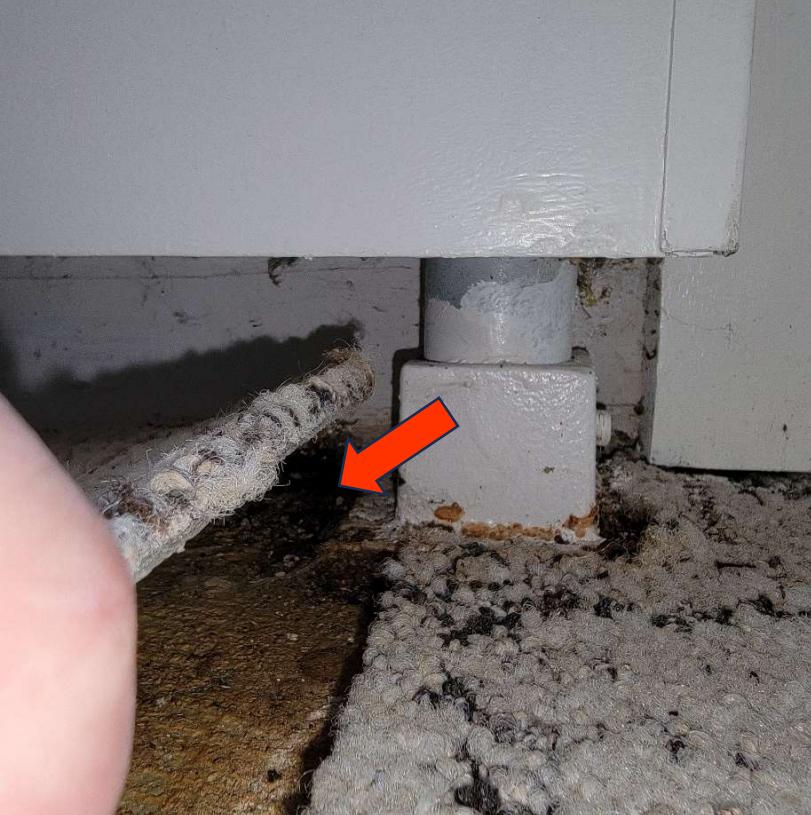
<p><b>Photo 42:</b> Water was applied to the bottom of the entry door for twenty-five minutes. After fifteen minutes, water was observed seeping beneath the carpet and leaking over the threshold, beneath the entry door.</p>

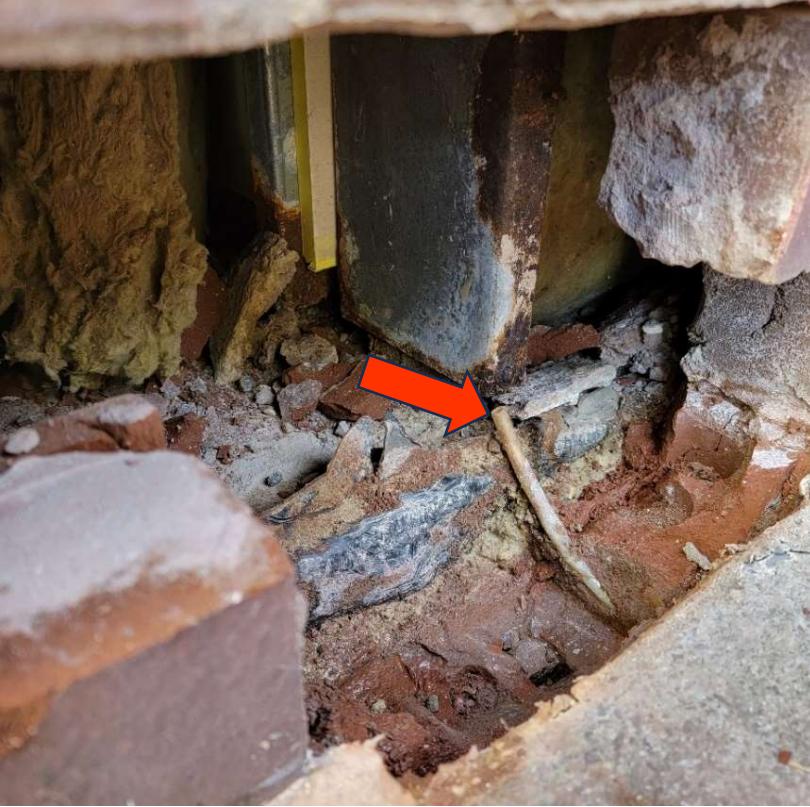
At the south exterior wall of the first-floor common area, three bricks were removed above the terrace slab between the west planter and the exterior door (Photos 43 - 44). We observed the following, at this location:

- Corroded steel studs and steel bottom track, wet insulation, deteriorated exterior sheathing, and water within the pea stone in the cavity.
- Steel studs are not in contact with the bottom track due to excessive corrosion (Photo 44).
- Straw vent weeps are installed between the split slab and extend up into the brick cavity wall (Photo 43).

<p><b>Photo 43:</b> Corroded steel studs and steel bottom track, wet insulation, deteriorated exterior sheathing, and water within the pea stone in the cavity.</p> <p>Steel studs are not in contact with the bottom track due to excessive corrosion.</p> <p>Straw vent weeps are installed between the split slab and extend up into the brick cavity wall.</p>

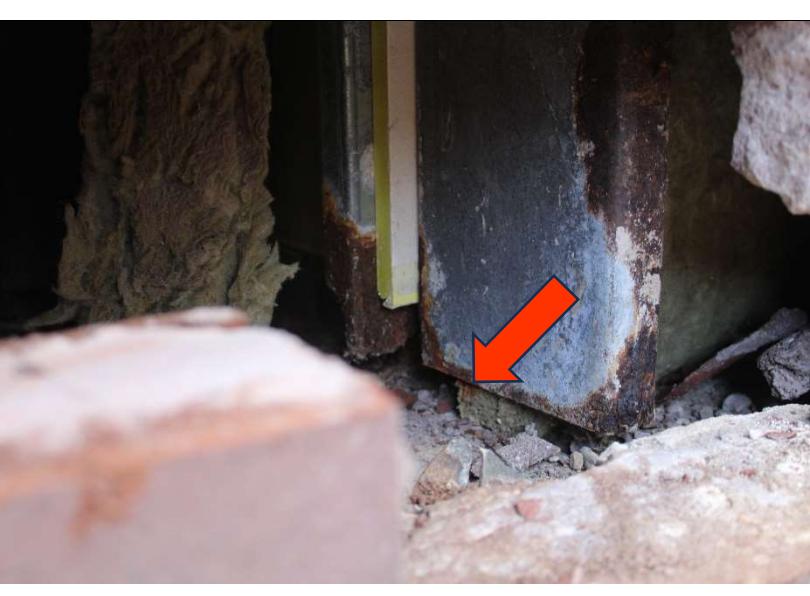
<p><b>Photo 44:</b> Corroded steel studs and steel bottom track, wet insulation, deteriorated exterior sheathing, and water within the pea stone in the cavity.</p> <p>Steel studs are not in contact with the bottom track due to excessive corrosion.</p>

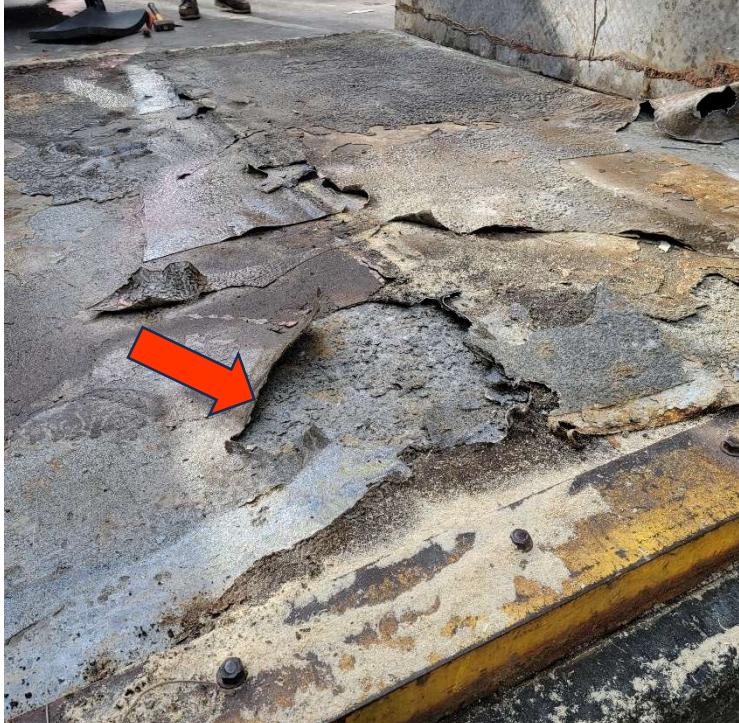
- Traffic coating on the loading dock slab that has failed and debonded from the concrete slab (Photo 45).
- Deteriorated concrete slab with exposed aggregate and moisture within the concrete slab (Photo 46).

<p><b>Photo 45:</b> Traffic coating on the loading dock slab that has failed and debonded from the concrete slab.</p>

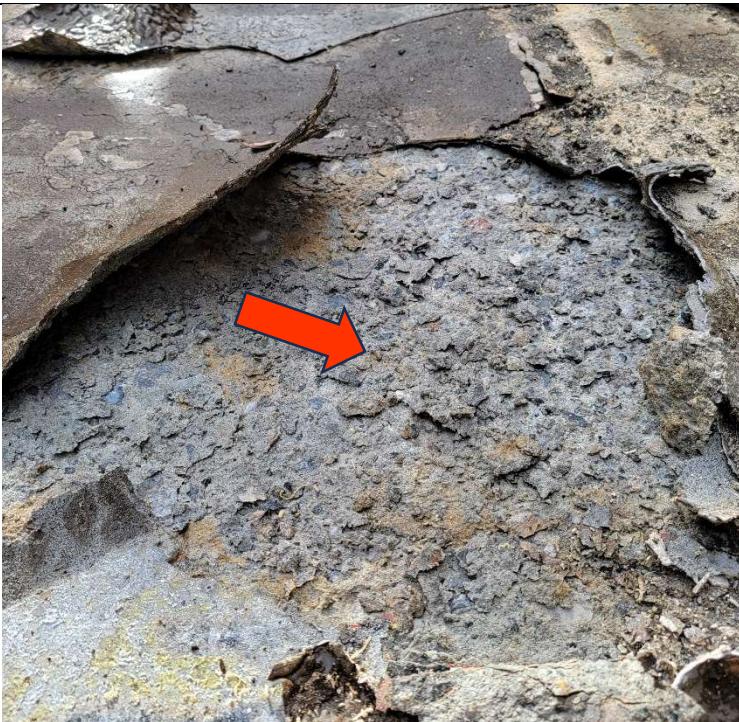
<p><b>Photo 46:</b> Deteriorated concrete slab with exposed aggregate and moisture within the concrete slab.</p>

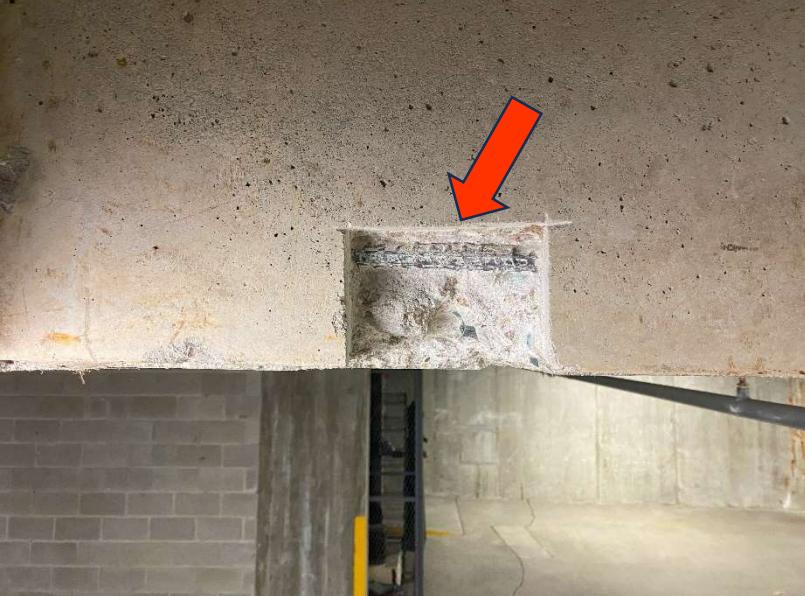
- Reinforcing steel with no evidence of corrosion (Photo 47).
- Proper concrete cover over the reinforcing steel (Photo 48).

<p><b>Photo 47:</b> Reinforcing steel with no evidence of corrosion at the upper-level parking garage floor beam.</p>

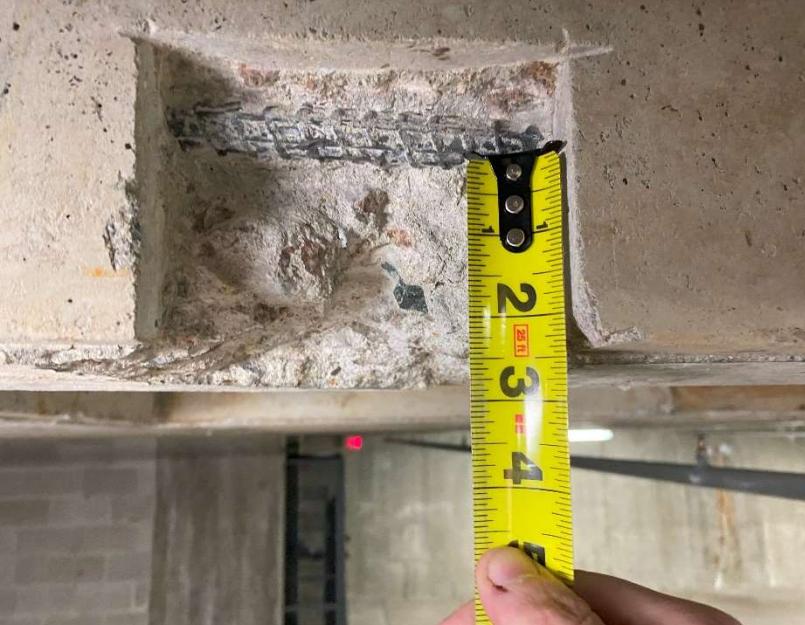
<p><b>Photo 48:</b> Proper concrete cover over the reinforcing steel at the upper-level parking garage floor beam.</p>
