# *Condominium* Capital Needs Assessment and Replacement Reserve Analysis

Bay Square  
Cambridge, MA

March 25, 2016

*Final Report (v.3)*

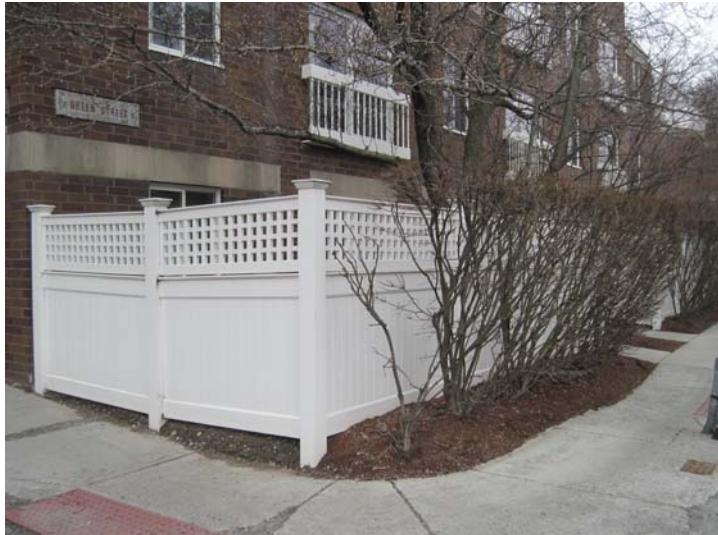
The townhouse-style units at the rear (Green Street) elevation feature low-maintenance Azek PVC privacy screen fence enclosures, all newly installed in 2012

7. New Azek PVC fencing was installed at the Green Street private patios in 2010 and at the rear courtyard in 2012. All fencing remains in good observable condition with no cracked or damaged/leaning sections noted during the assessment. Replacement of the Green Street patio fencing is shown in Year 19, based on a twenty-five year expected useful service life. Replacement of the rear courtyard fencing is not anticipated within the twenty-year timeframe of this plan.

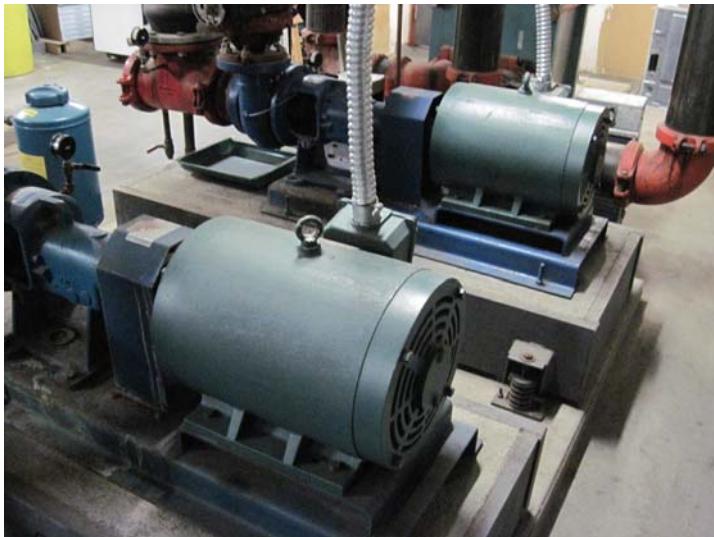
The service loop water is circulated by this pair of Leeson WattSaver 40-hp pumps. Both pump motors were recently replaced in 2012.

16. The 40-hp service loop pump motors were replaced in 2011; and future replacement of both motors is shown in Year 15, based on a twenty-year expected useful service life. The service loop pumps are rebuilt approximately every fifteen years; and alternating rebuild costs are shown in Years 2, 9, and 17.

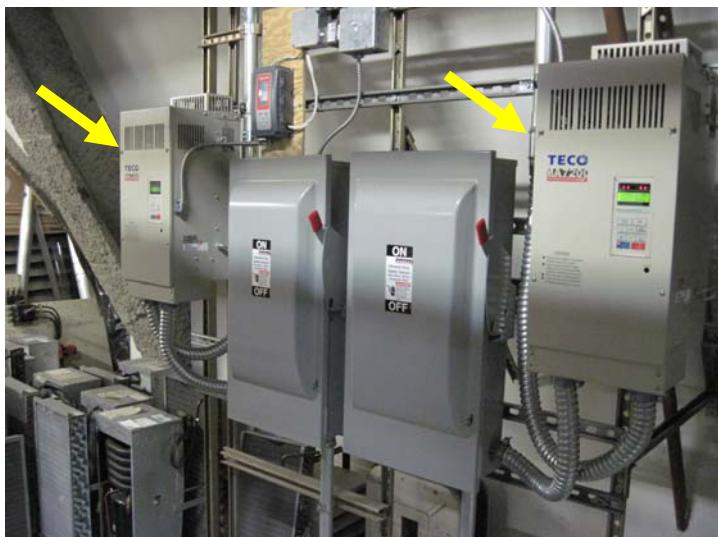
The service loop pumps are each controlled by a 40-hp Teco MA7200 variable frequency drive (VFD) which save energy, reduce wear and tear, and help extend the life of the pumps

17. The Teco service loop pump VFD's were newly installed in 2014. Replacement of these units is shown in Year 13, after fifteen years of use.
18. Rebuilding of the cooling tower loop pumps and motors are shown on alternating cycles throughout the plan based on the last-reported rebuild for each pump and motor.

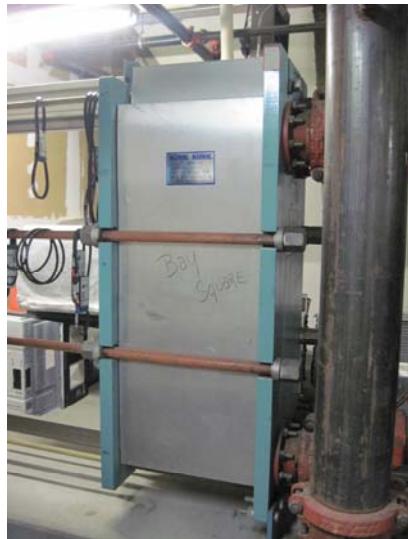
The service loop is warmed by the boiler water or cooled by the cooling tower water via this Alfa-Laval A15-BFG, 4600 sf, 150 PSI, plate and frame heat exchanger.

15. The Alfa-Laval plate and frame heat exchanger is periodically opened, inspected, cleaned, and all gaskets are checked and replaced as-needed. Costs to continue this preventative maintenance work are shown every five years throughout the plan.

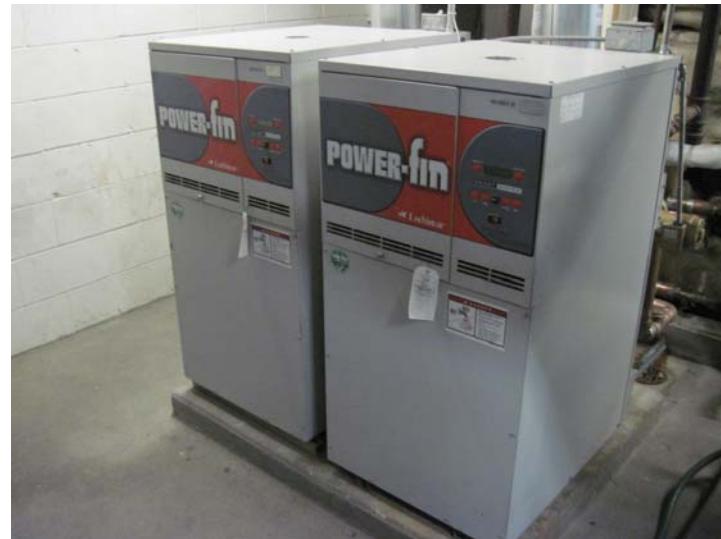
The building domestic hot water is created by this pair of dedicated Power-Fin 500 MBH (87% AFUE) natural gas-fired DHW boilers.

21. Future replacement of the Power-Fin DHW boilers with high-efficiency condensing boilers is shown in Year 12.
22. The DHW storage tank was last re-lined in 2008. Future allowances for inspection and re-lining are shown in Years 2 and 12.

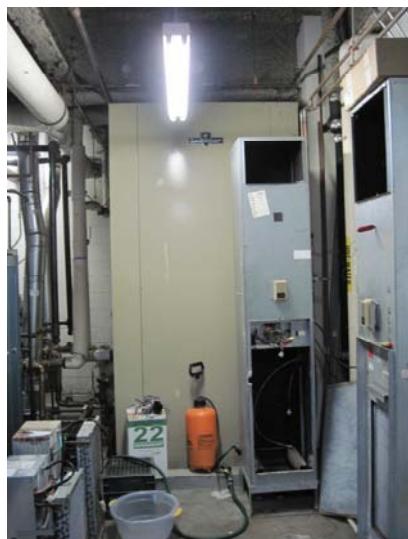
Domestic hot water is stored in this single Lochinvar 1,000 gallon indirect-fired storage tank which is periodically cleaned, inspected, and re-lined.

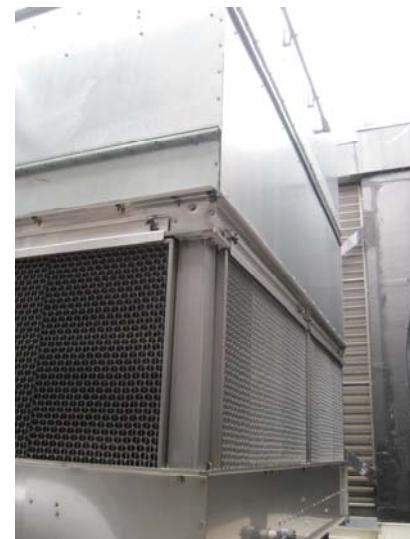
View of the Evapco induced draft, counterflow cooling tower. Newly installed in 2012.

20. The cooling tower was newly installed in 2012 and remains in good observable condition with no reported operating issues. Future replacement is shown in Year 20, after twenty-five years of use.

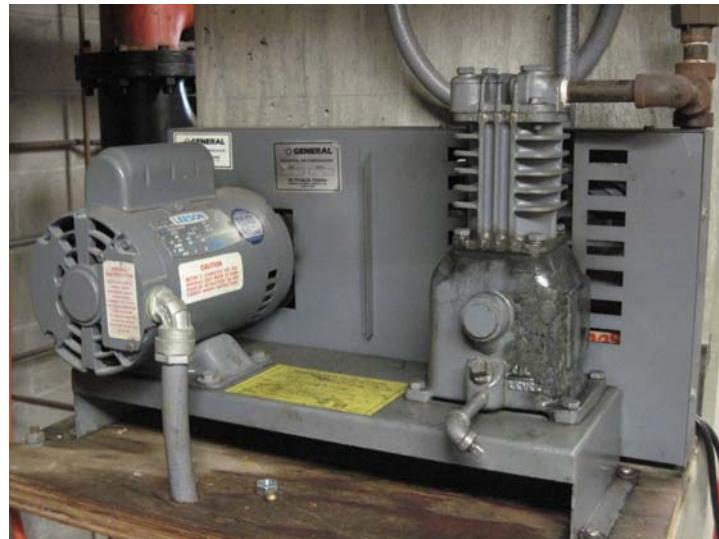
View of the parking garage dry-pipe fire suppression system Leeson 3/4-horsepower compressor.

28. The parking garage features a dry-pipe fire suppression system with 3/4-horsepower compressor that was reportedly replaced approximately fifteen years ago. Future compressor replacement is shown in Year 10, after twenty-five years of use.

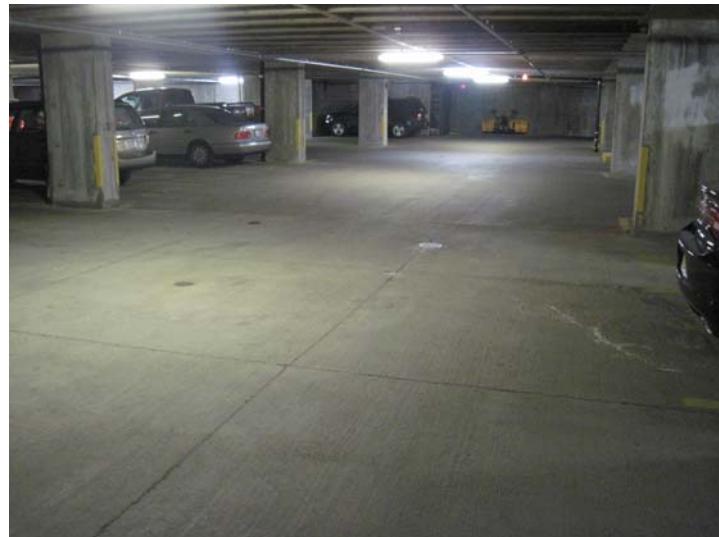
The lower garage currently has no epoxy concrete deck surface coating.

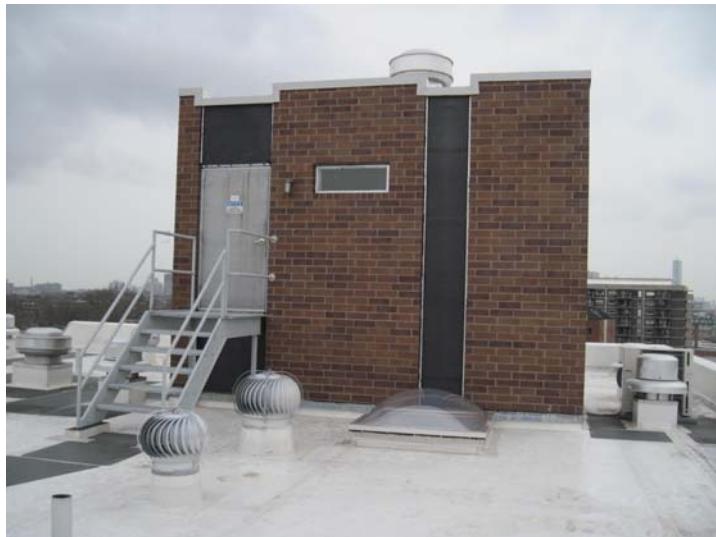
View of the east elevator penthouse.

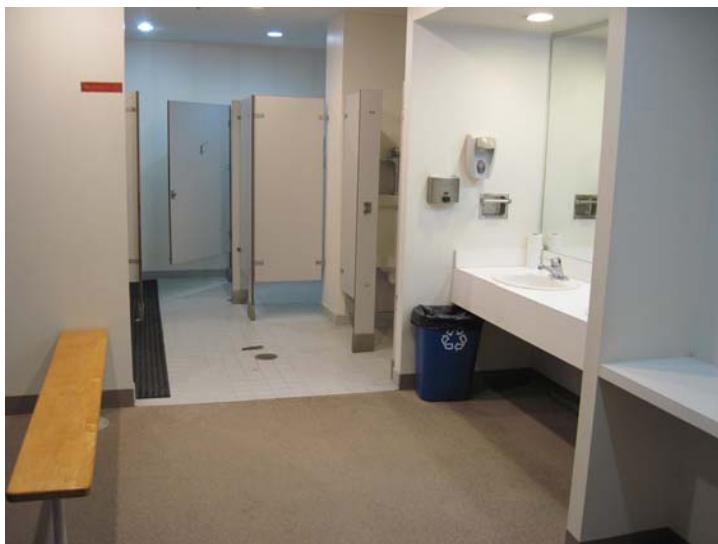
View of the men's locker room finishes. Painted walls and ceilings. Carpet in the dry area and ceramic tile in the wet area.
