CopelandBEC Engineering Study Addenda, Notes, and Errata

Bay Square Condominiums

950 Massachusetts Avenue
Cambridge, MA

Building Condition Assessment

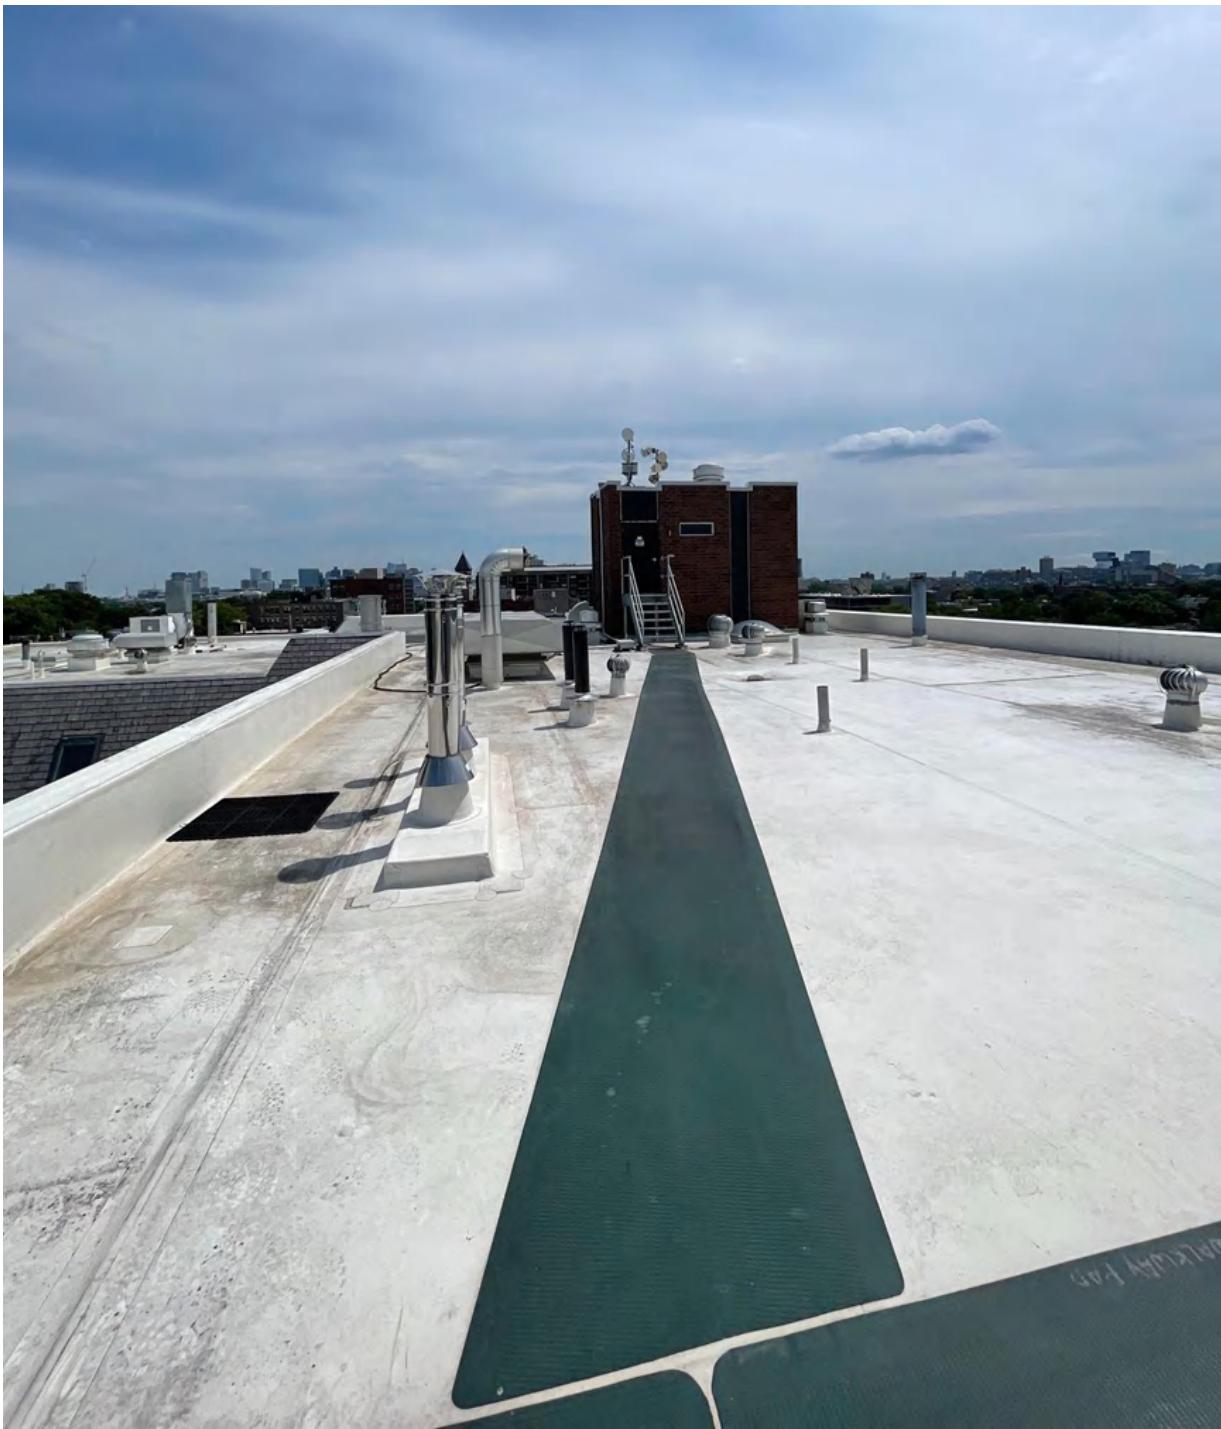
- L-shaped, 7th floor, low-slope roof area includes two, 1-story brick penthouses at the east and west side of the roof area with low-slope roofs that drain onto the main roof via scuppers and downspouts (Photo 1)

Photo 1: 7th floor low-slope roof

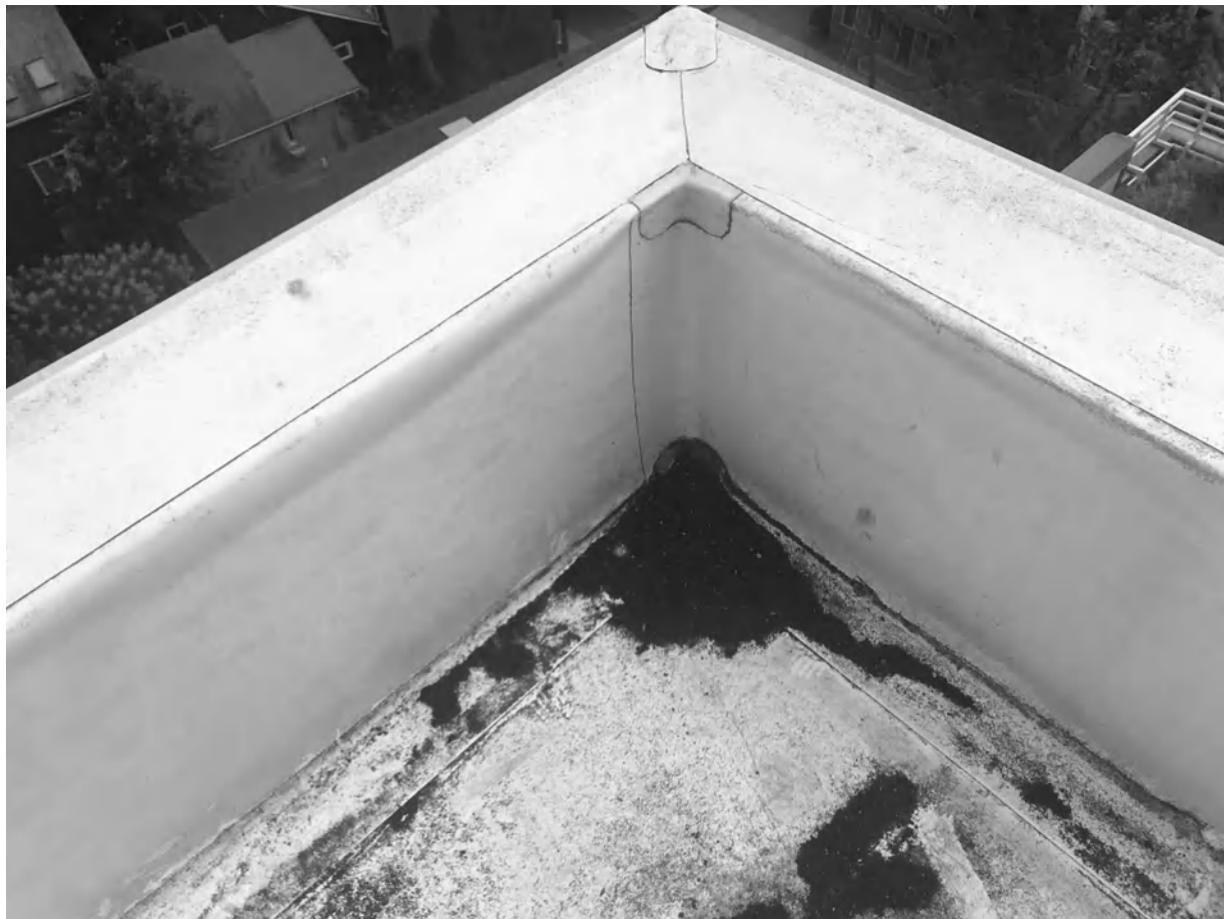
Photo 2: organic build-up on white reflective roof membrane surfaces in random locations

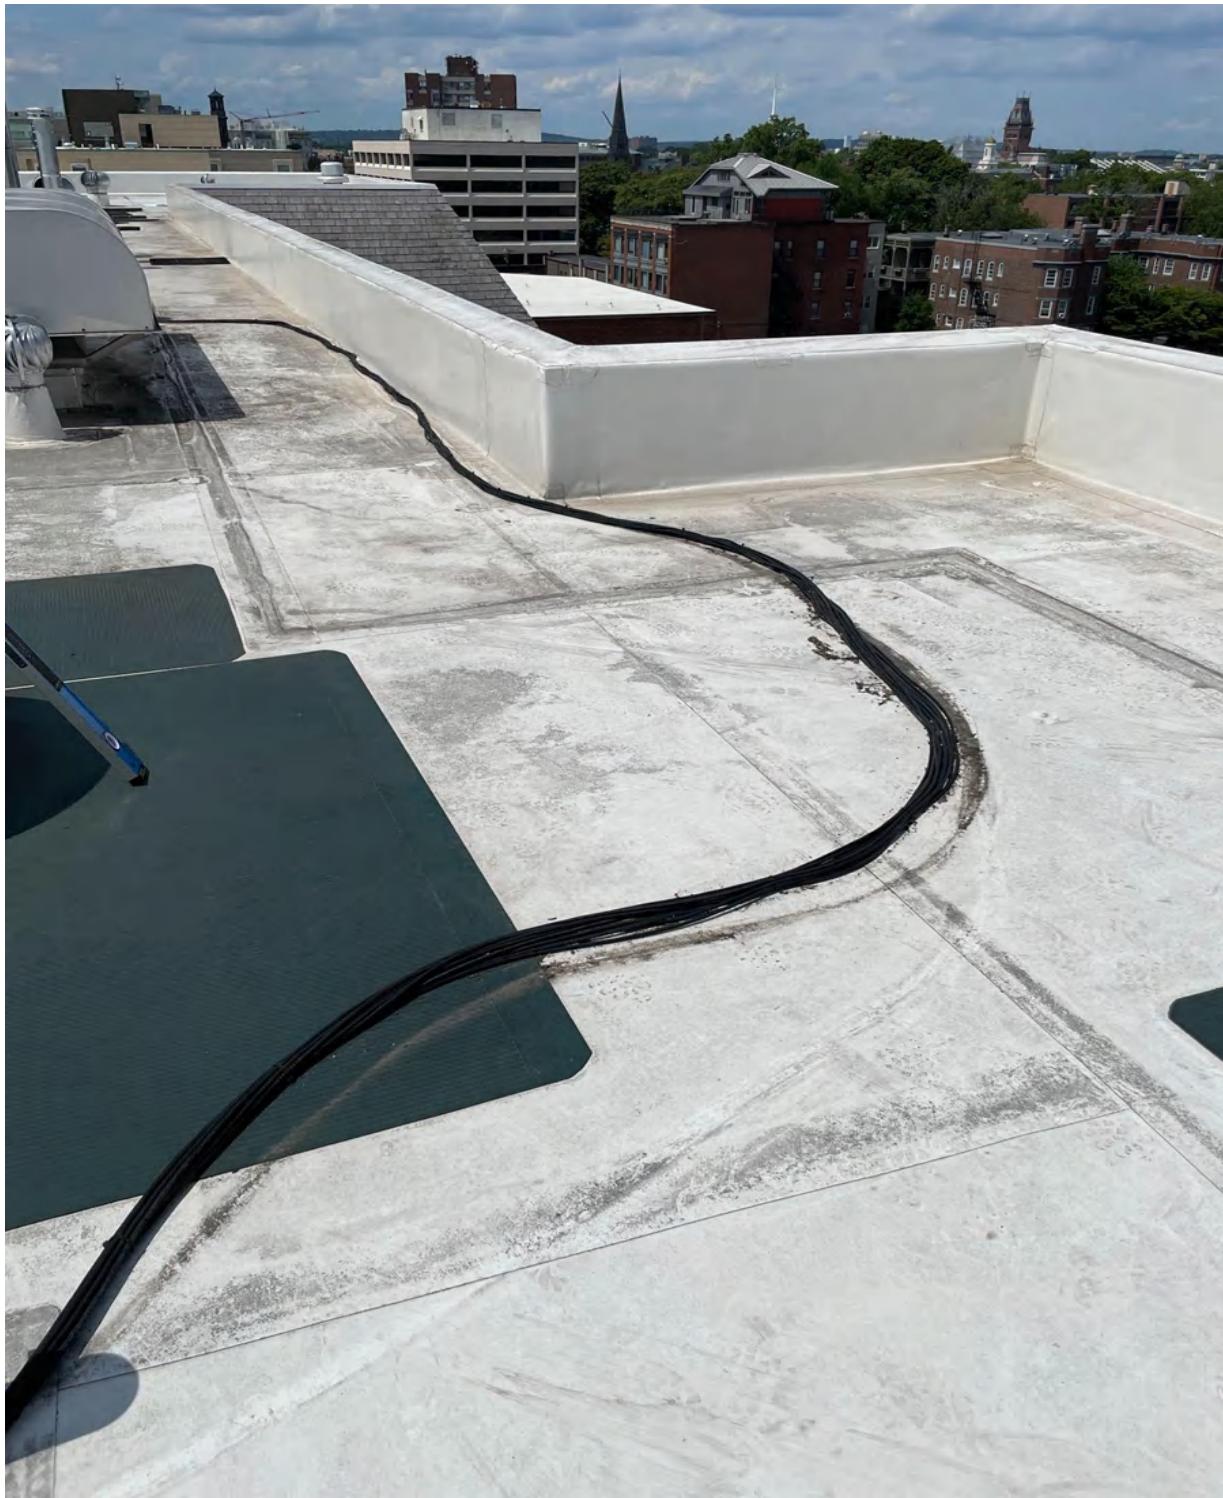
Photo 3: computer/data cabling laying directly on roof membrane surface (unattached)

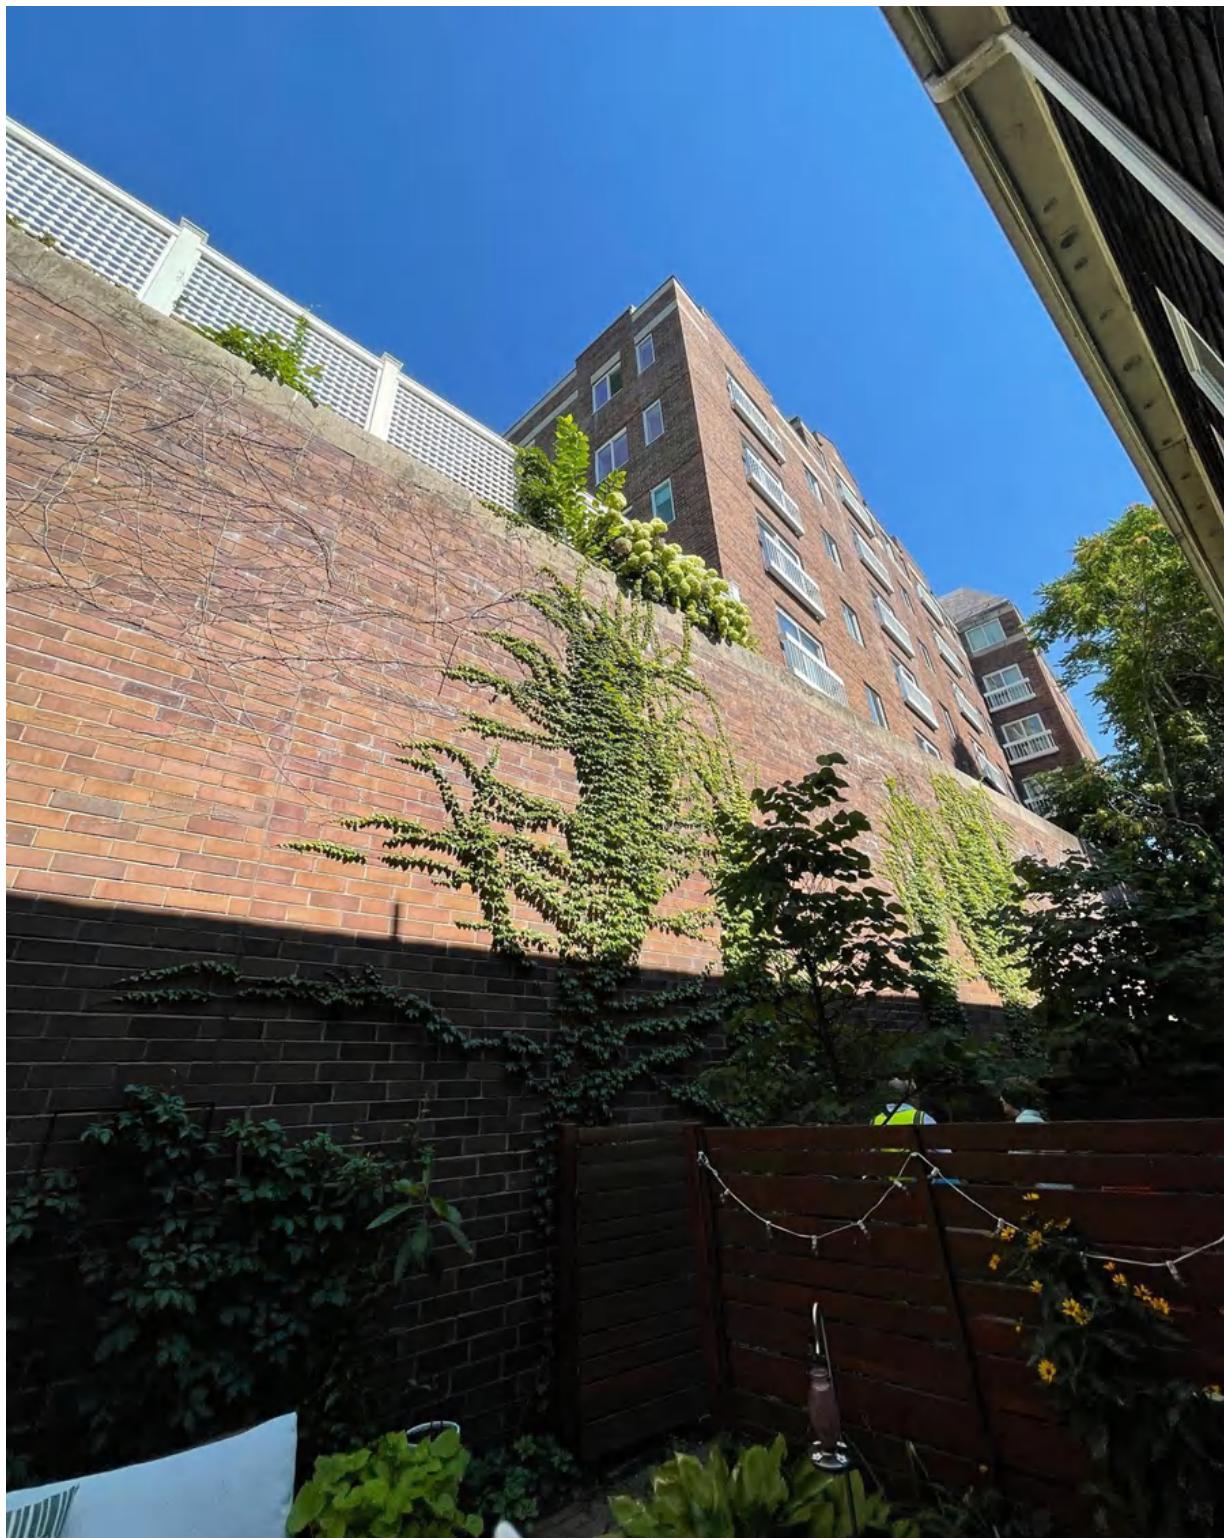
- ❖ thru-wall flashing with 1/4" diameter weeps holes spaced at typically spaced 3'-0" o.c. with some inconsistent, wider weep hole spacing observed
- ❖ approximately 20-25% of the wall area is covered in ivy growth (Photo 15)

Photo 15: ivy growth on wall at east elevation

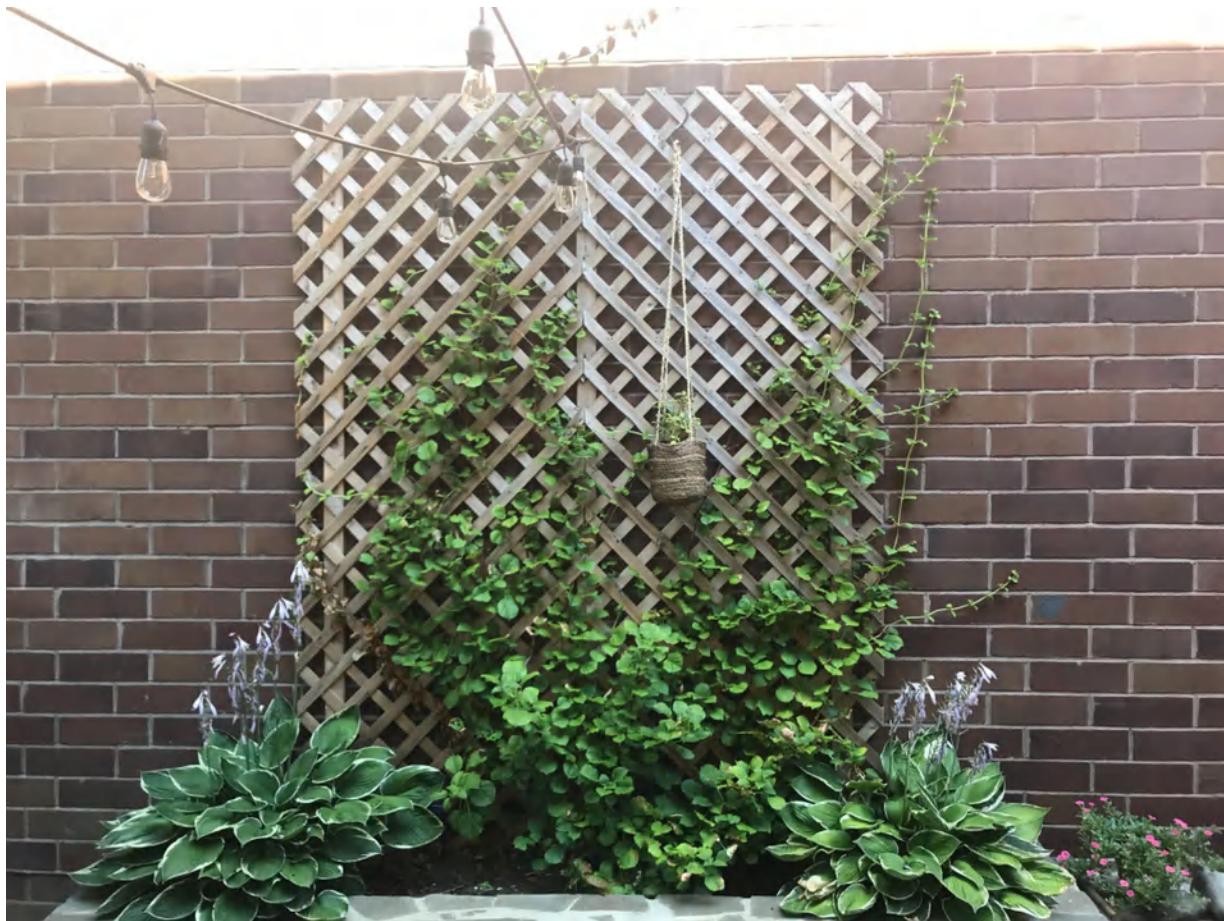
- ❖ 551 Green Street residents have installed wall trellis promoting additional ivy growth on the masonry wall (Photo 16)
- ❖ general mortar wear and deterioration at brick veneer mortar joints (approximately 25-35% of wall areas) – more precise quantities should be confirmed as ivy growth partially inhibited wall area review

Photo 16: wall trellis' installed promoting additional ivy growth on the masonry wall

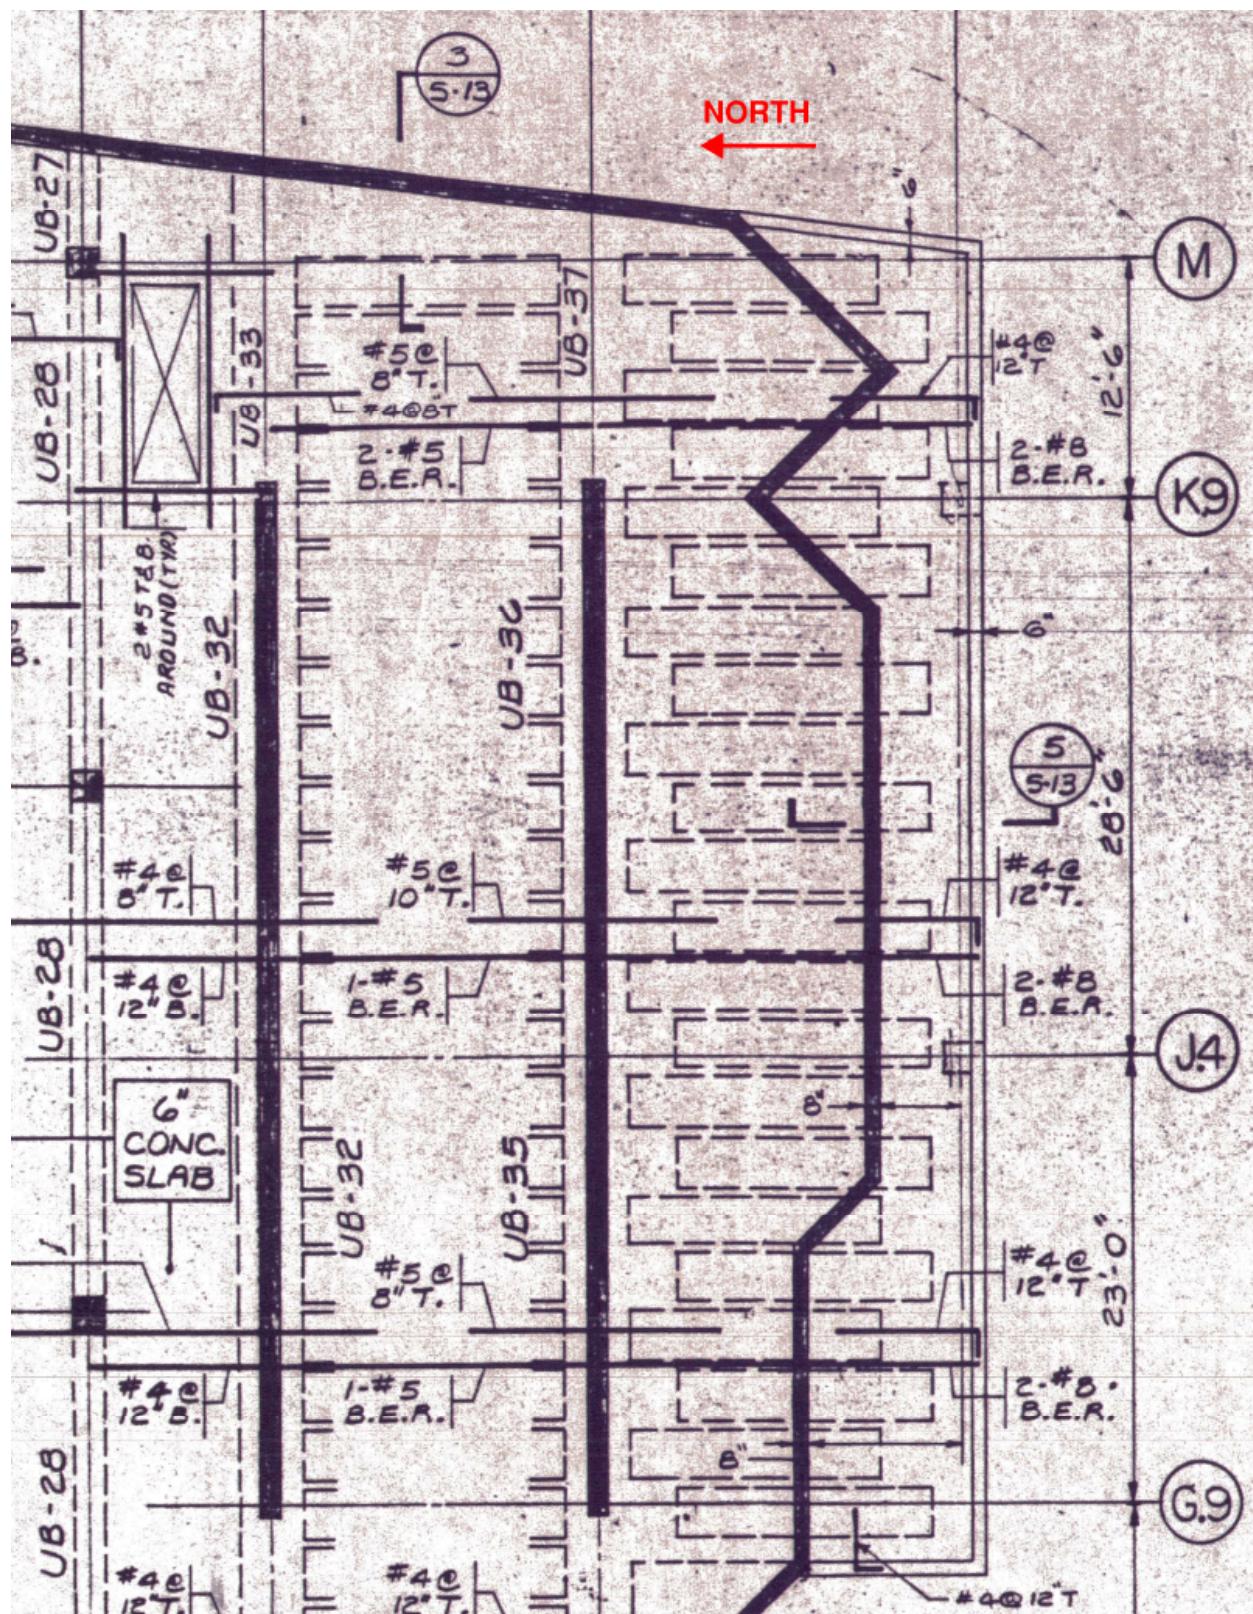
- a. The pool is supported by a conventionally reinforced, cast-in-place rectangular concrete enclosure structure (similar to a “concrete bathtub”) which is supported by continuous, 10 to 12-inch thick, approx. 53-feet long, concrete walls (Photo 1-05 and Figure 1) along the north and south edges of the pool, which are supported by concrete beams, columns, and six concrete footings at the Green Street Garage Area at the Level below.

Figure 1 – Excerpt from Upper Garage Floor Framing Plan (i.e., framing above Green Street Garage). Long dark straight lines in east-west direction are the pool support walls. Beams labeled “UB-32, UB-35 and UB-36” are the supporting concrete girders.

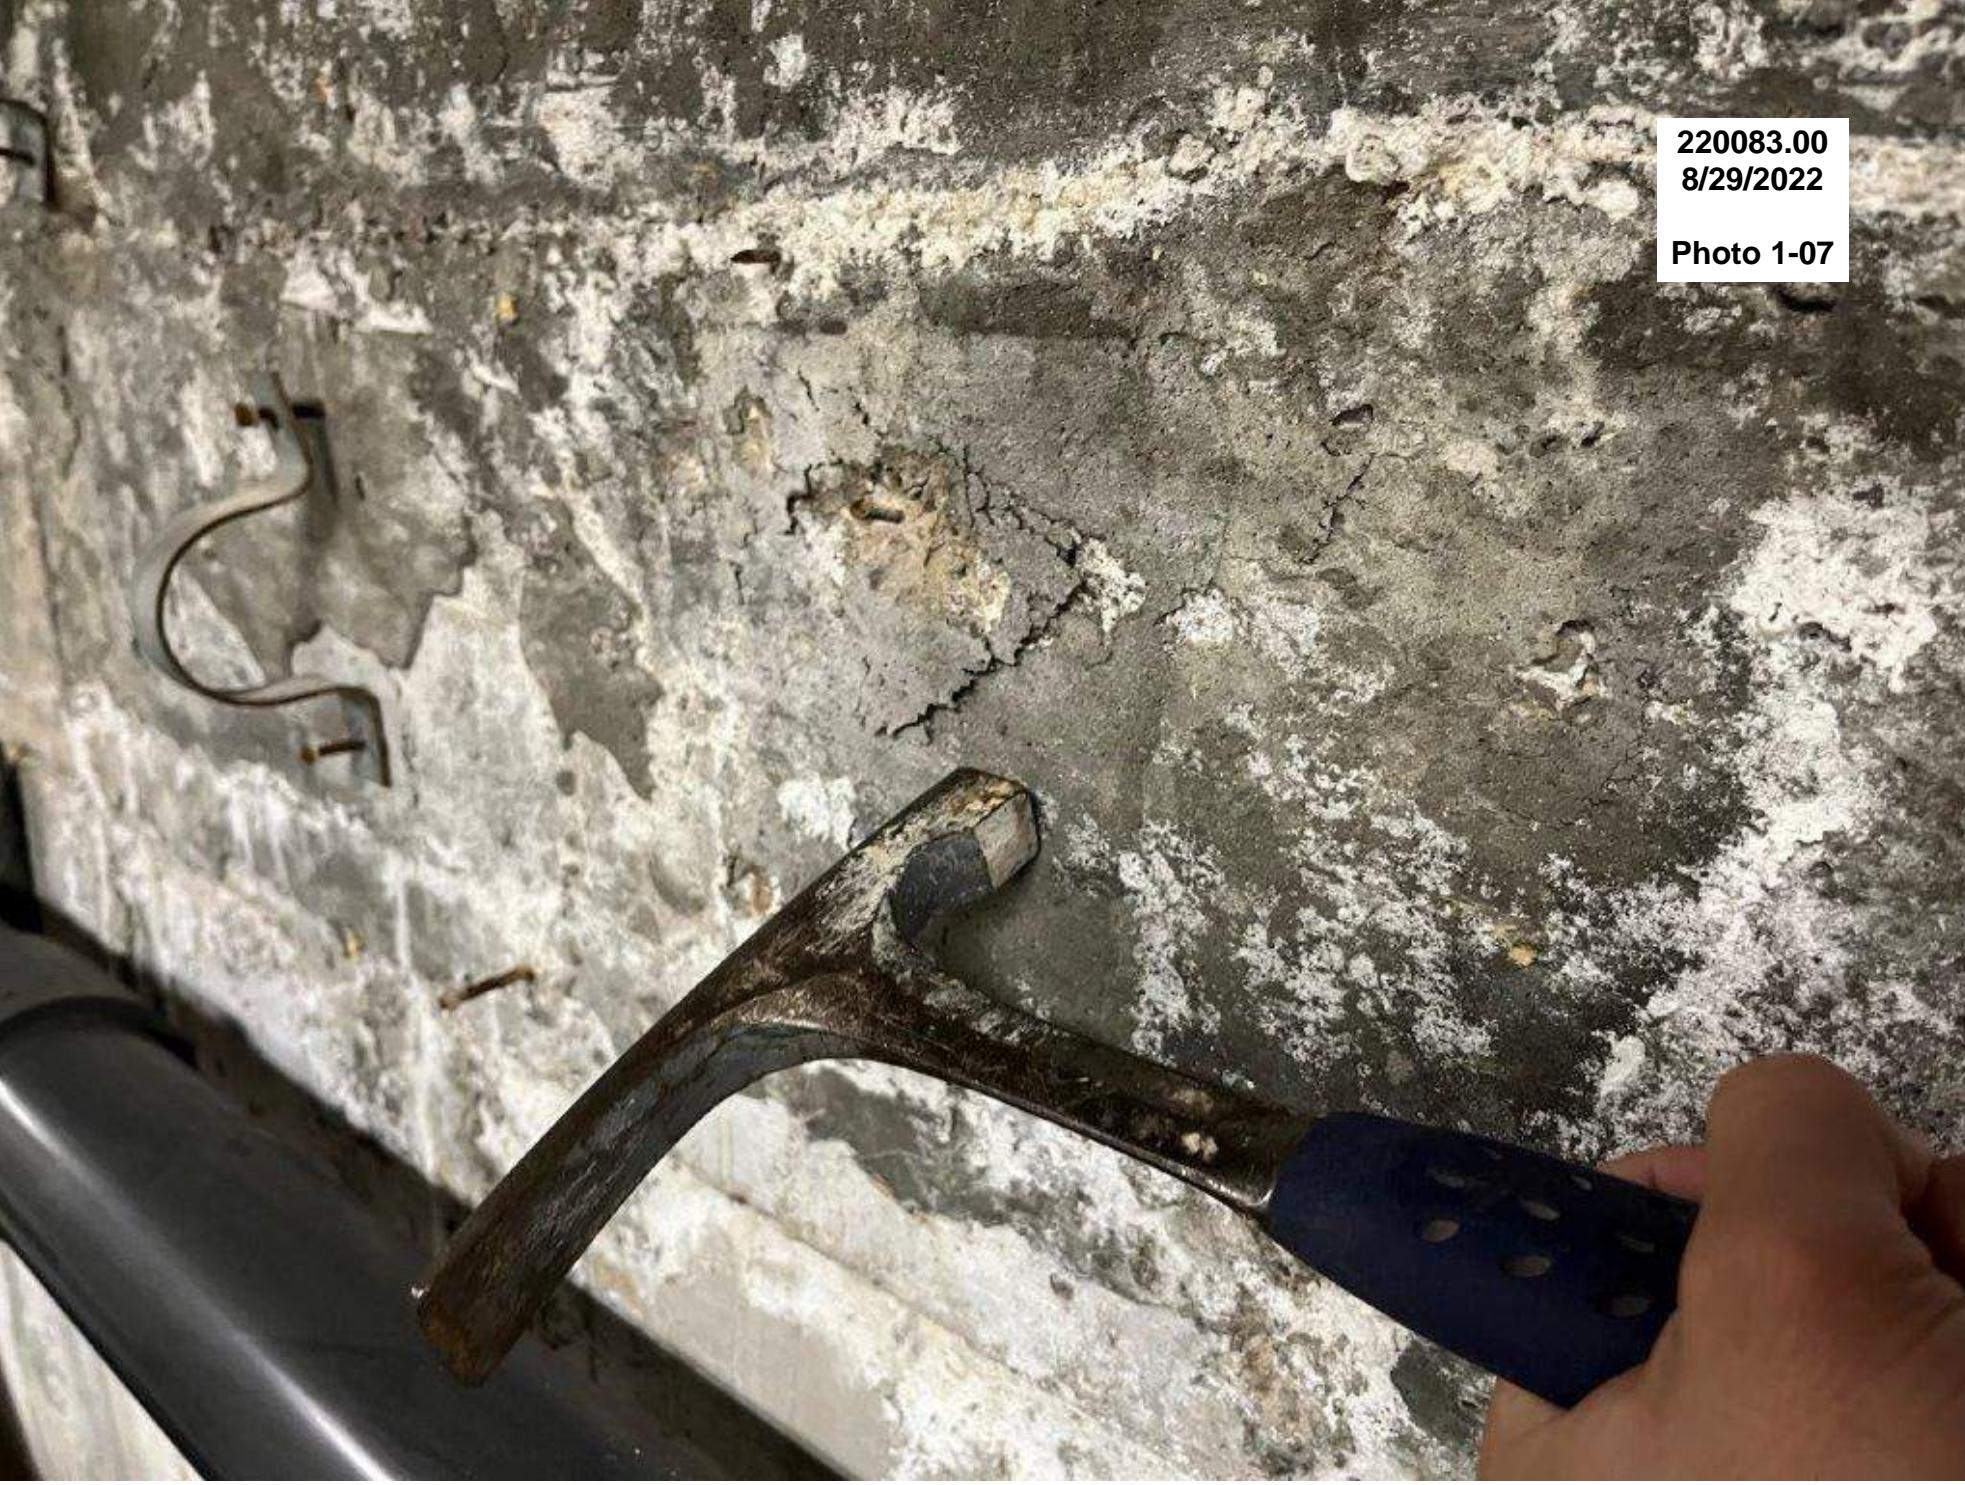
Photo 1-07

- b. Portions of the concrete enclosure structure and supporting walls below are moisture-stained and there are areas of significant surface deterioration / spalling (Photo 1-06 through 1-08 and 1-15 through 1-18), particularly along the north edge of the pool.

- d. Hammer sounding the walls (Photo 1-07) generally revealed the that underlying concrete is sound, but the outer approx. $\frac{1}{2}$ to 1-inch thick, layer at the surfaces is deteriorated in several areas.

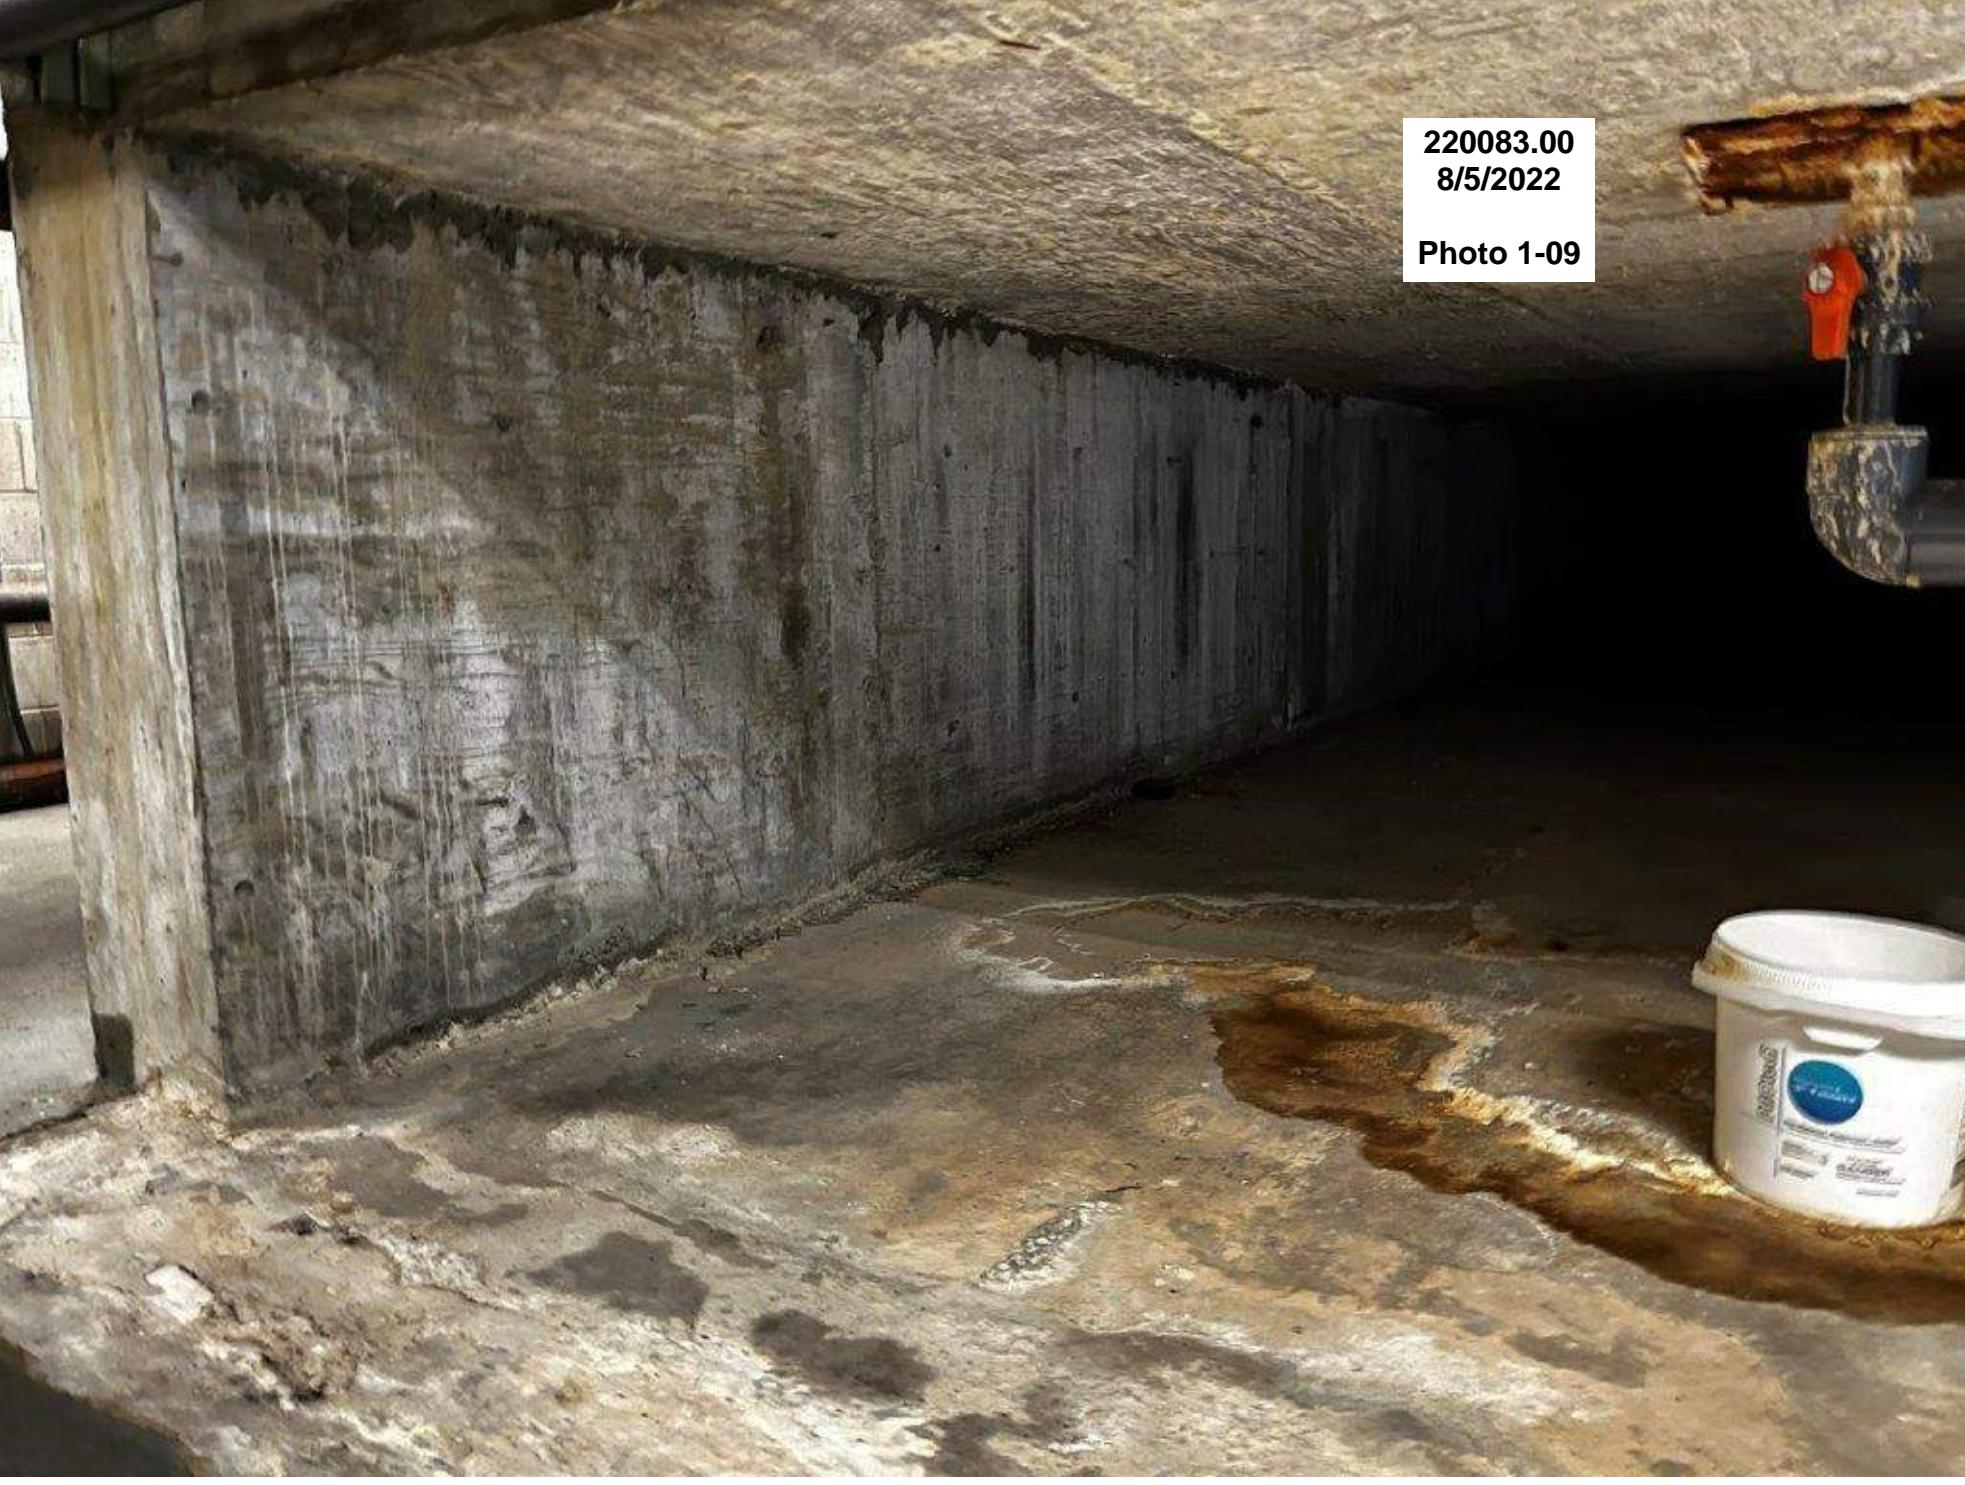
Photo 1-09

- e. Hammer sounding the underside of the concrete enclosure (Photos 1-09 through 1-14) generally revealed that the concrete is sound, but there are isolated spalls in some areas (Photos 1-11 through 1-13), and some areas where the outer approx. $\frac{1}{2}$ -inch of the concrete surfaces is soft / deteriorated (Photo 1-14). There is evidence of leaks around pipe penetrations at some locations (Photo 1-10), and the leaks have deteriorated the concrete floor structure below (Photos 1-09 and 1-10).

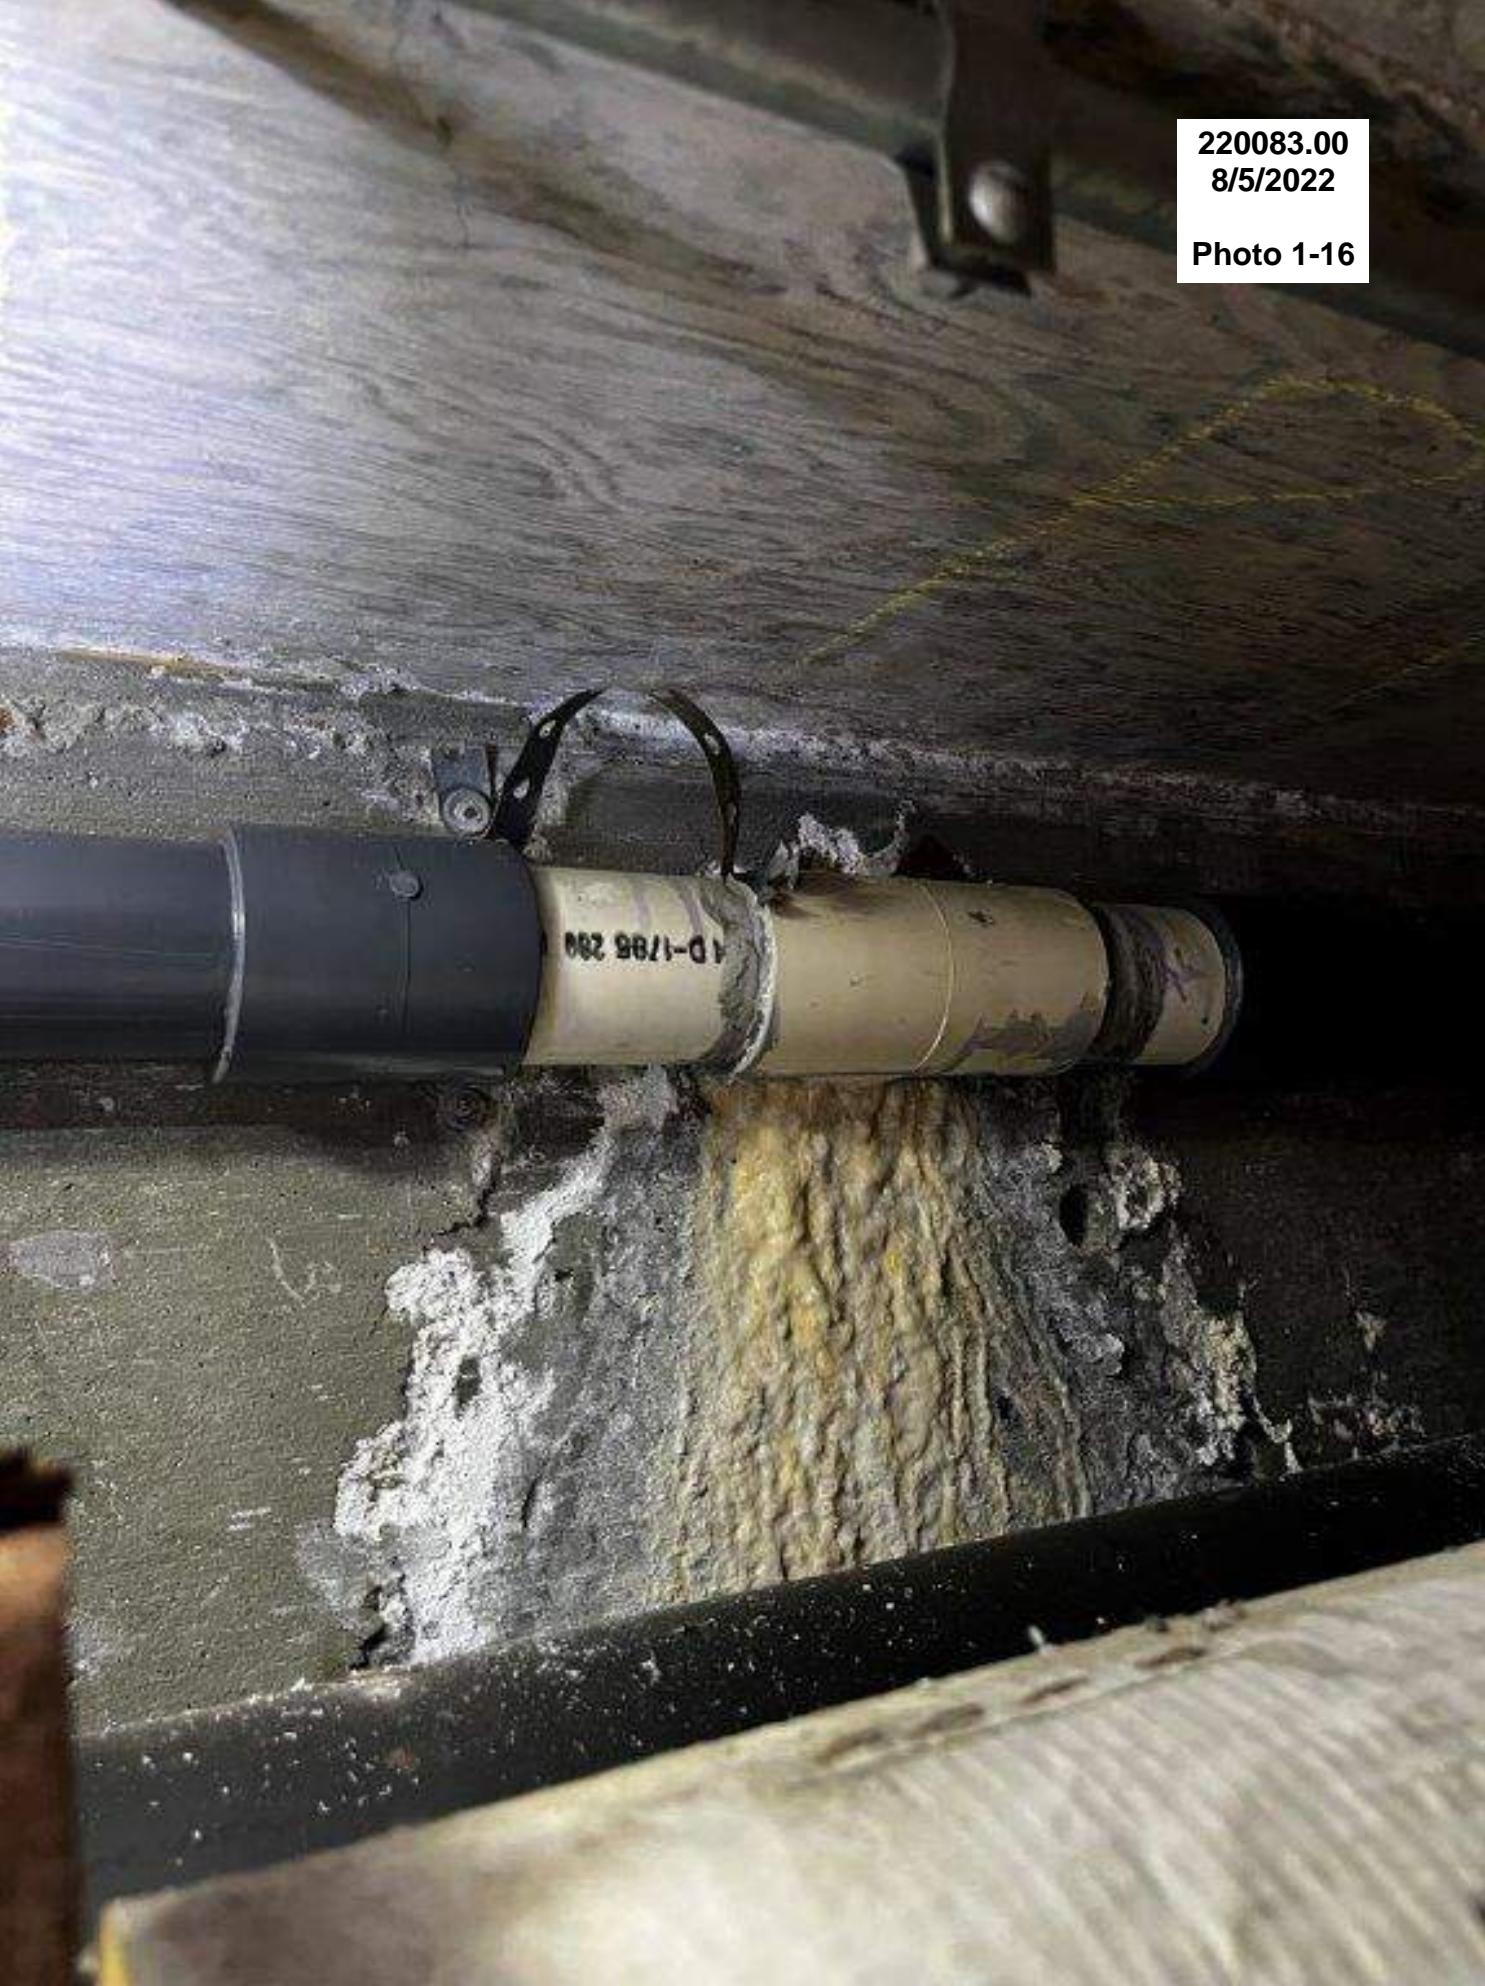
Photo 1-16

- c. Efflorescence / salt leaching is visible at several areas, mostly corresponding to locations of penetrations for the pool piping system (Photos 1-08, 1-15, 1-16, and 1-17).

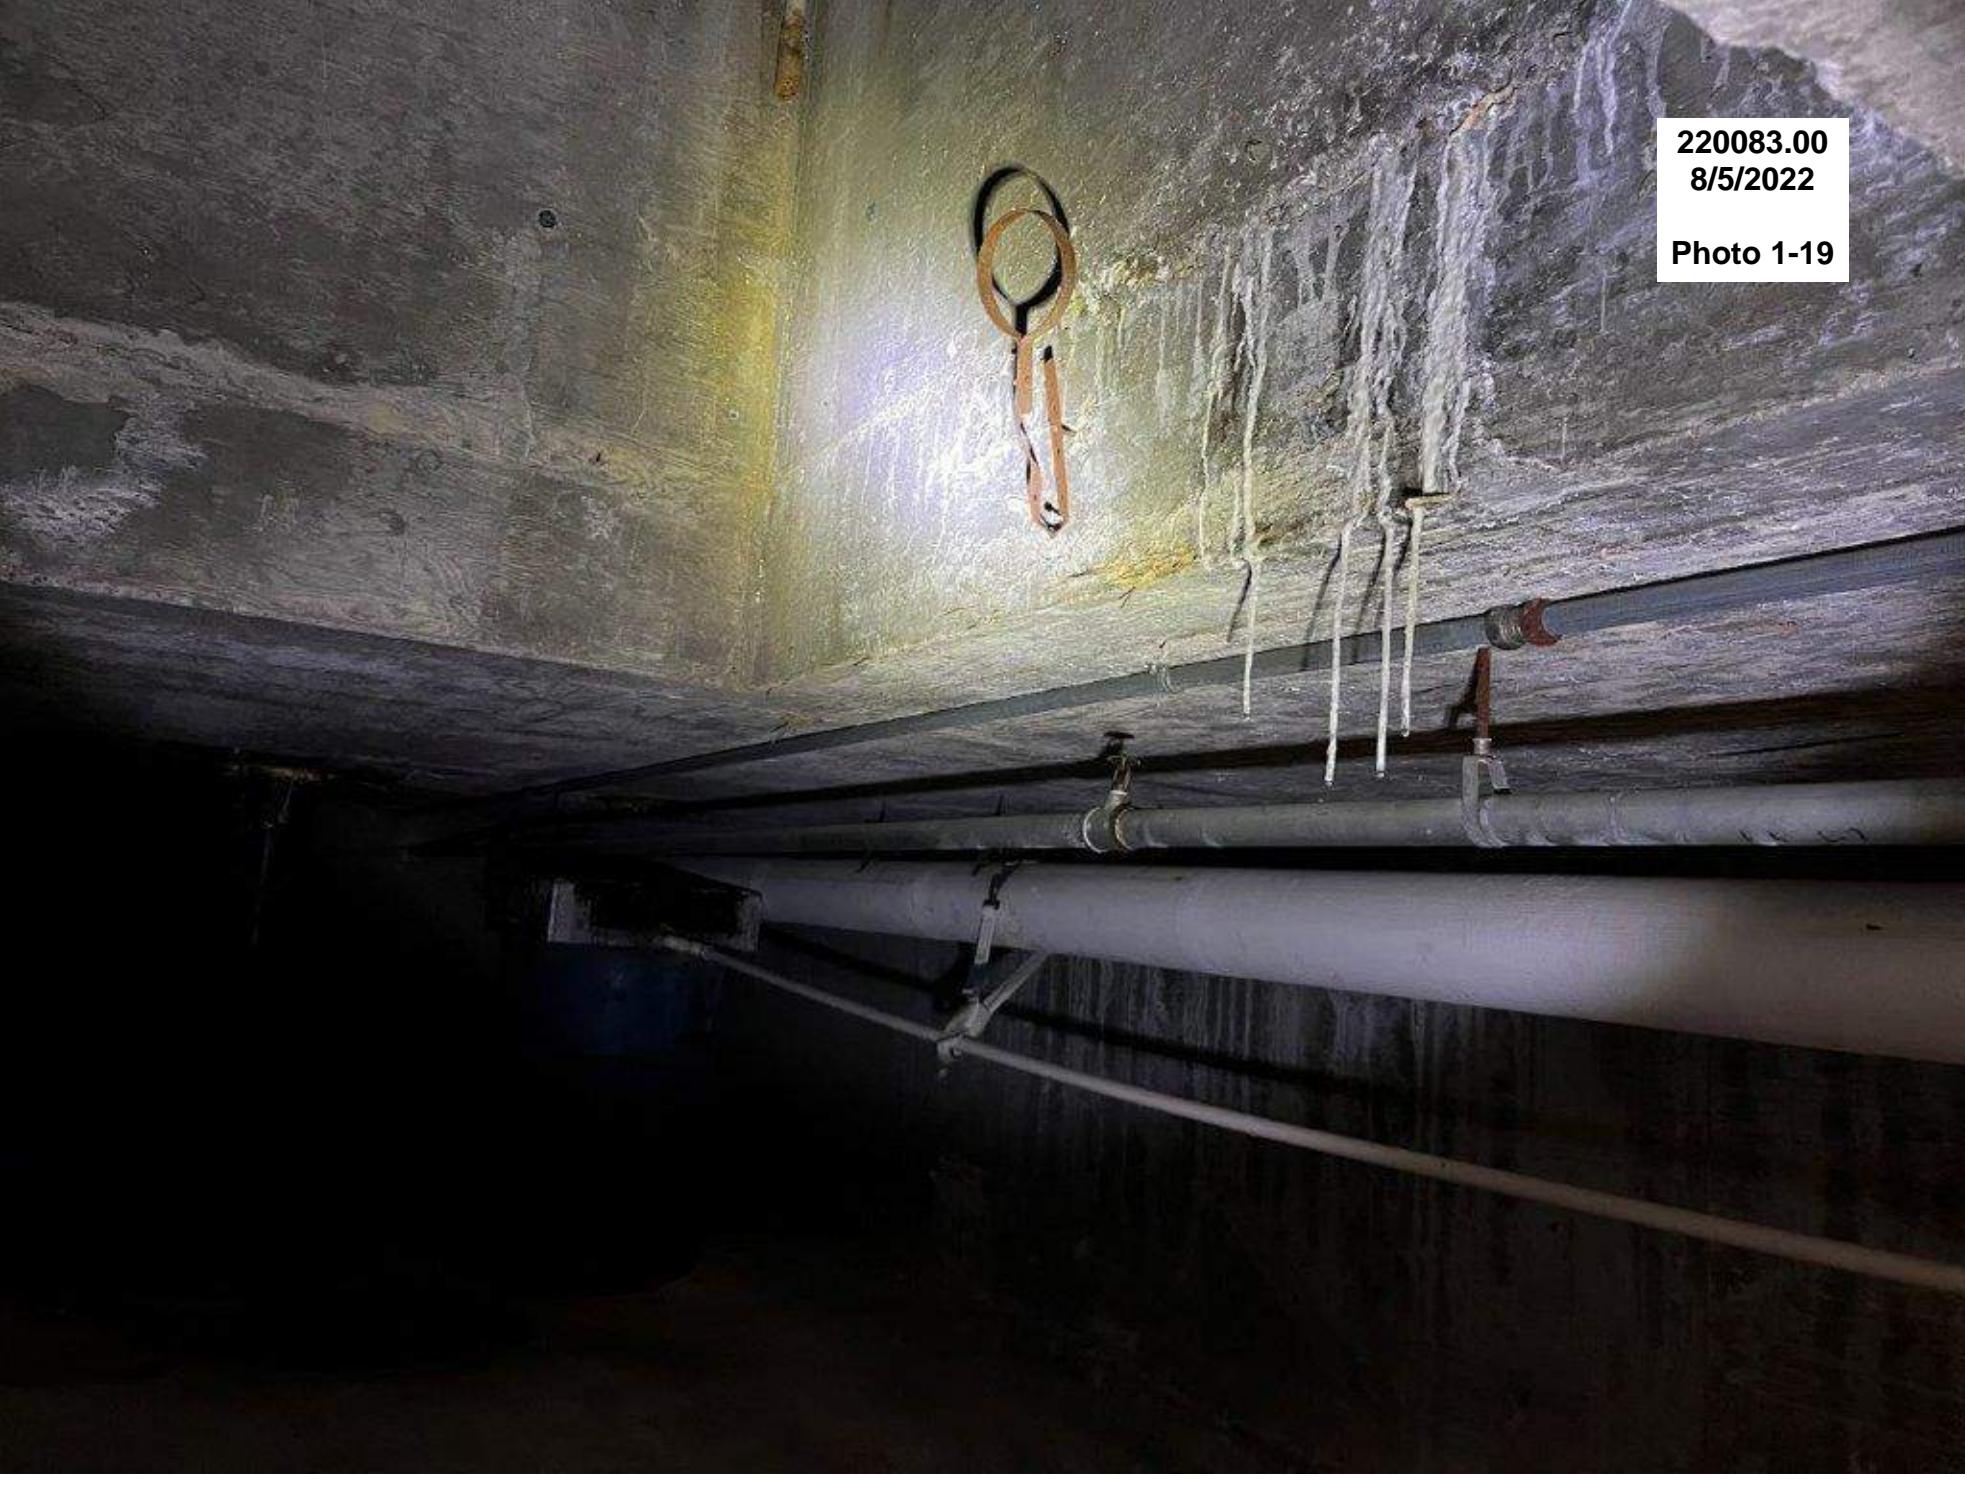
Photo 1-19

- g. Similar conditions are present beneath the hot tub area (Photos 1-19 through 1-21), with active leaching / dripping observed at some locations.
