CopelandBEC Engineering Study Addenda, Notes, and Errata

Bay Square Condominiums

950 Massachusetts Avenue
Cambridge, MA

Building Condition Assessment

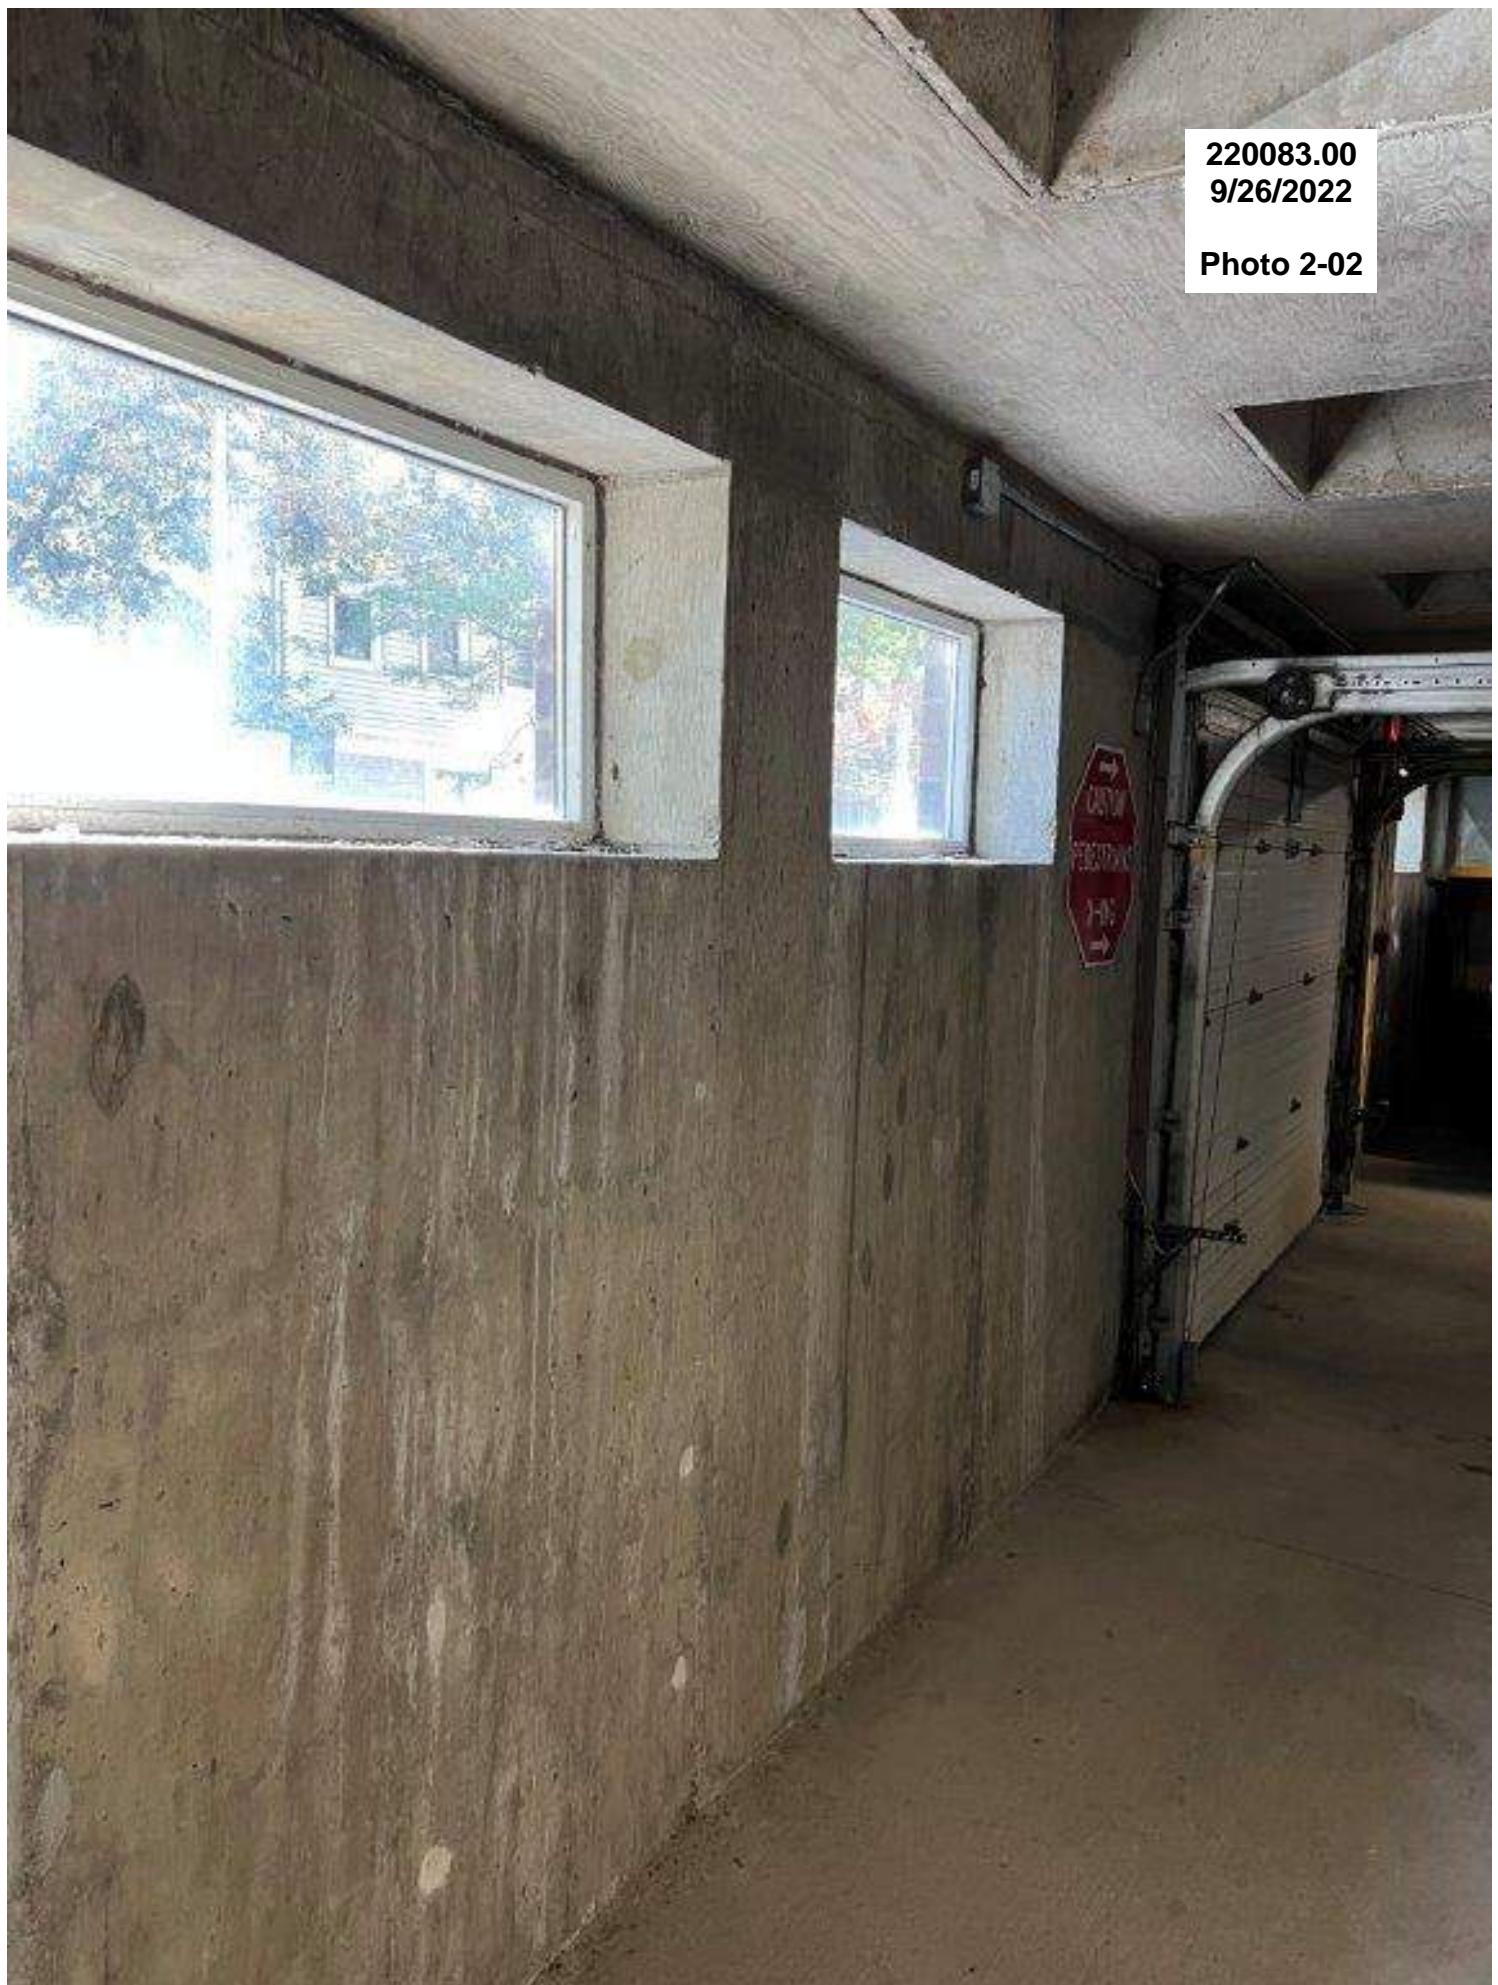
Photo 2-03

12. The exterior wall and floor above this garage space are constructed of conventionally reinforced, cast-in-place concrete (Photo 2-02). Similar to the rest of the building, the floor structure above is a concrete joist (“rib”) slab system created using metal pan forms (Photo 2-03). The joists span in the north-south direction and are supported at two locations above the garage space by large, integrally placed concrete girders (Photo 2-03 is looking north, parallel to joists, white arrows show supporting girders spanning in the east-west direction). Photo 2-04 shows one of the concrete girders bearing on top of a cast-in-place concrete column inside the Green Street Garage. According to the original structural drawings, these girders also align with and support the pool enclosure support walls at the level above (Photo 1-05). Figure 1 shows an excerpt from the original drawing set with the pool enclosure support walls and concrete girders below.

13. There are several cracks and signs of moisture staining / salt leaching through the joist slab system (Photos 2-03, and 2-05 through 2-09, red arrows).

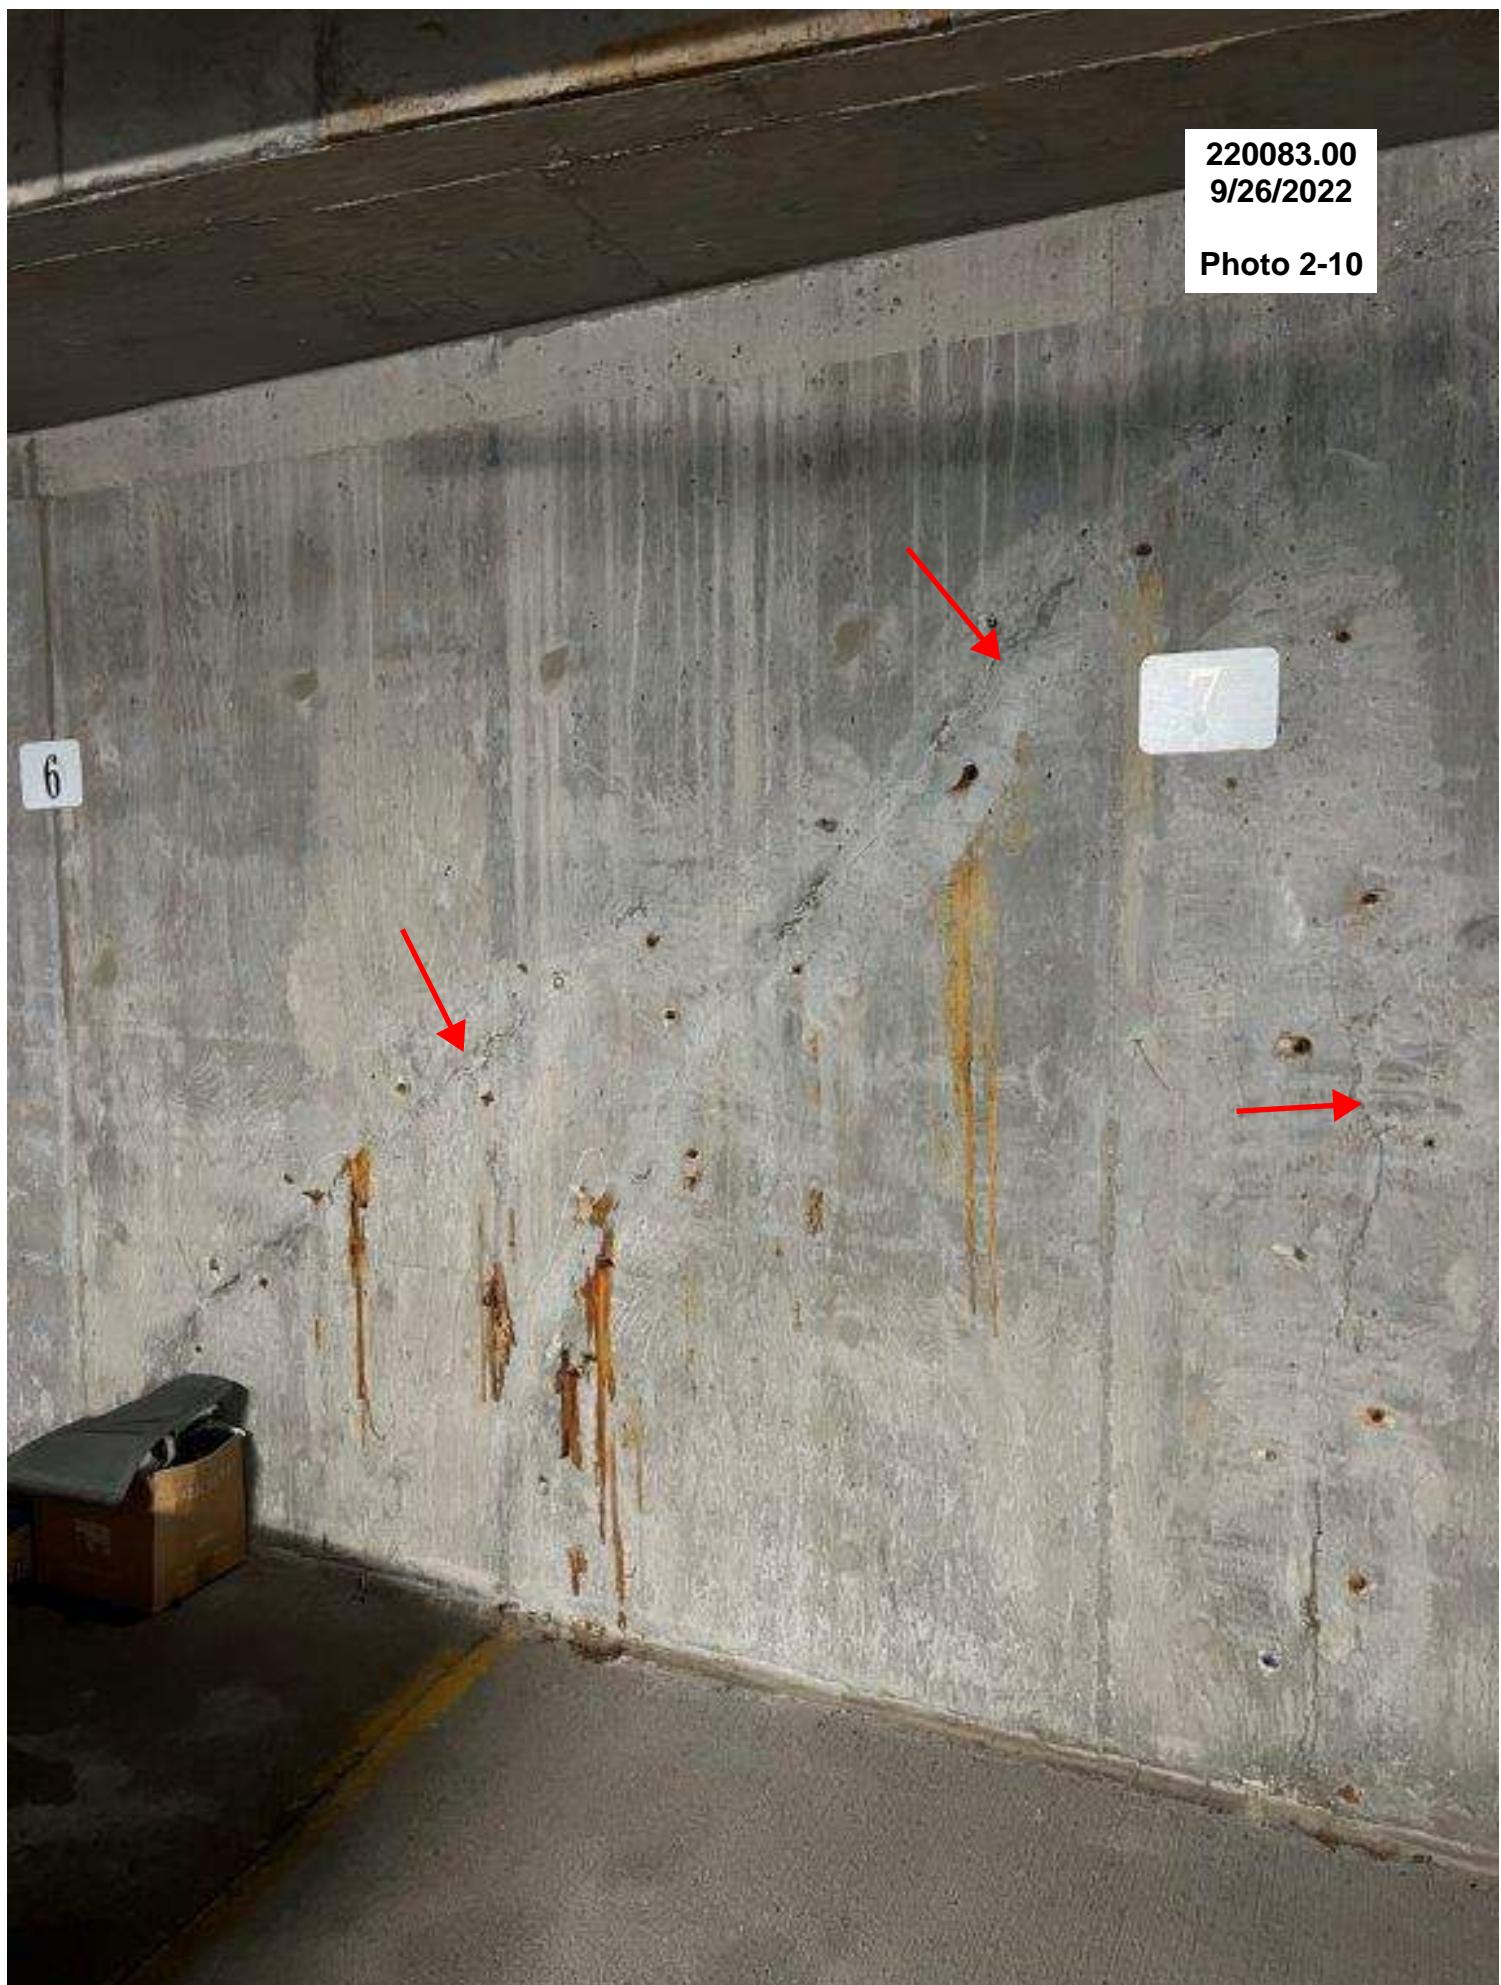
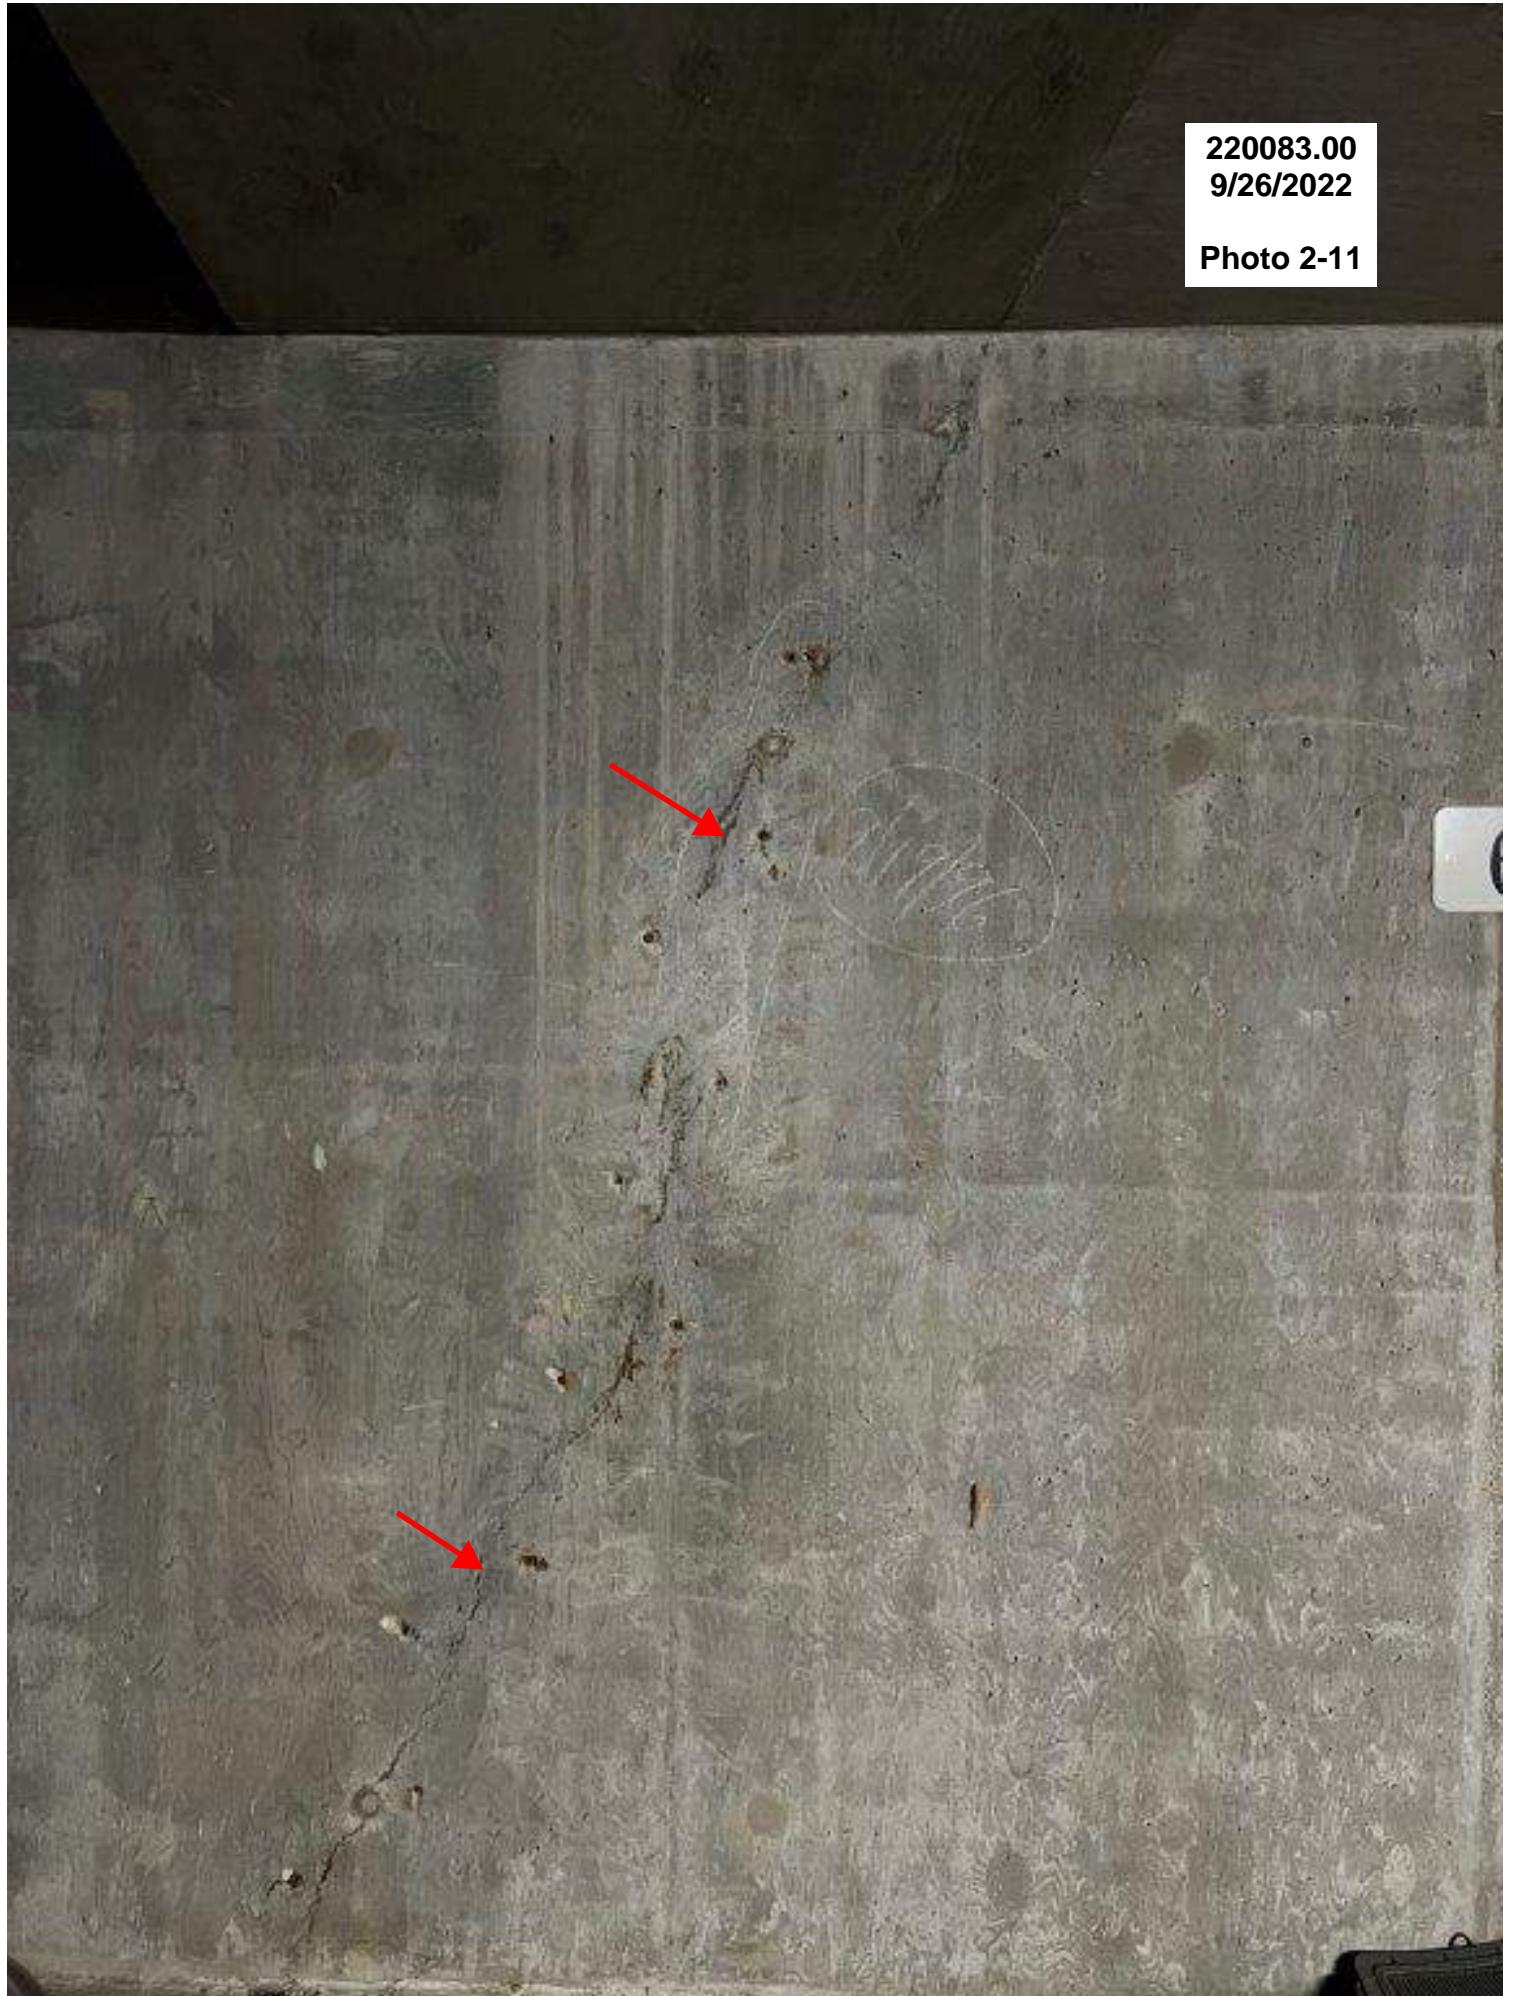
14. There are diagonal and vertical cracks in the concrete walls of the garage that appear to have been previously injected with some repair material at some time during the life of the building (Photos 2-10 and 2-11, red arrows). Markings on the wall next to one of the cracks are dated September 1996 (Photo 2-11).

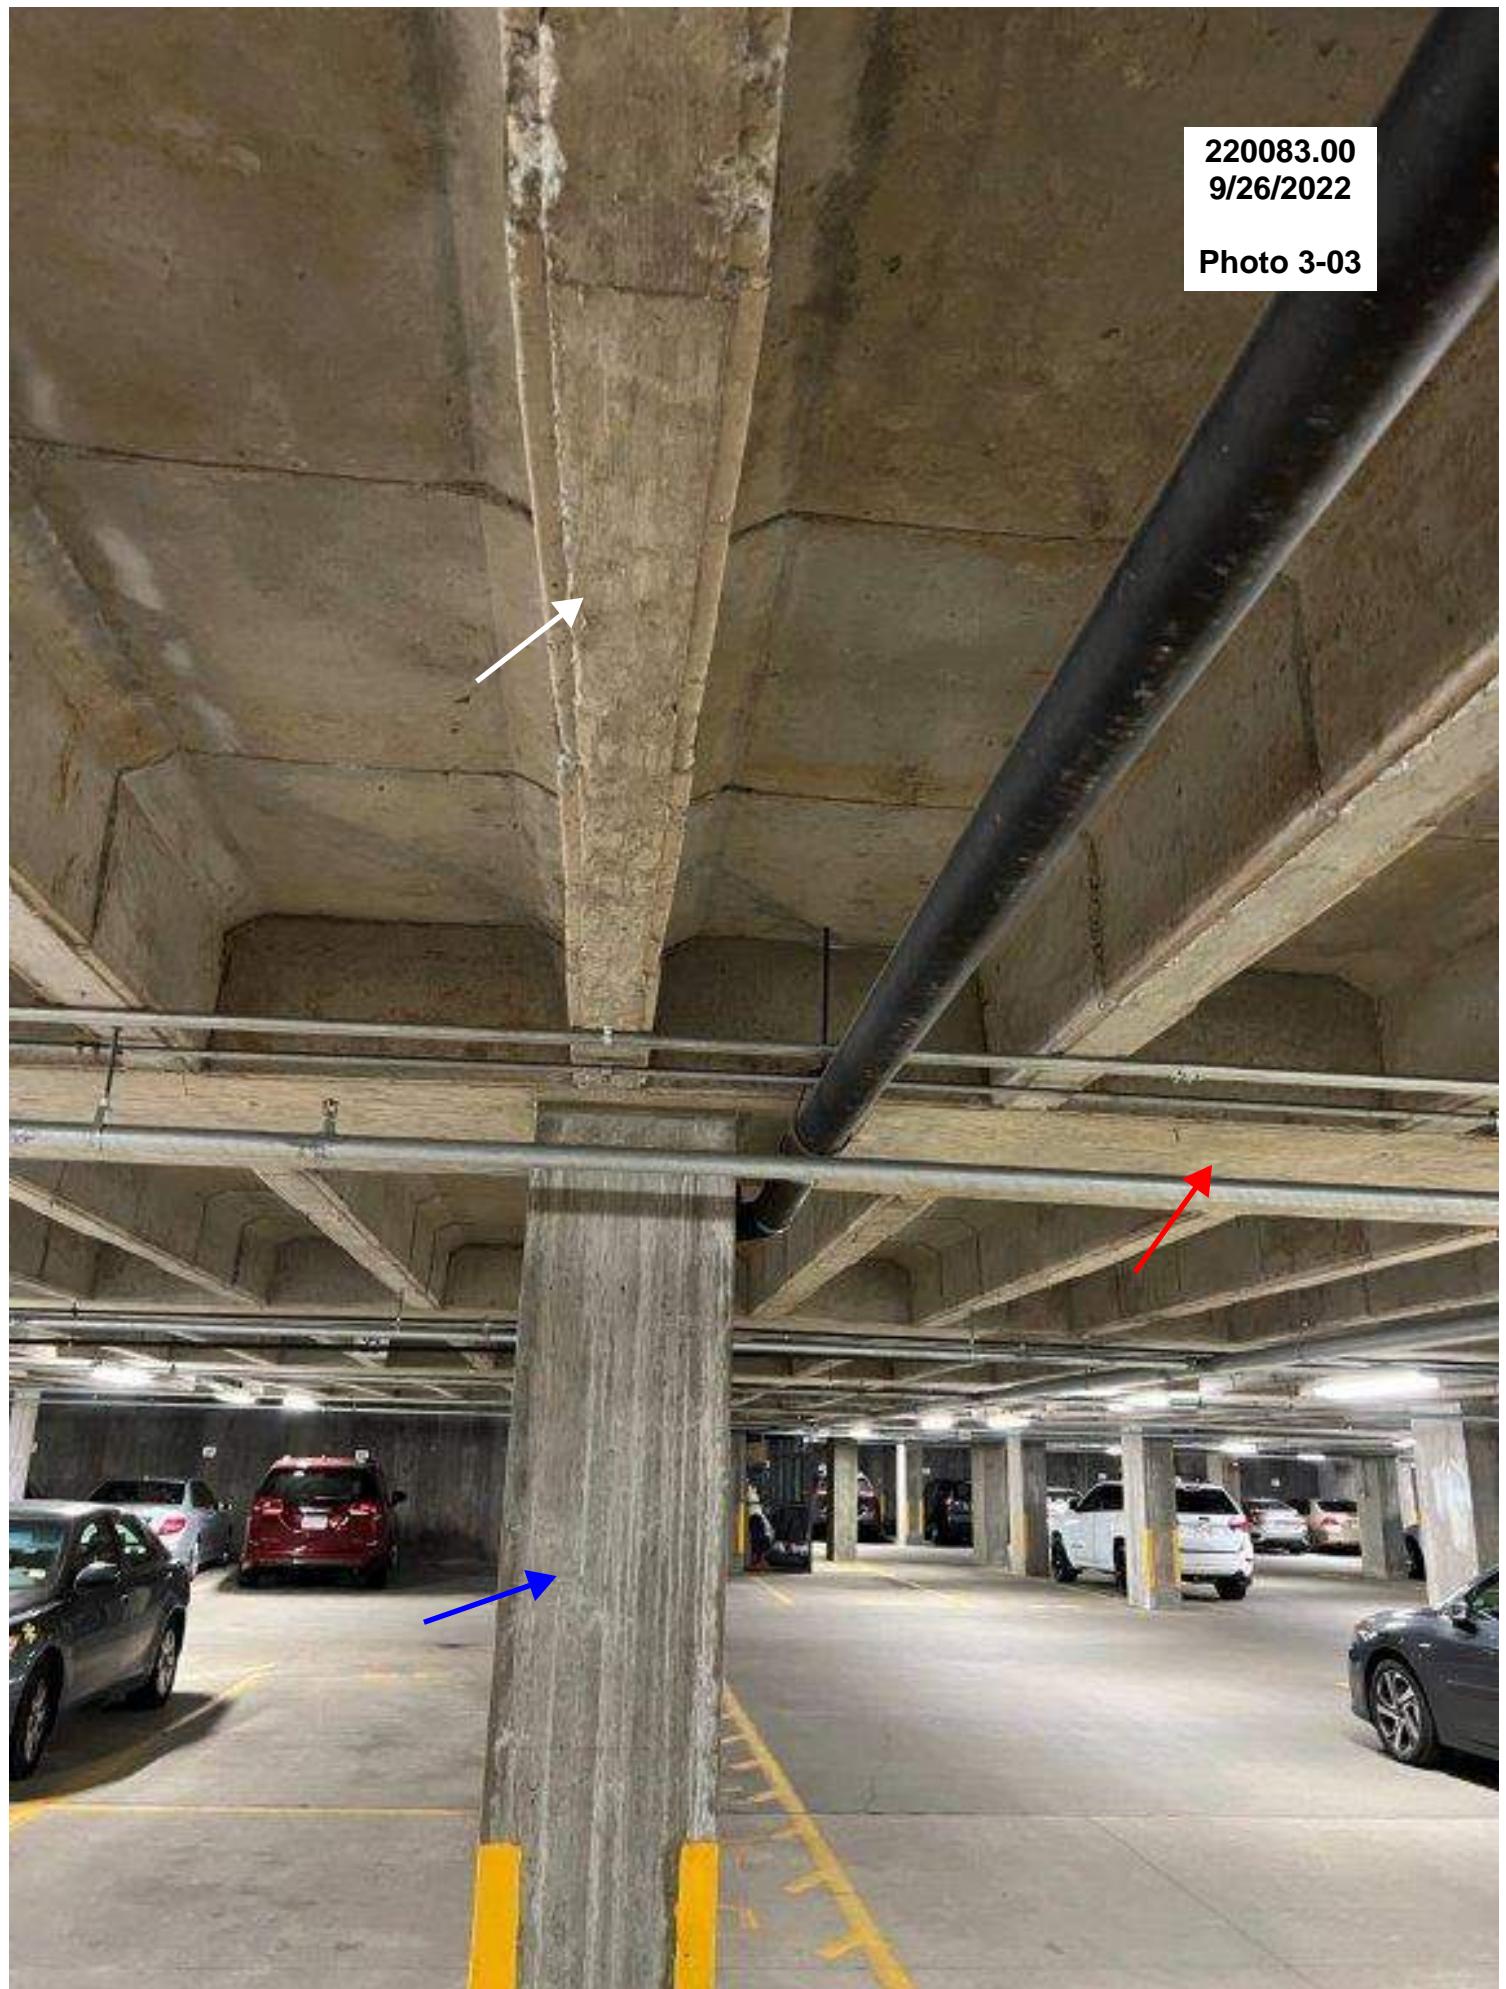
Photo 3-03

17. The floor structure above the Lower Level Garage is a concrete joist / rib slab system, with the joists spanning in the north-south direction (Photos 3-02 and 3-03, white arrows). The concrete ribs are supported by integrally placed concrete girders (Photo 3-03 red arrow) and cast-in-place concrete columns below (Photo 3-03 blue arrow).

22. Some evidence of moisture / efflorescence (Photo 3-03) and / or leakage from above (Photo 3-12) was observed at some of the columns within the Lower Level Garage.
