CopelandBEC Engineering Study Addenda, Notes, and Errata

Bay Square Condominiums

950 Massachusetts Avenue
Cambridge, MA

Building Condition Assessment

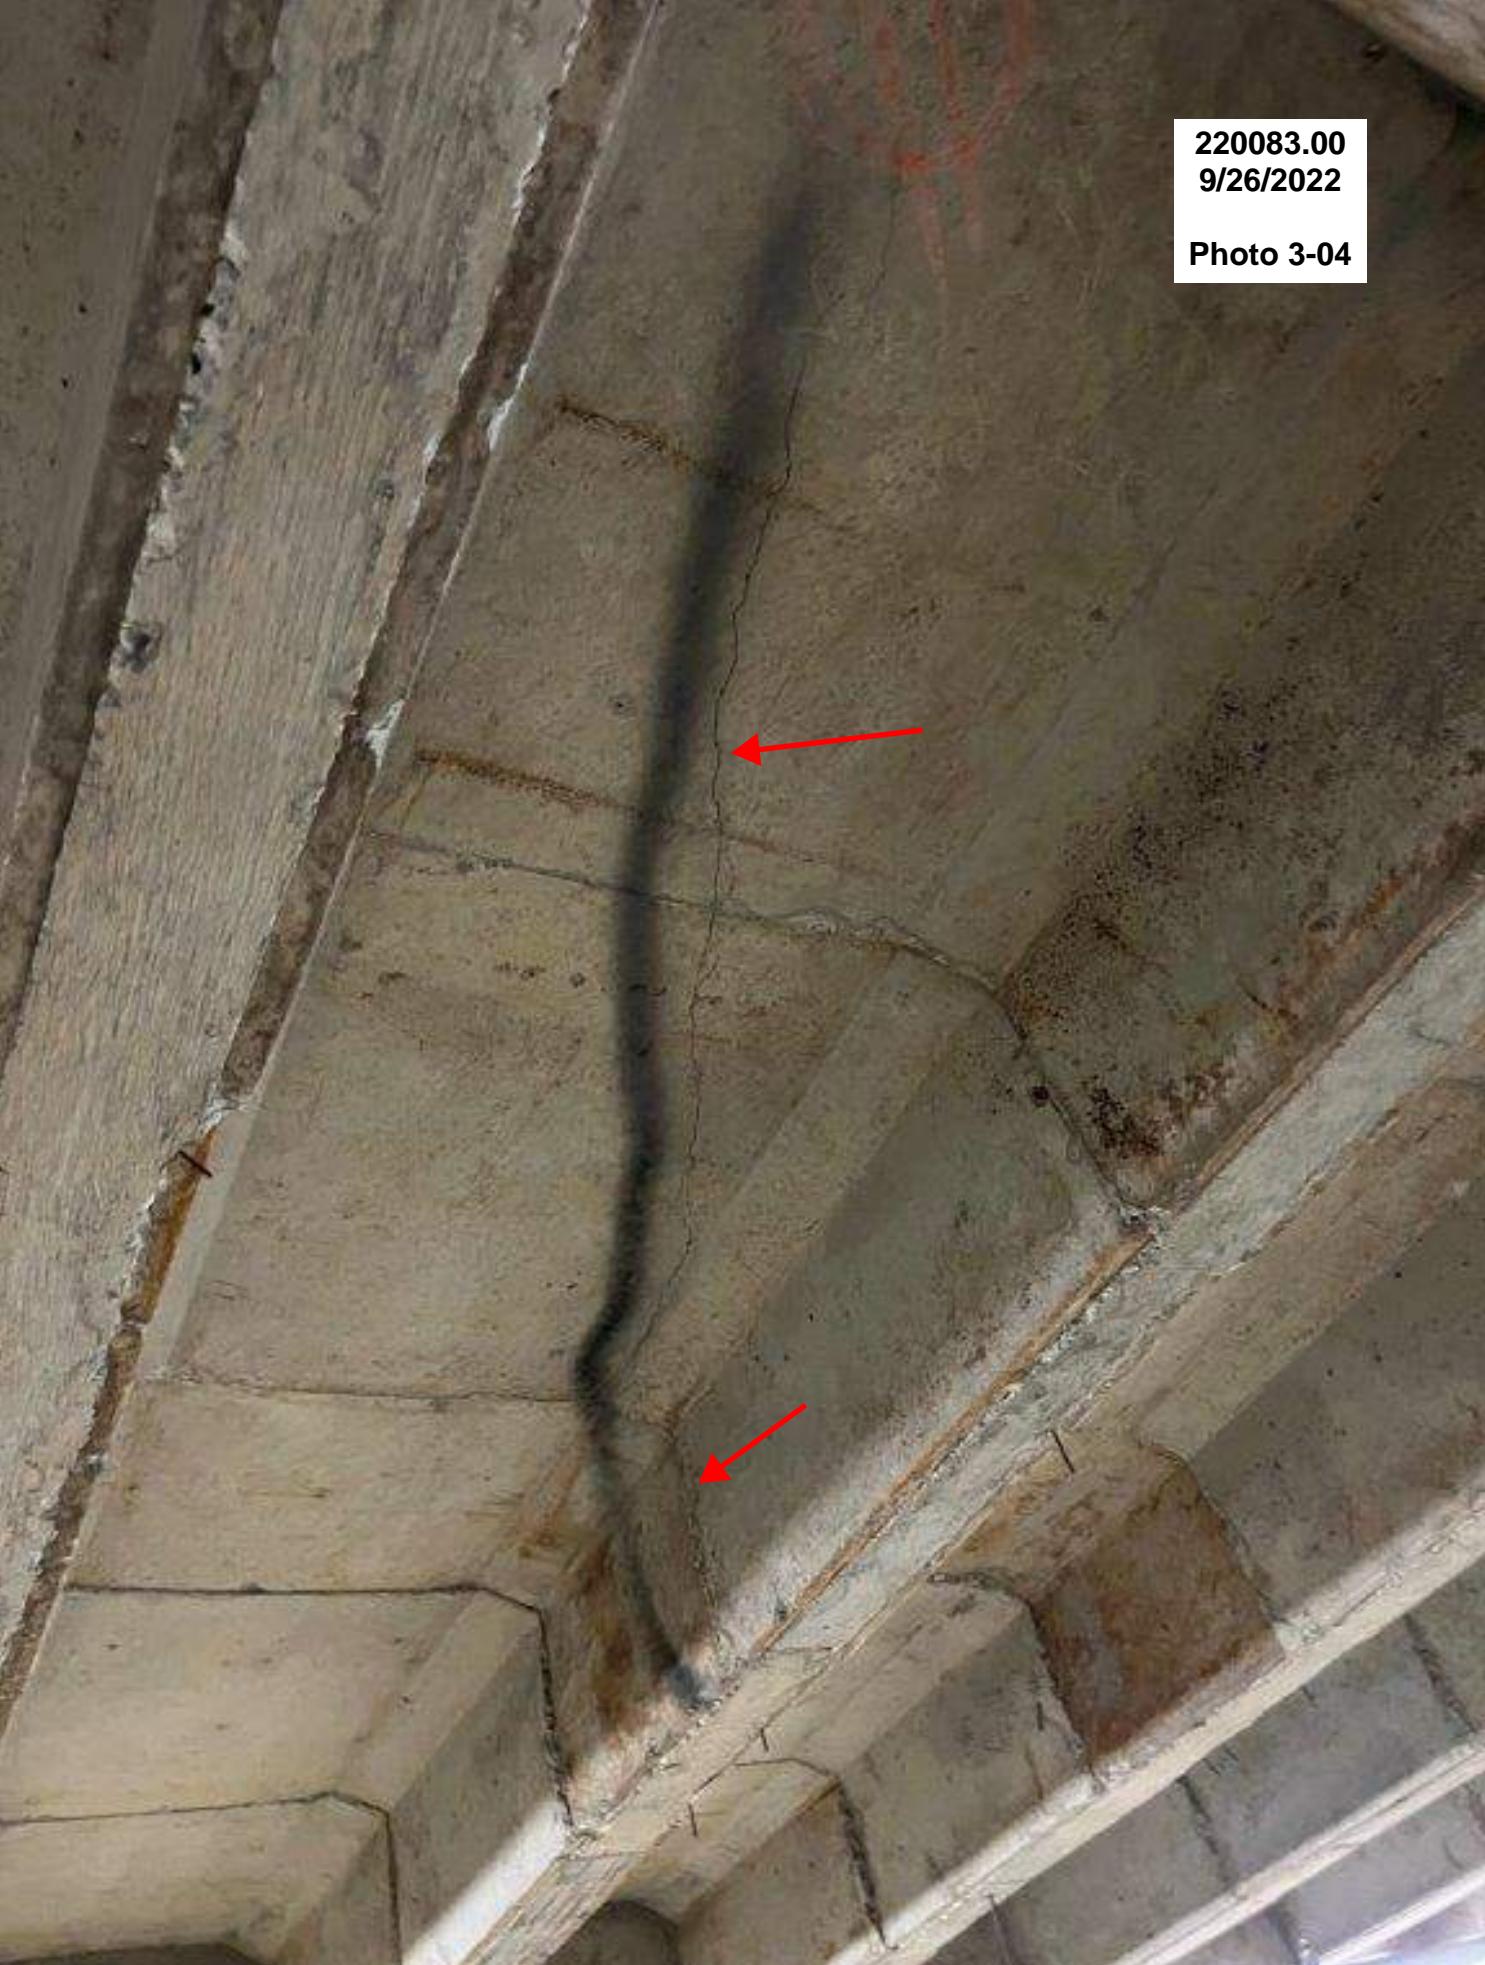
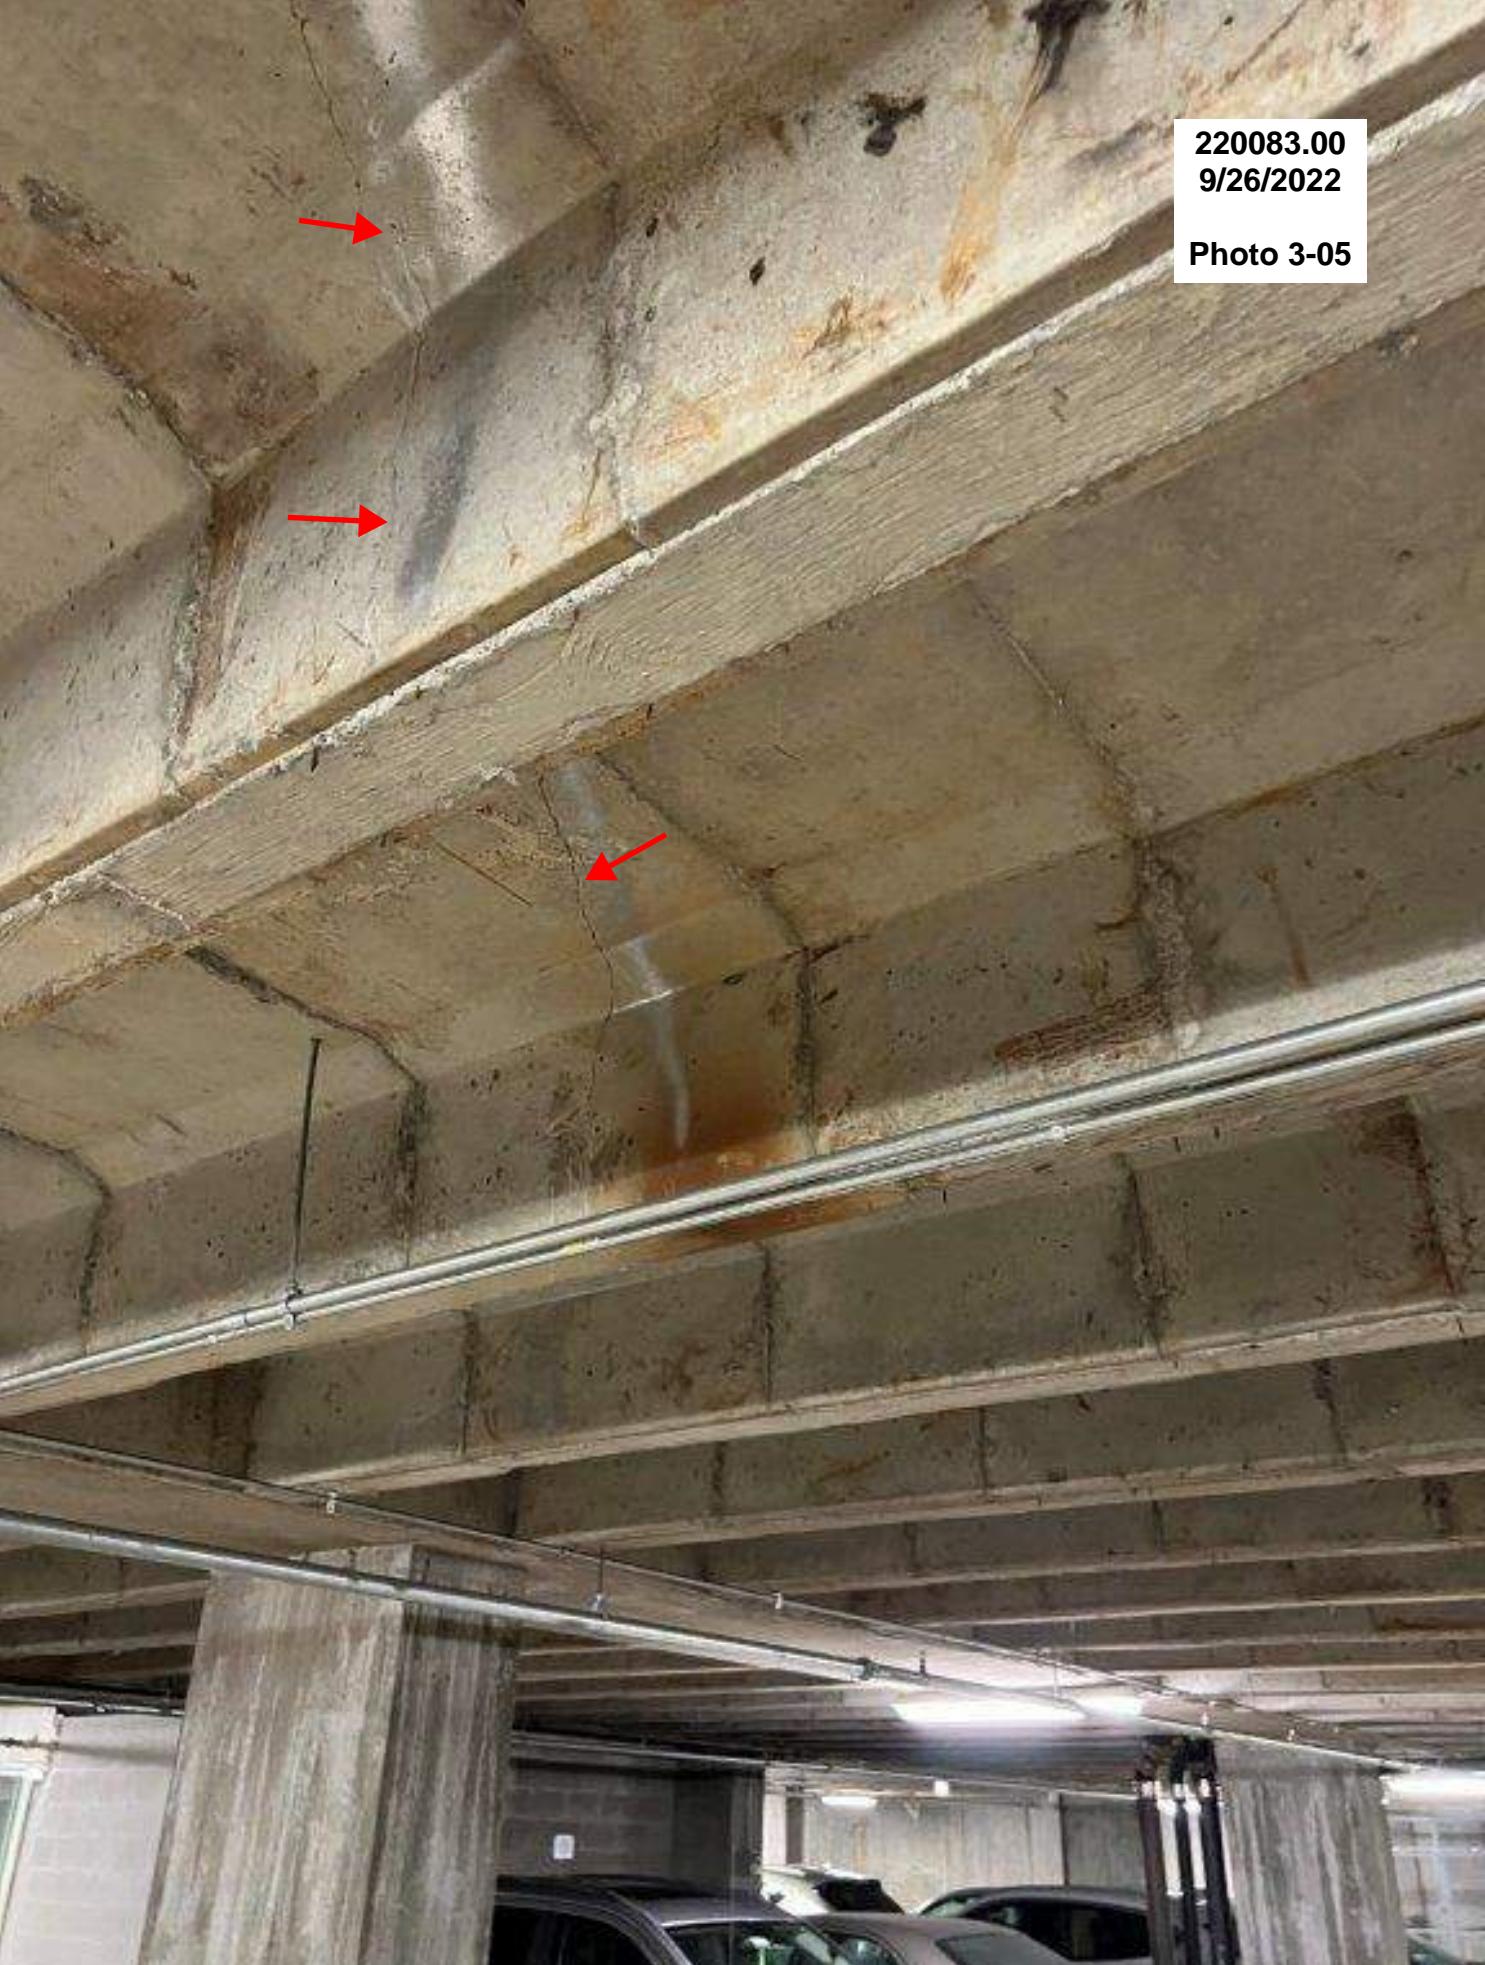
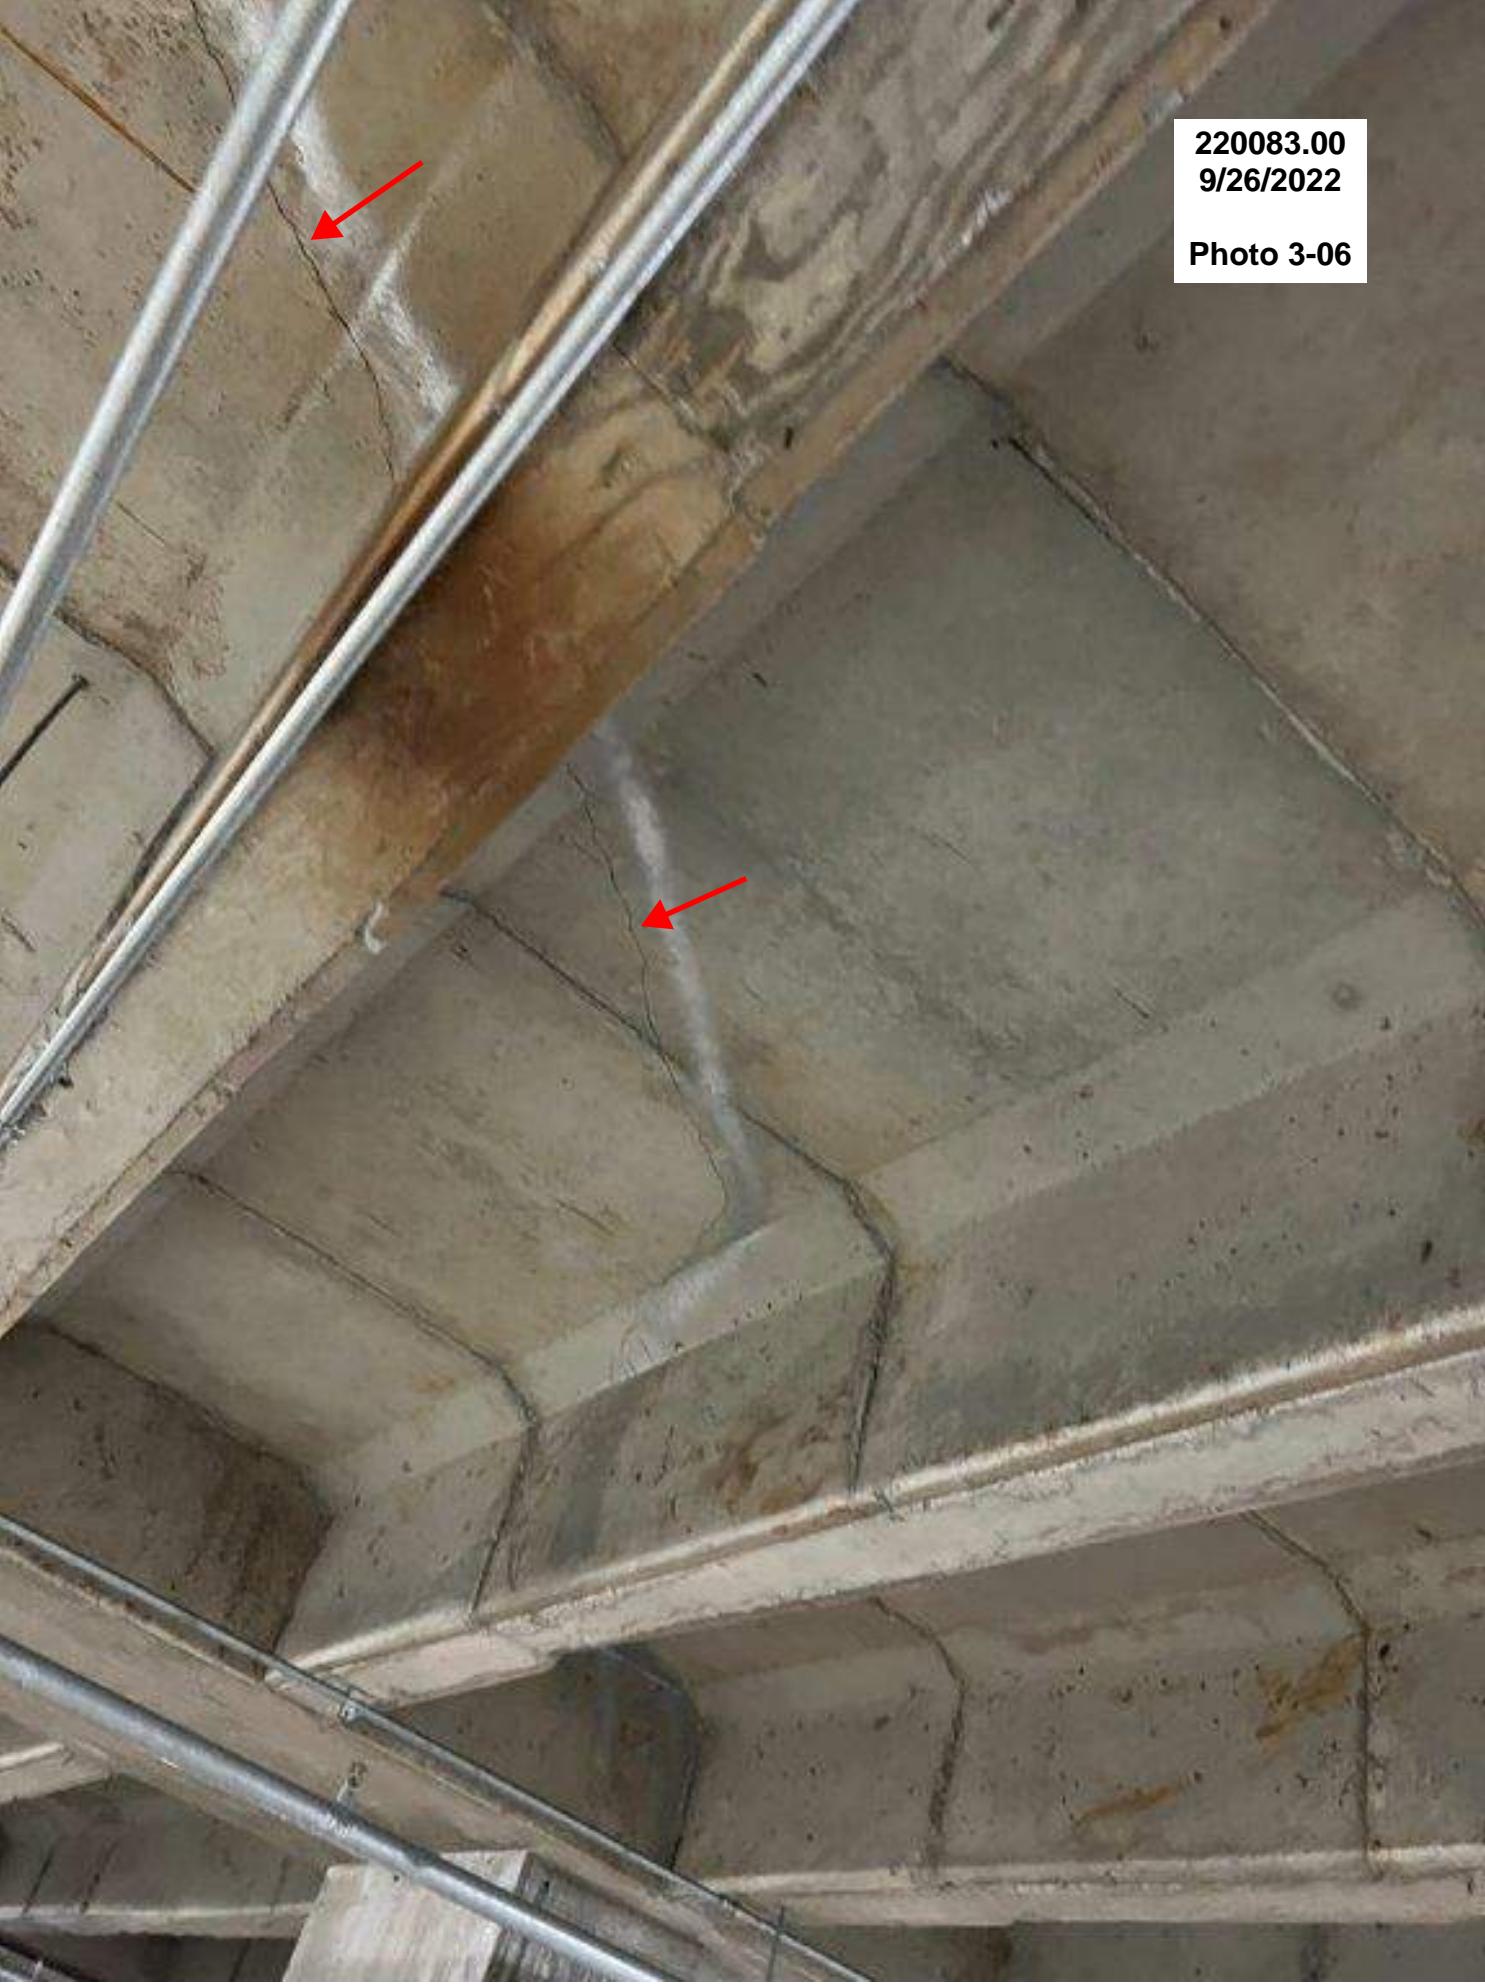
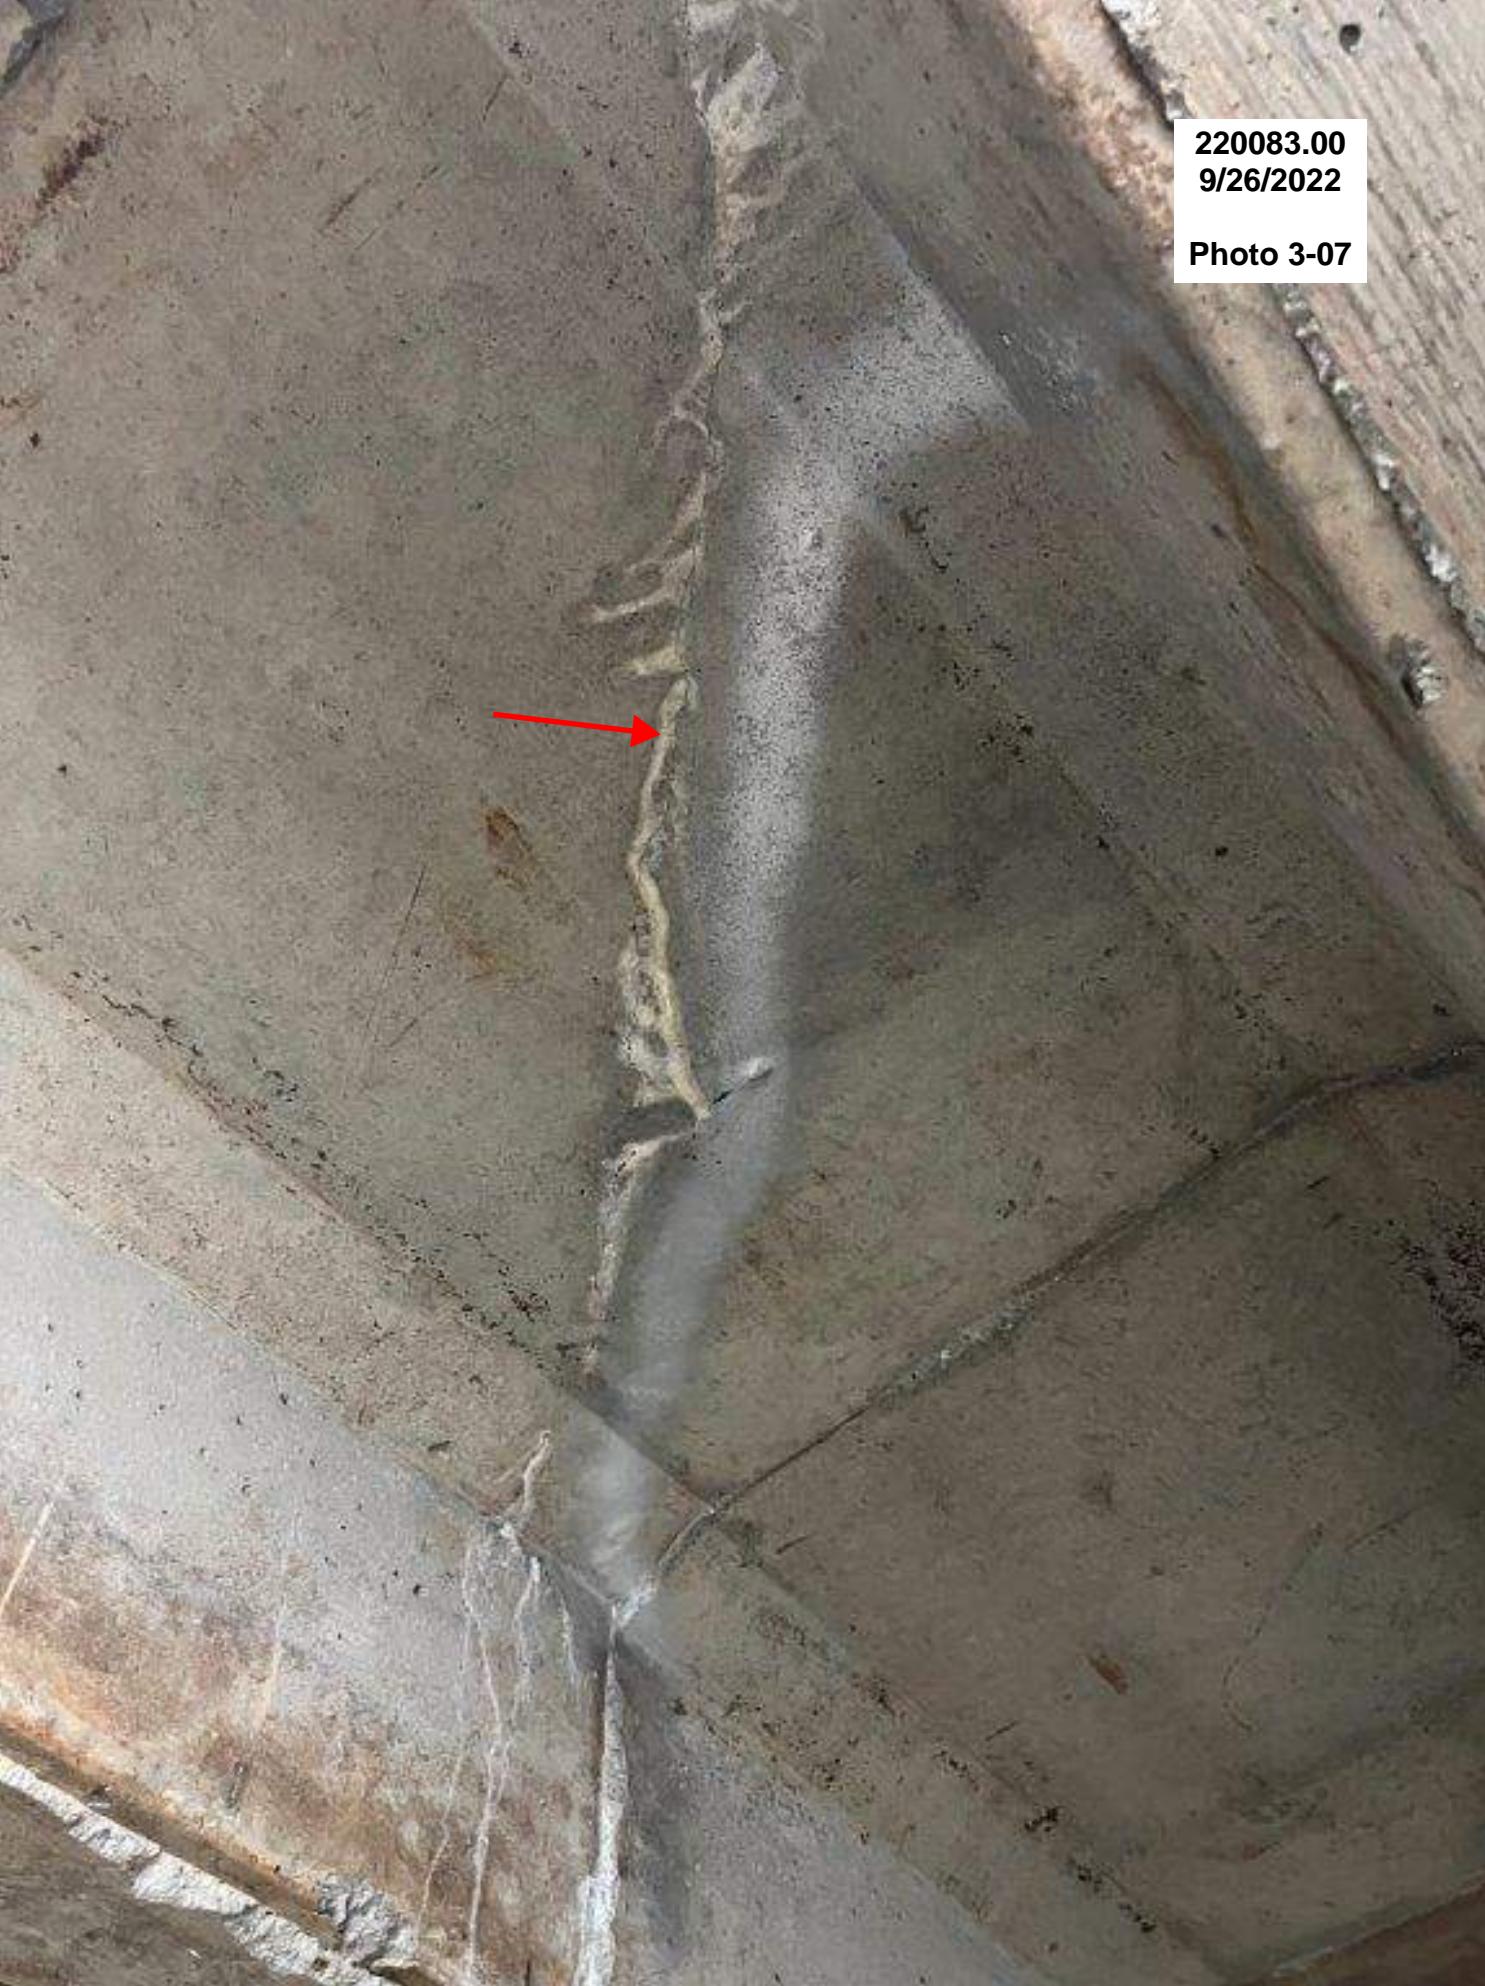
18. Several of the joists and the floor slab above are cracked, and some of the cracks show evidence of salt leaching (Photos 3-04 through 3-07). At some locations, the slab crack appears to extend across several joists (Photo 3-06).

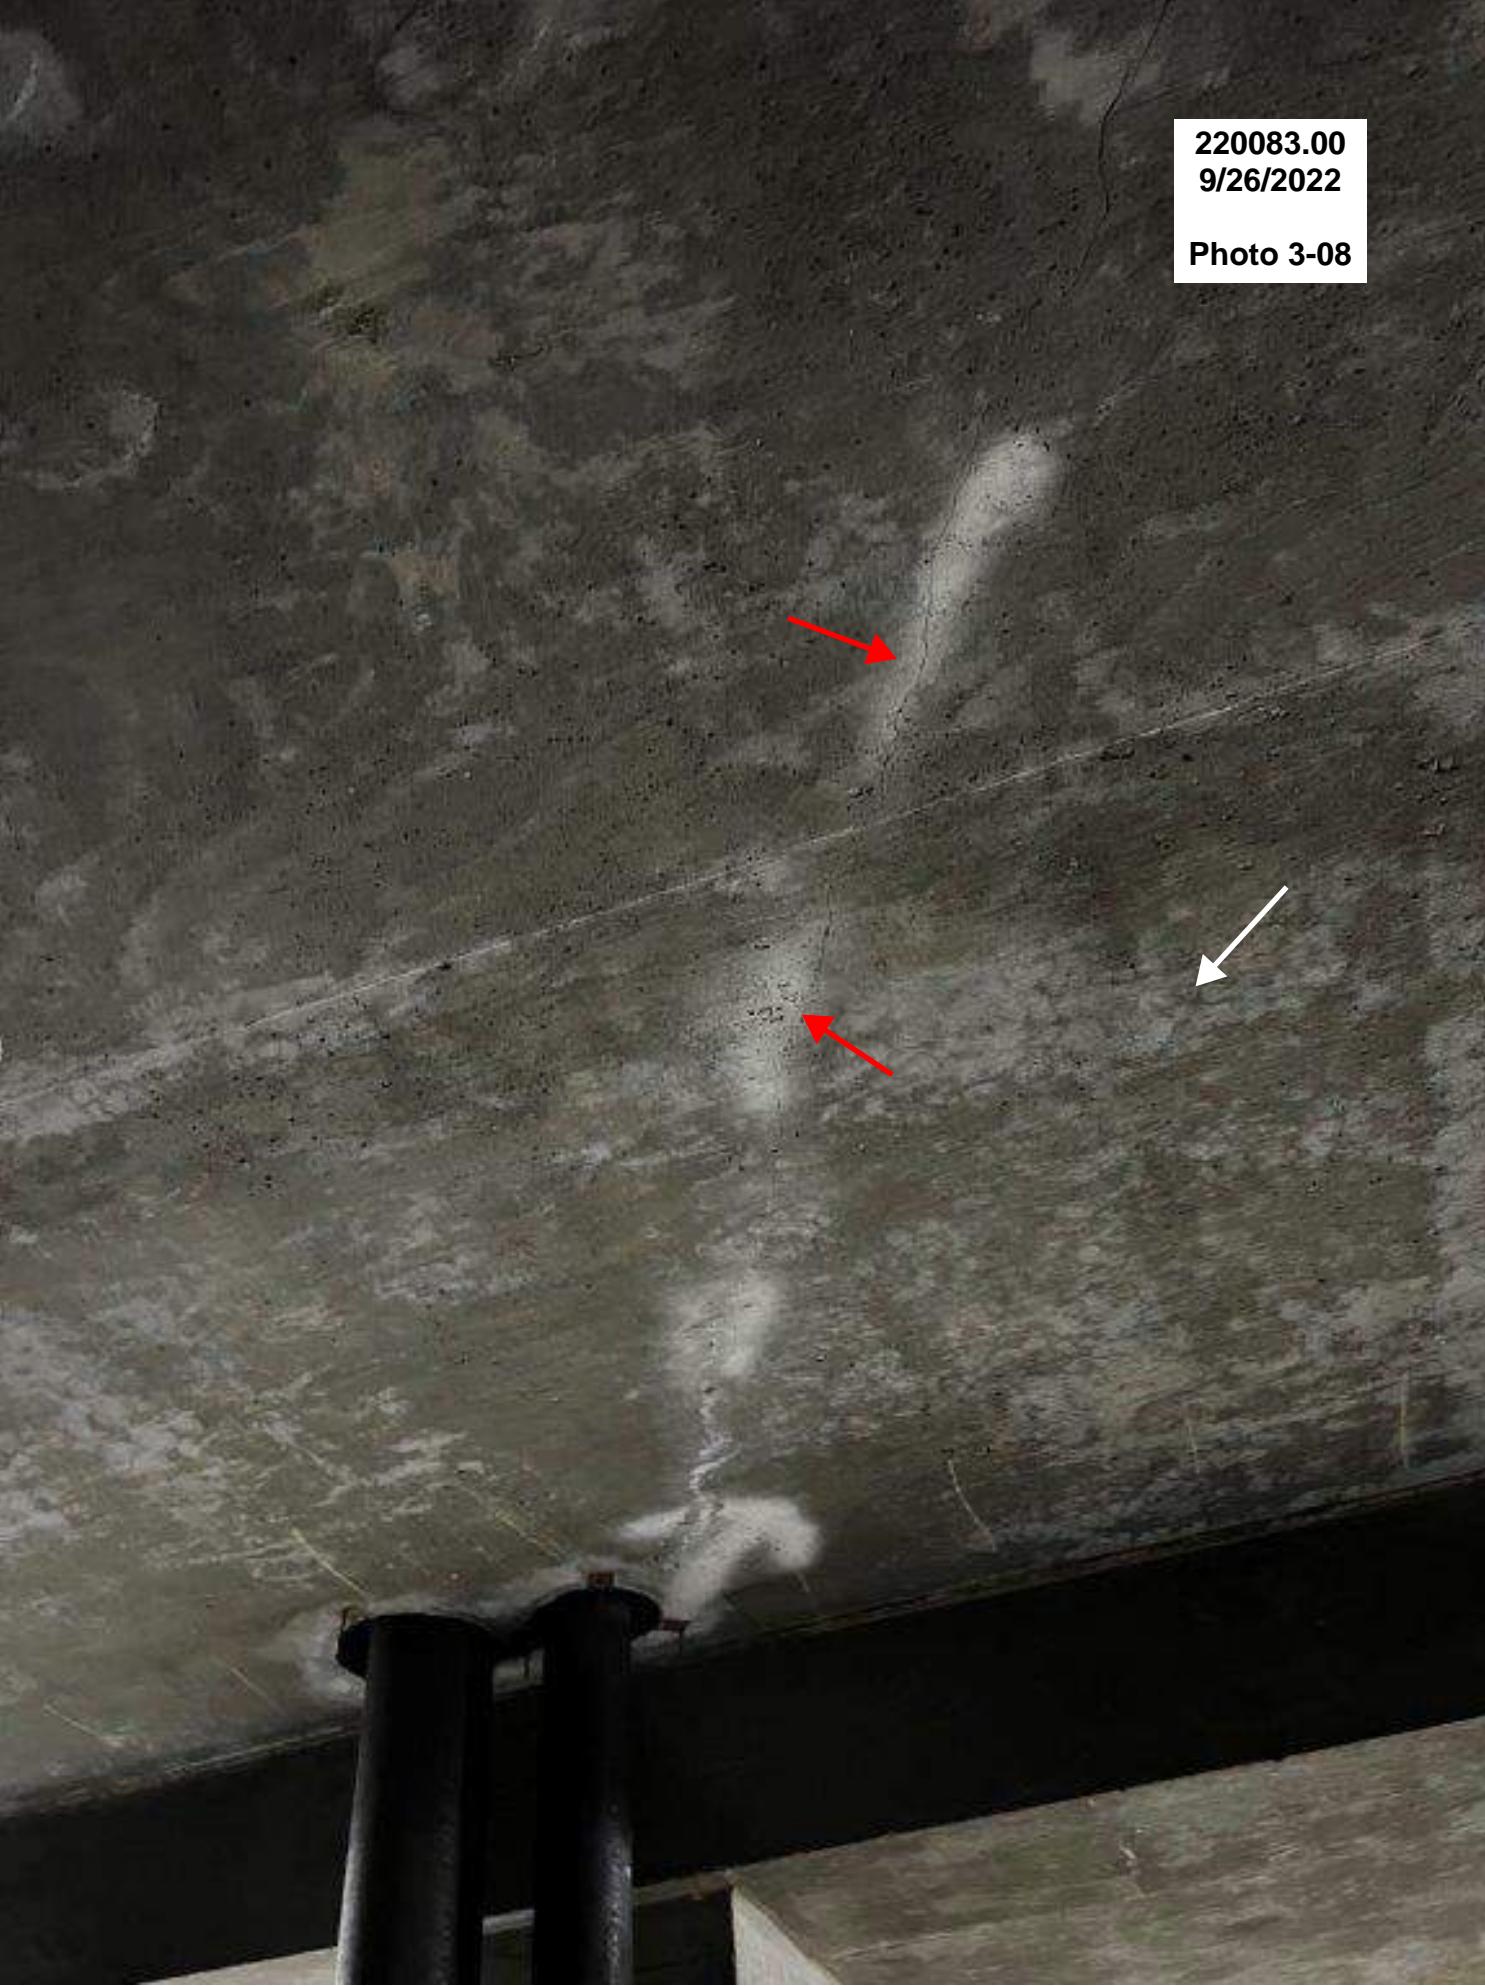
Photo 3-08

19. Some portions of the floor above are solid, conventionally reinforced concrete slabs instead of rib slabs (Photo 3-08). We observed cracks (Photo 3-08 red arrows) and areas of hairline crazing / staining (Photo 3-08 white arrow) at some portions of the flat slab.
