CopelandBEC Engineering Study Addenda, Notes, and Errata

Bay Square Condominiums

950 Massachusetts Avenue
Cambridge, MA

Building Condition Assessment

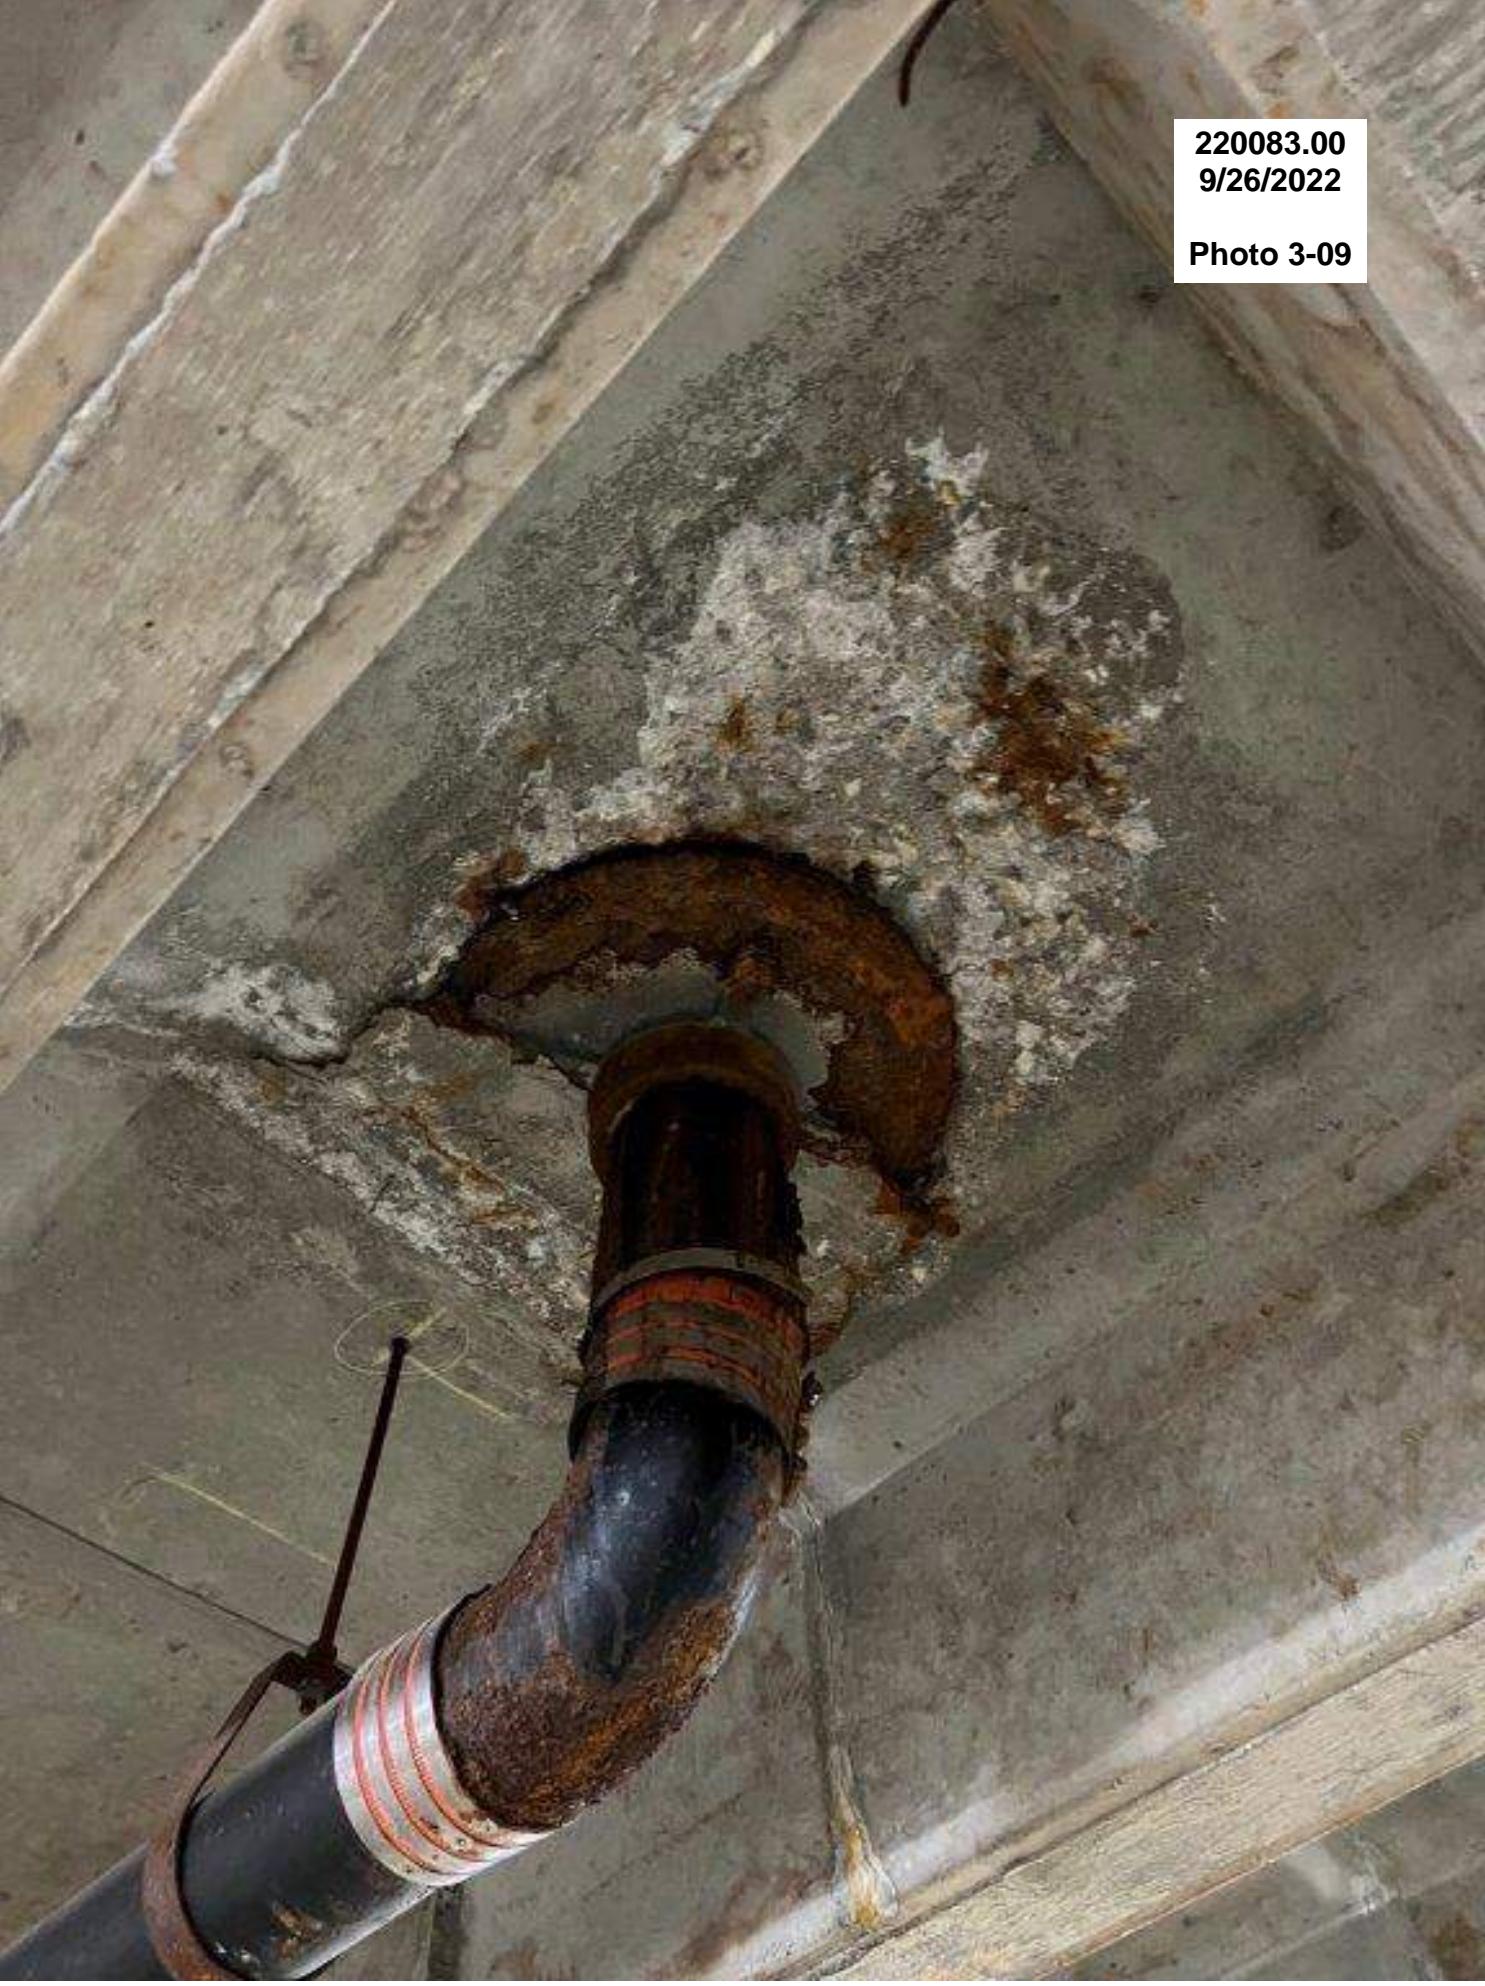
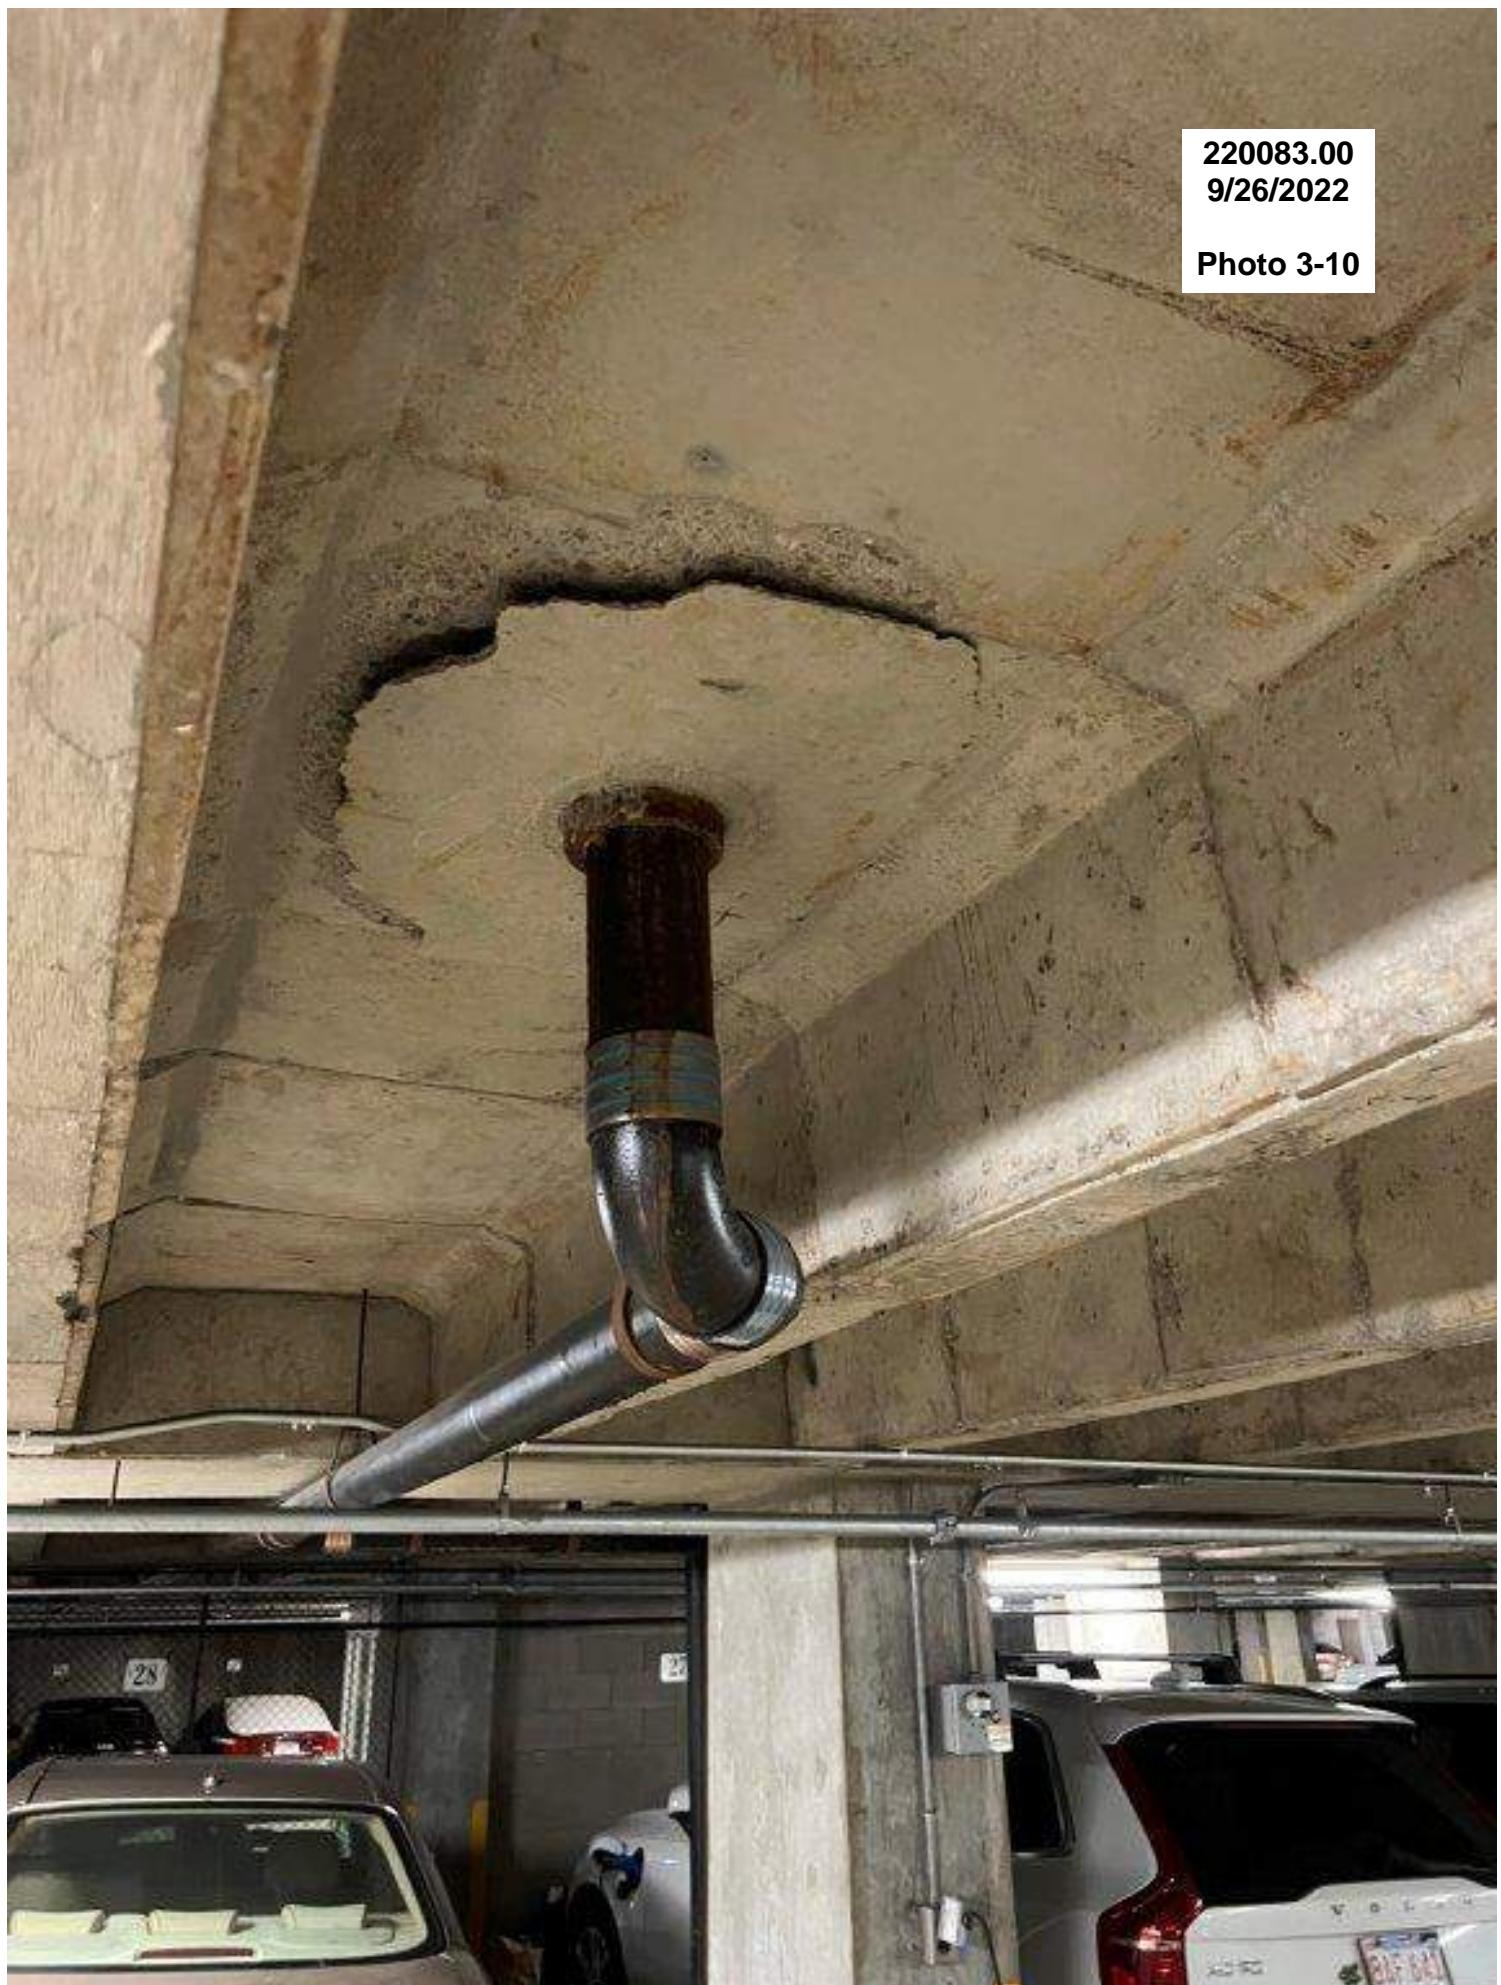
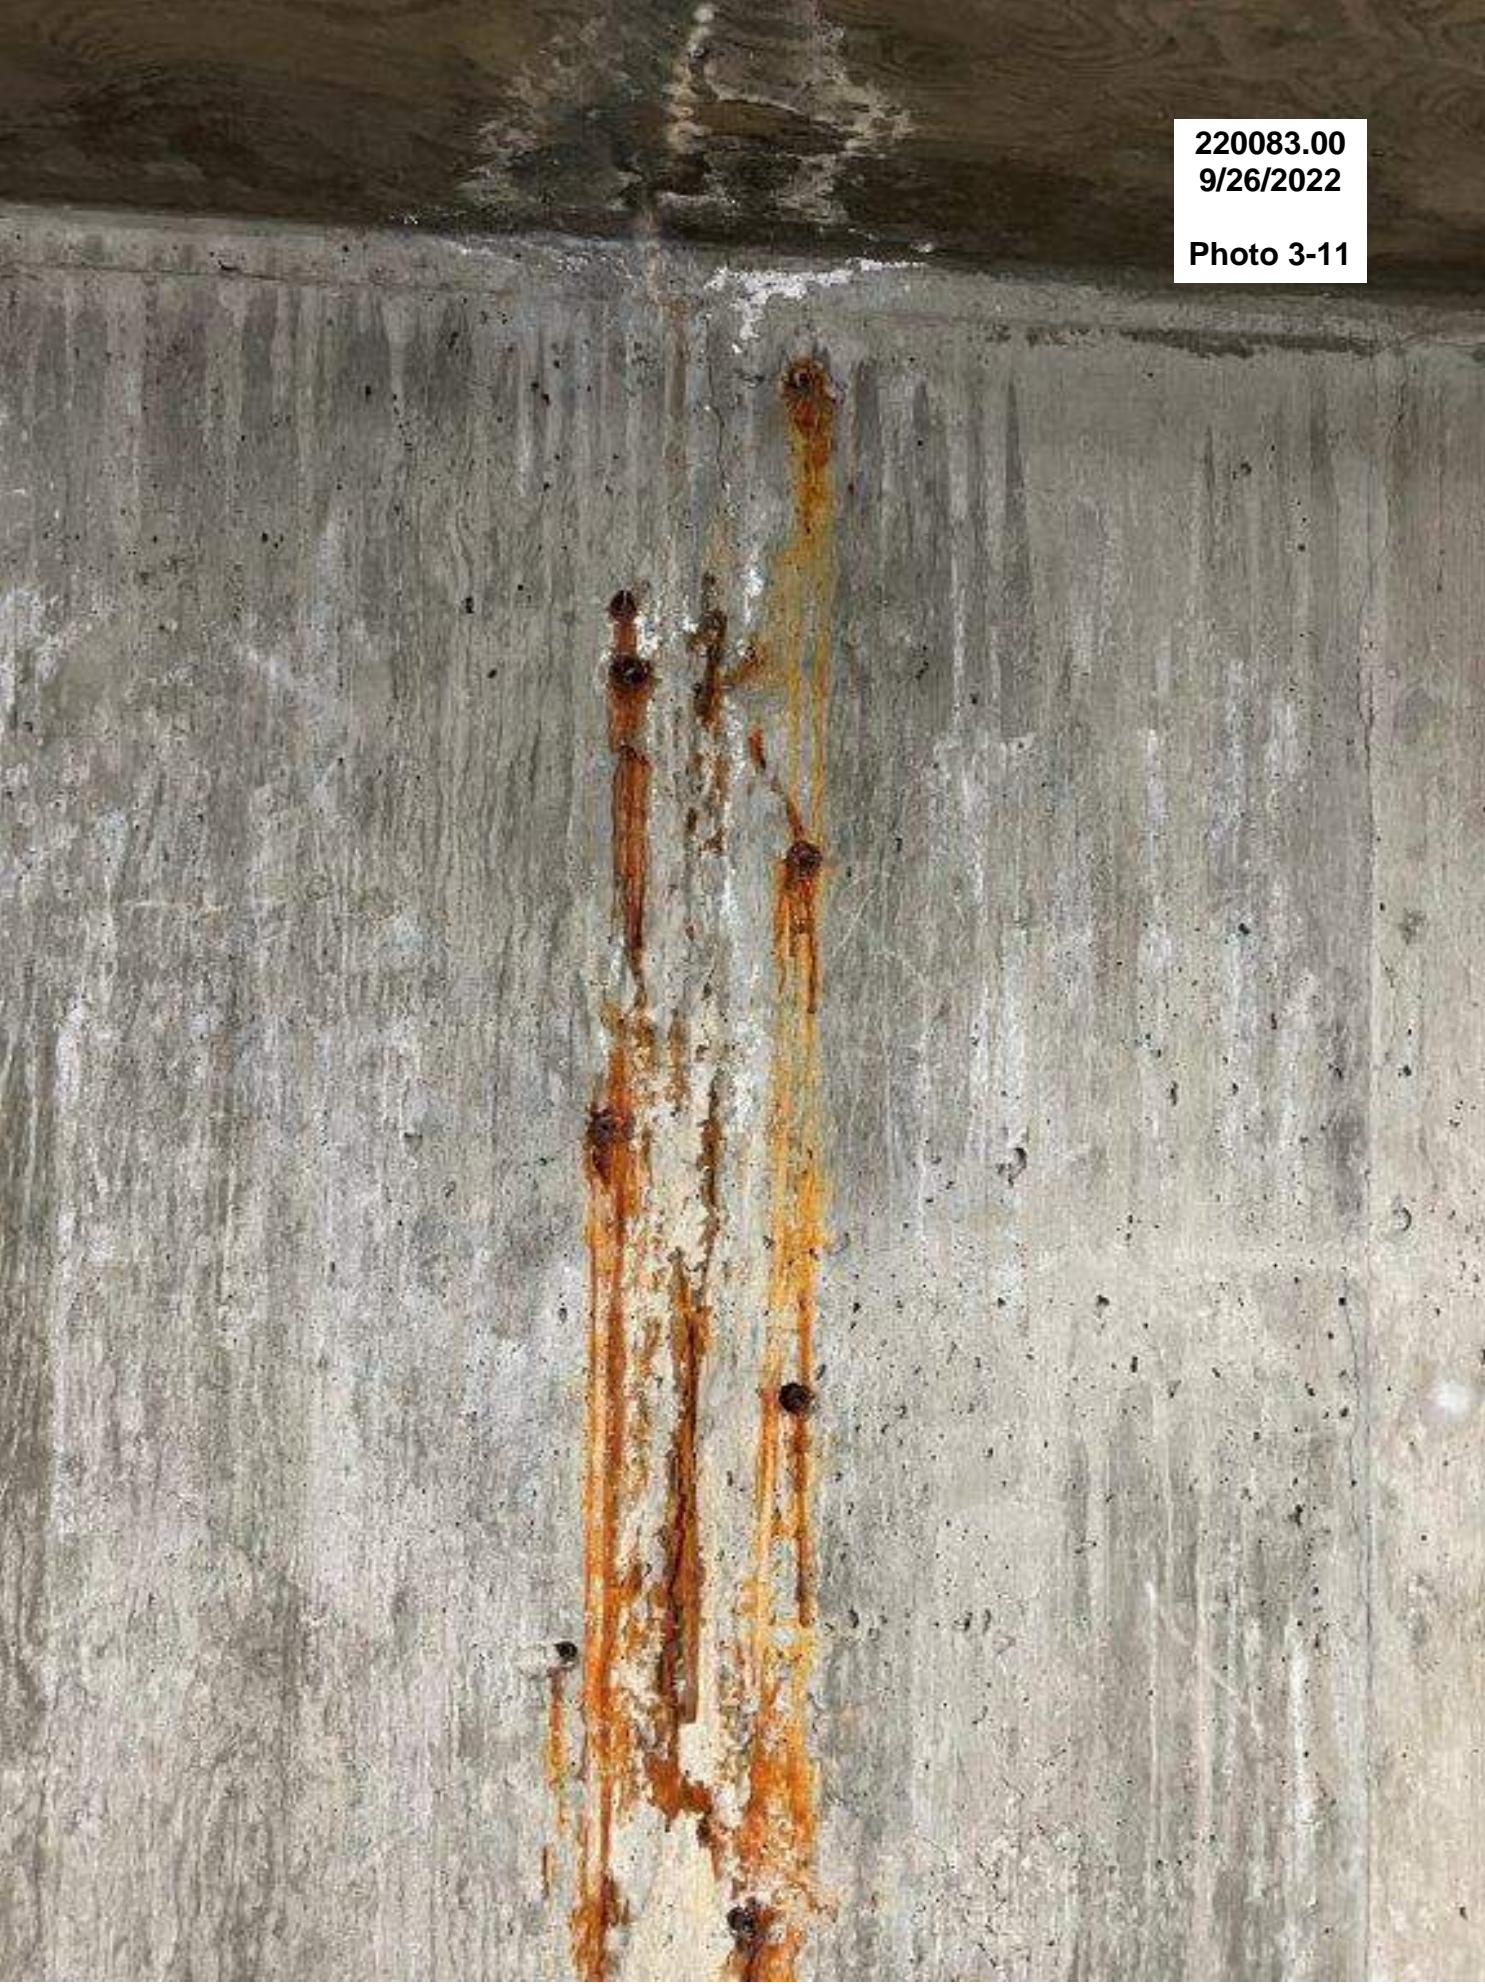
20. Slab deterioration and heavy spalling is present at some of the building drains (Photos 3-09 and 3-10).
21. There are diagonal and vertical cracks in the concrete walls of the garage that appear to have been previously injected with some repair material at some time during the life of the building (Photos 3-11).

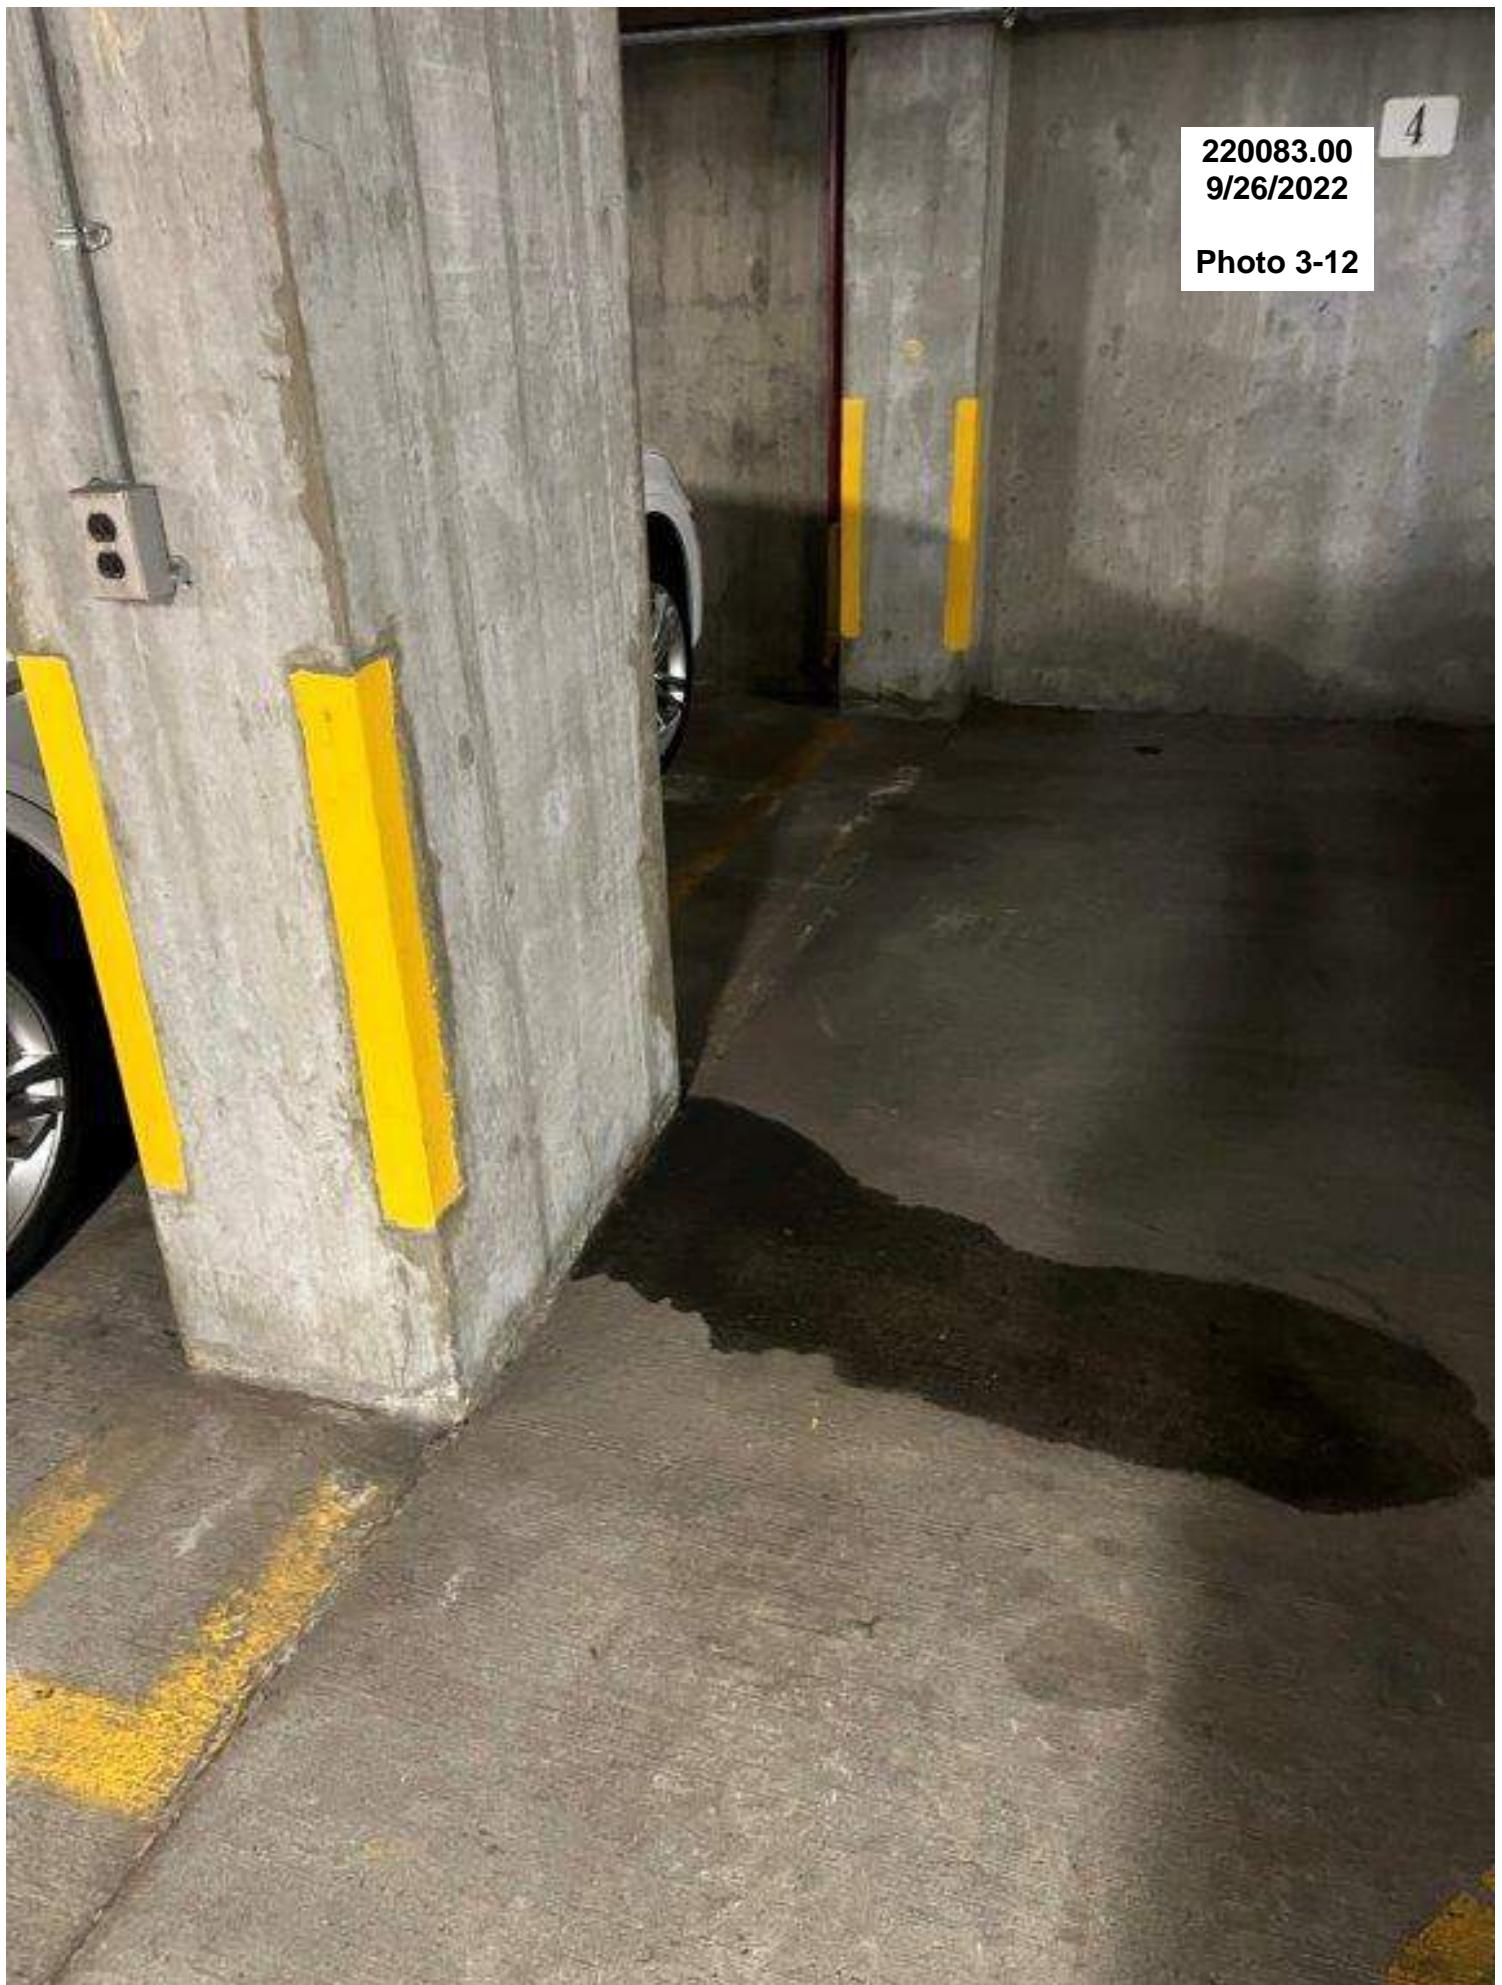
Photo 3-12

22. Some evidence of moisture / efflorescence (Photo 3-03) and / or leakage from above (Photo 3-12) was observed at some of the columns within the Lower Level Garage.
