CopelandBEC Engineering Study Addenda, Notes, and Errata

Bay Square Condominiums

950 Massachusetts Avenue
Cambridge, MA

Building Condition Assessment

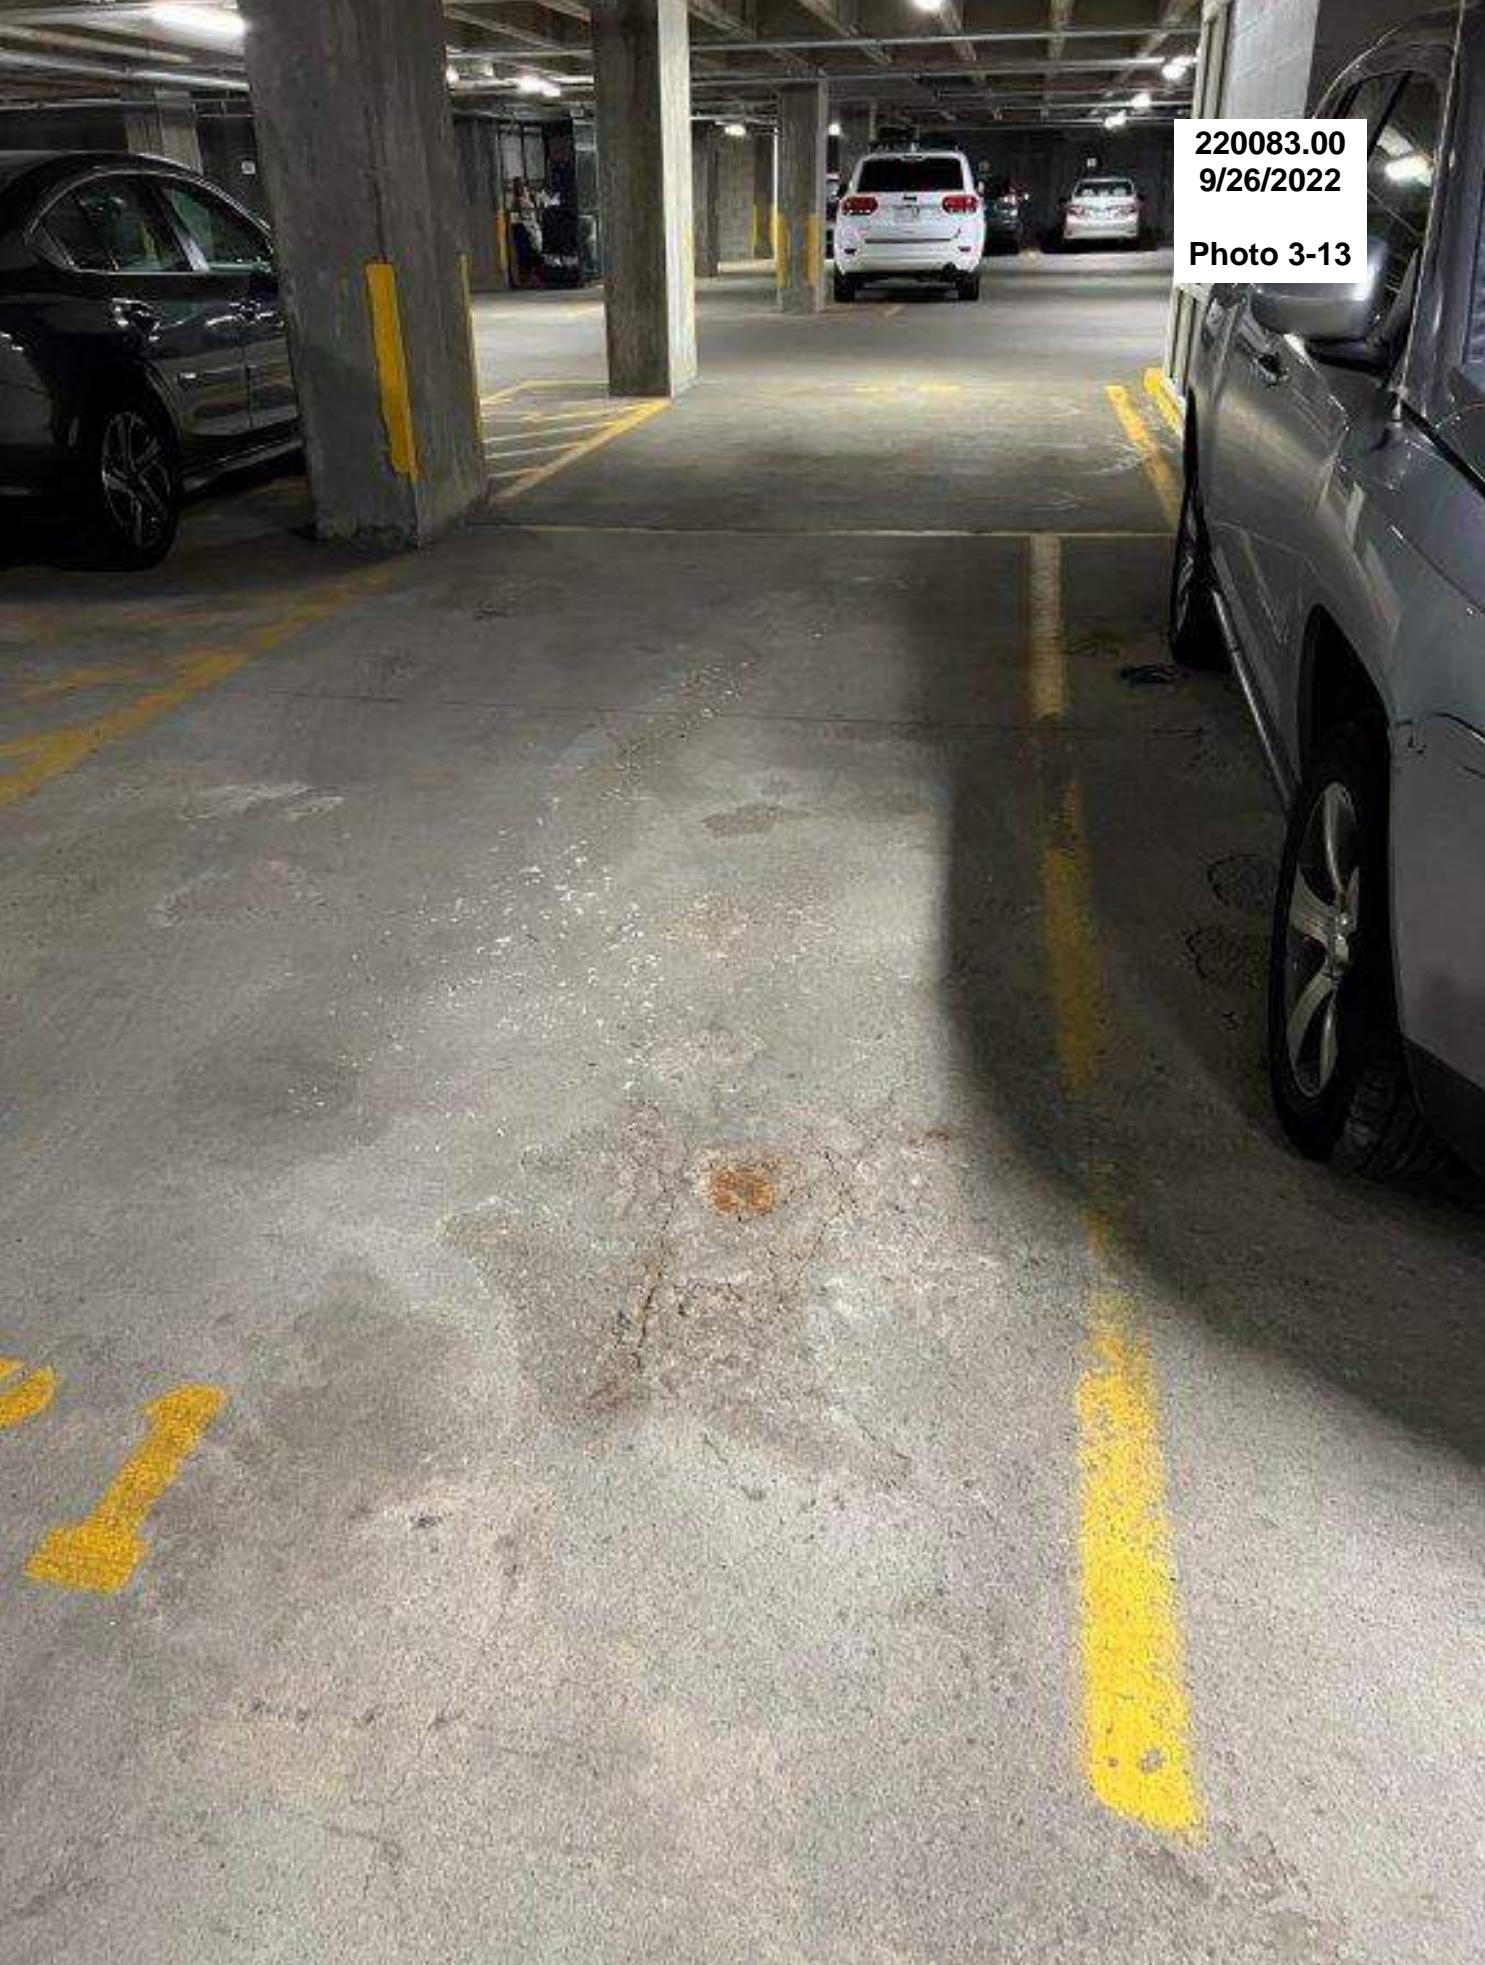
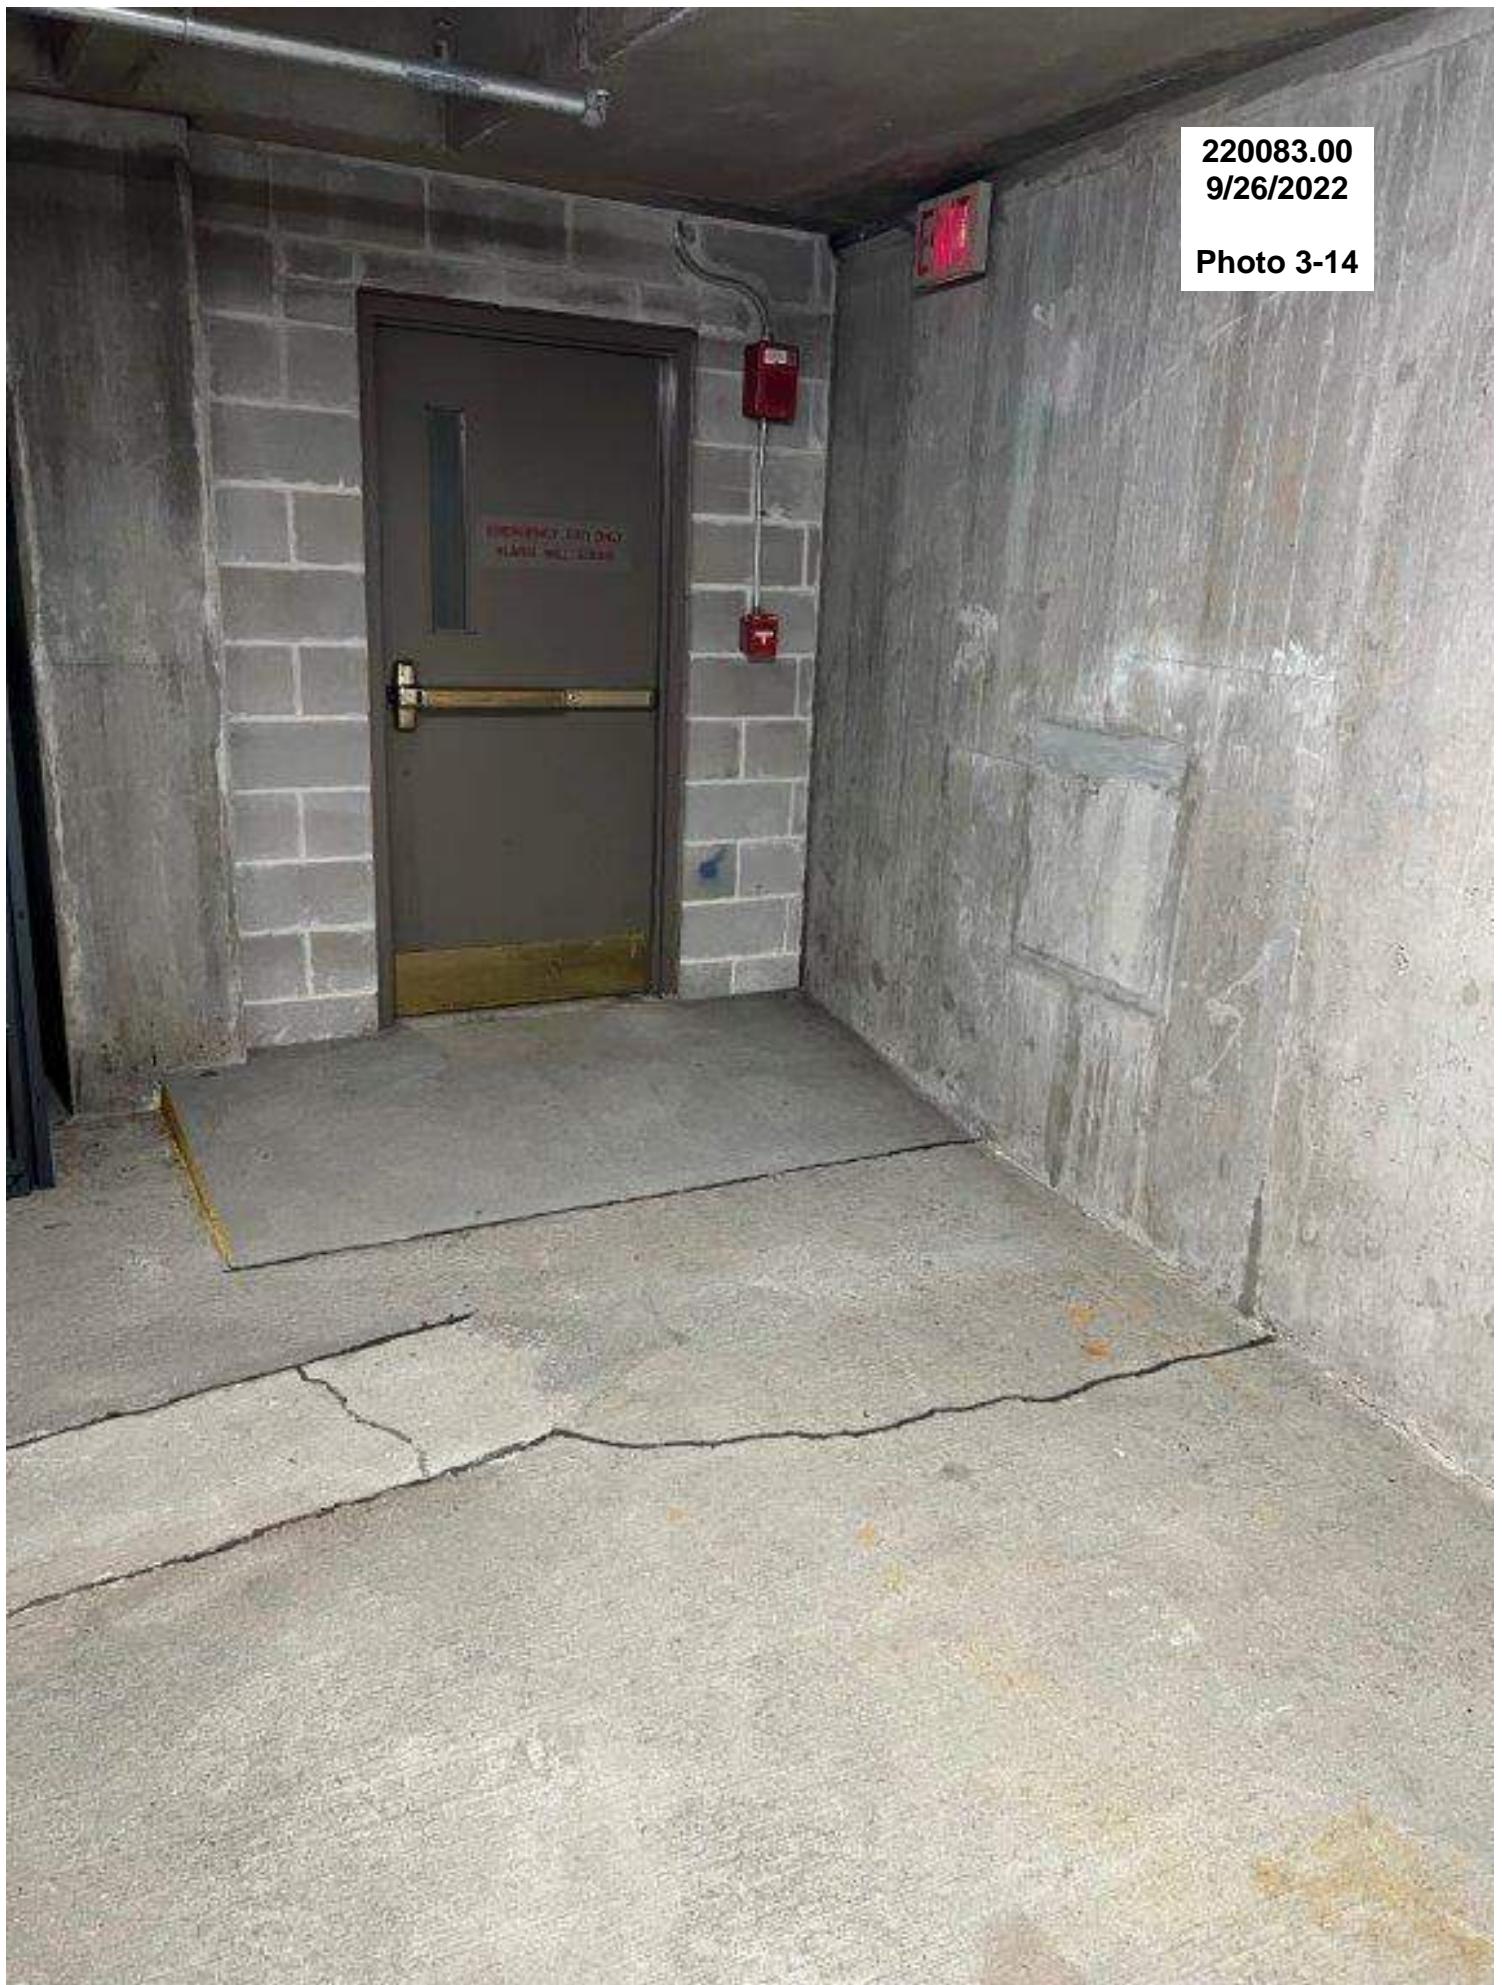
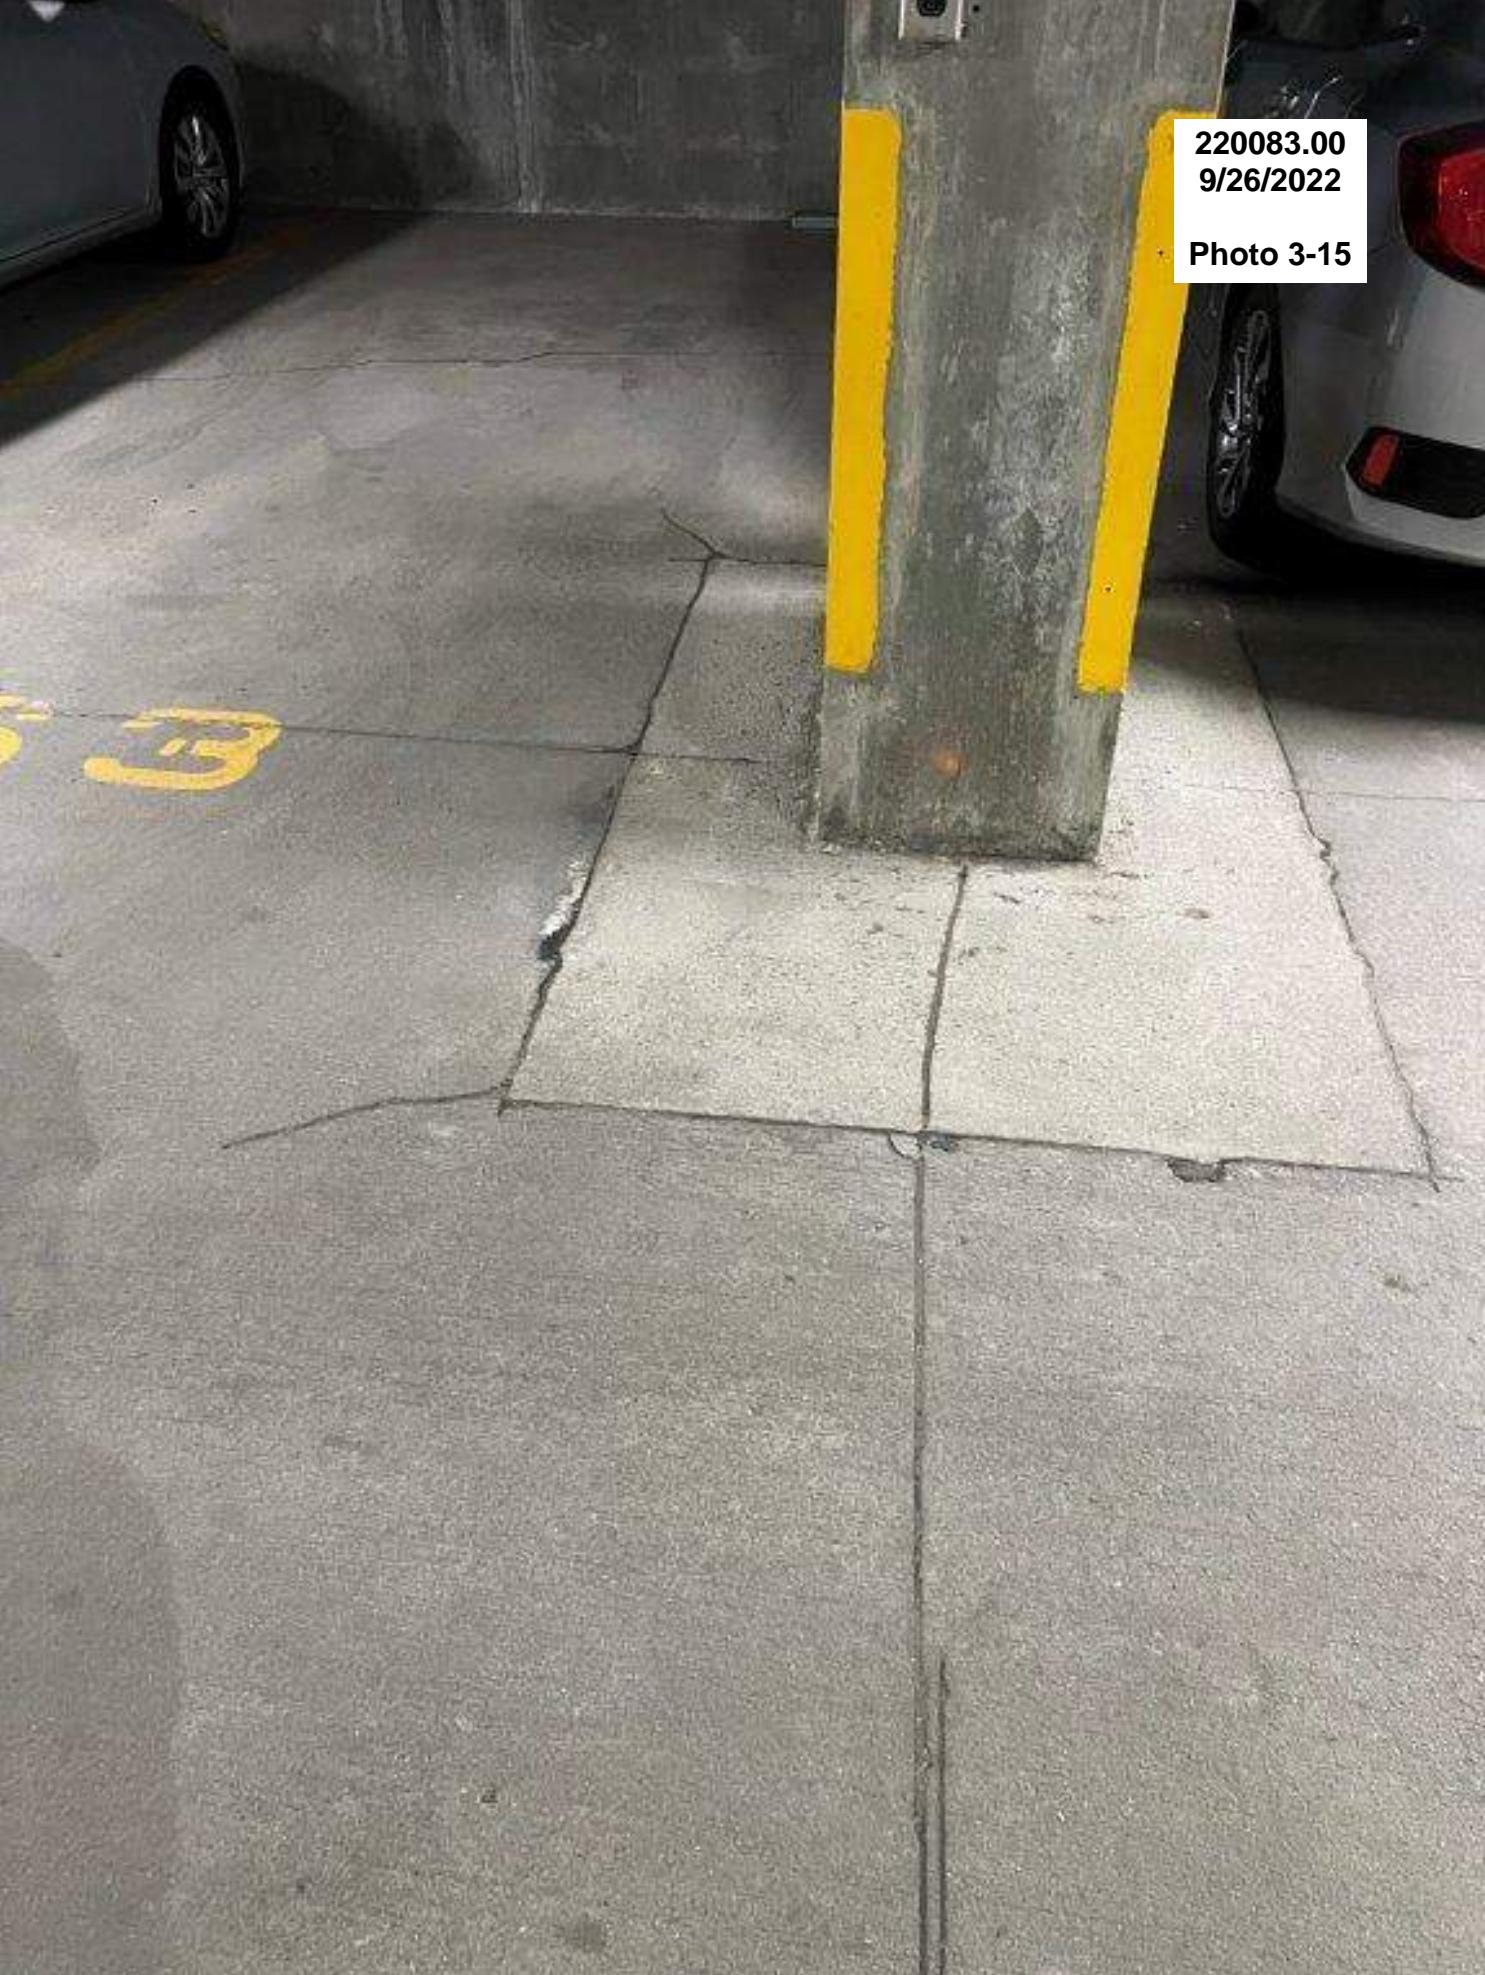
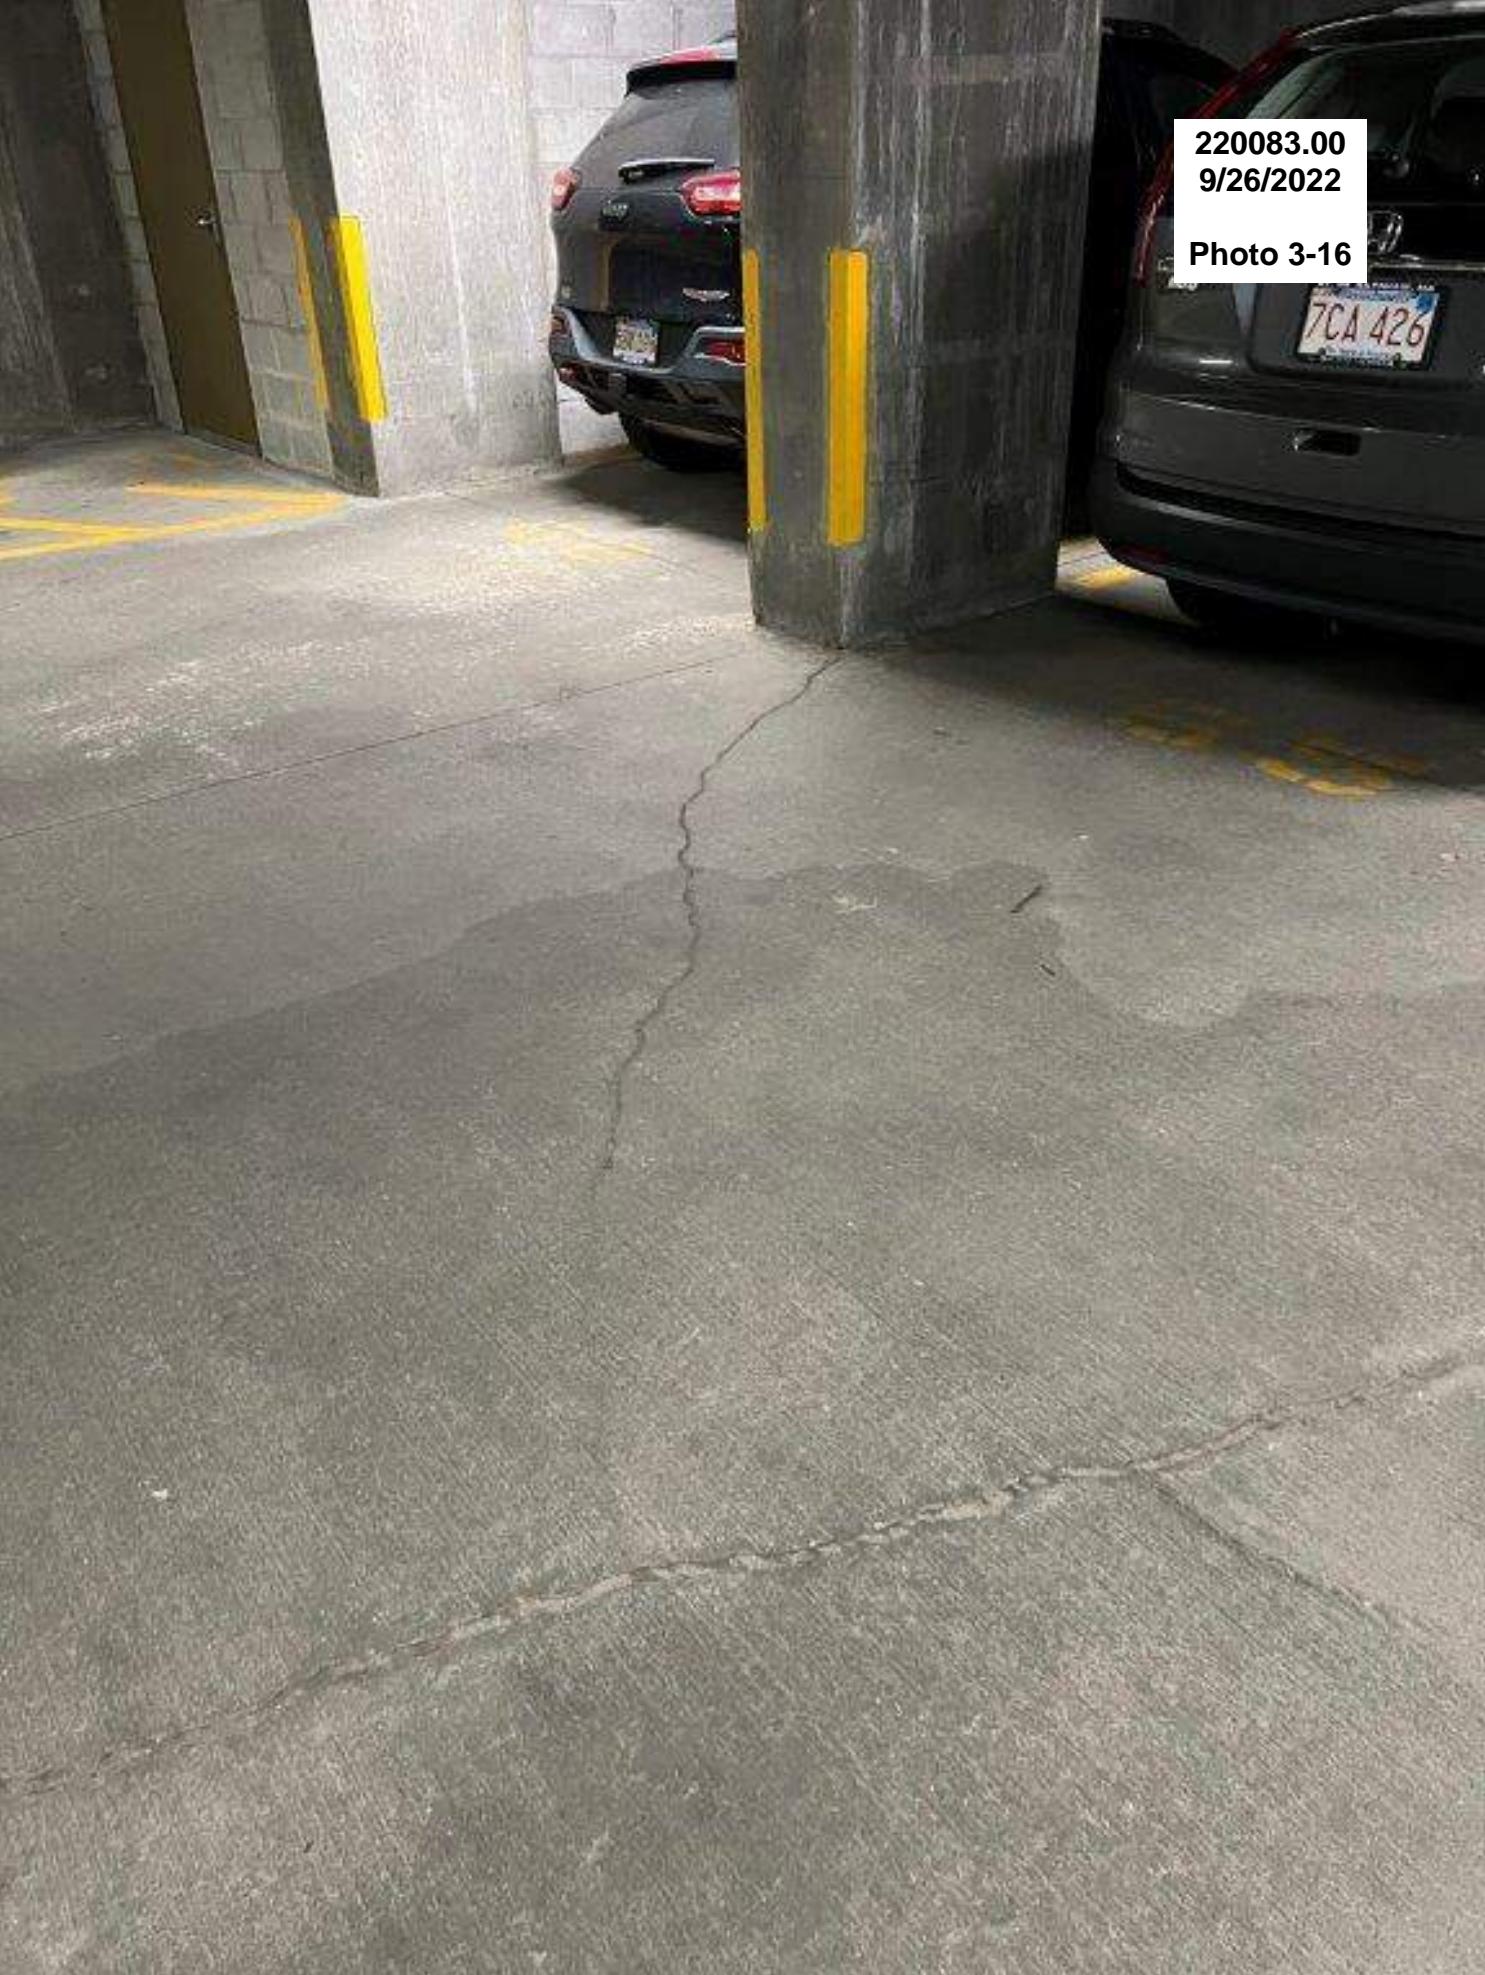
23. There are several cracks, weathered / deteriorated / spalled areas, and open / deteriorated joints throughout the garage floor slab (Photos 3-13 through 3-16).

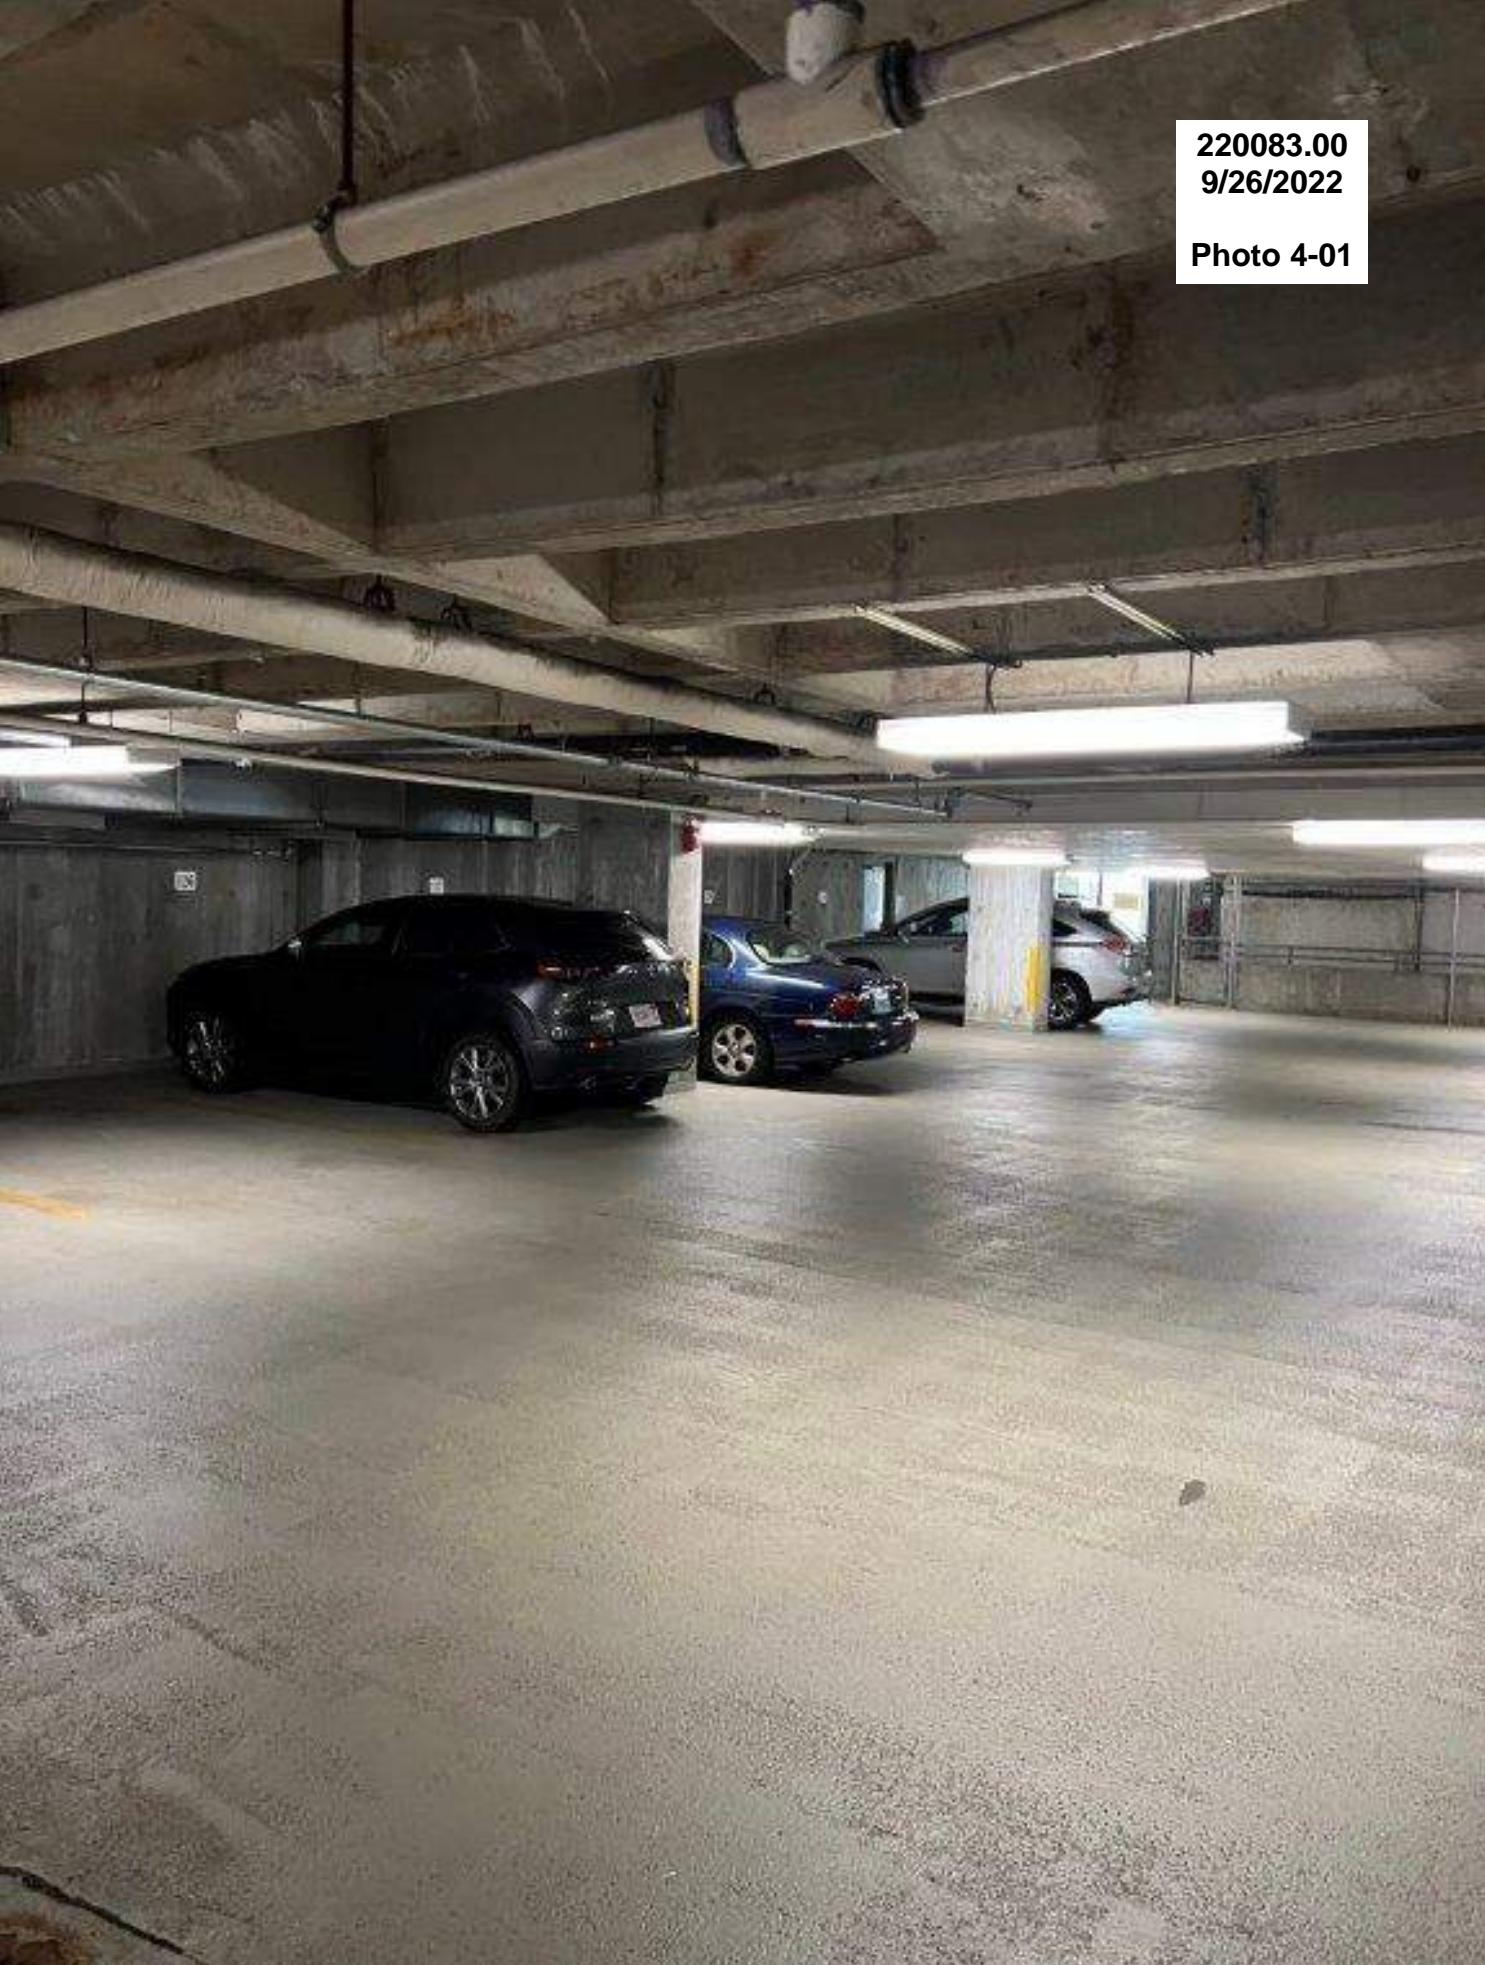
Photo 4-01

24. The floor surface of the Upper Level Garage has an elastomeric coating that is warn in several areas (Photo 4-01).
25. The floor structure above the Upper Level Garage is similar to the floor structure below (i.e., a concrete joist / rib slab system, with the joists spanning in the north-south direction, Photo 4-01). The concrete ribs are supported by integrally placed concrete girders and cast-in-place concrete columns below (Photo 4-01). Much of the structure above the Upper Level Is concealed by a drop panel ceiling (Photo 4-02).
