CopelandBEC Engineering Study Addenda, Notes, and Errata

Bay Square Condominiums

950 Massachusetts Avenue
Cambridge, MA

Building Condition Assessment

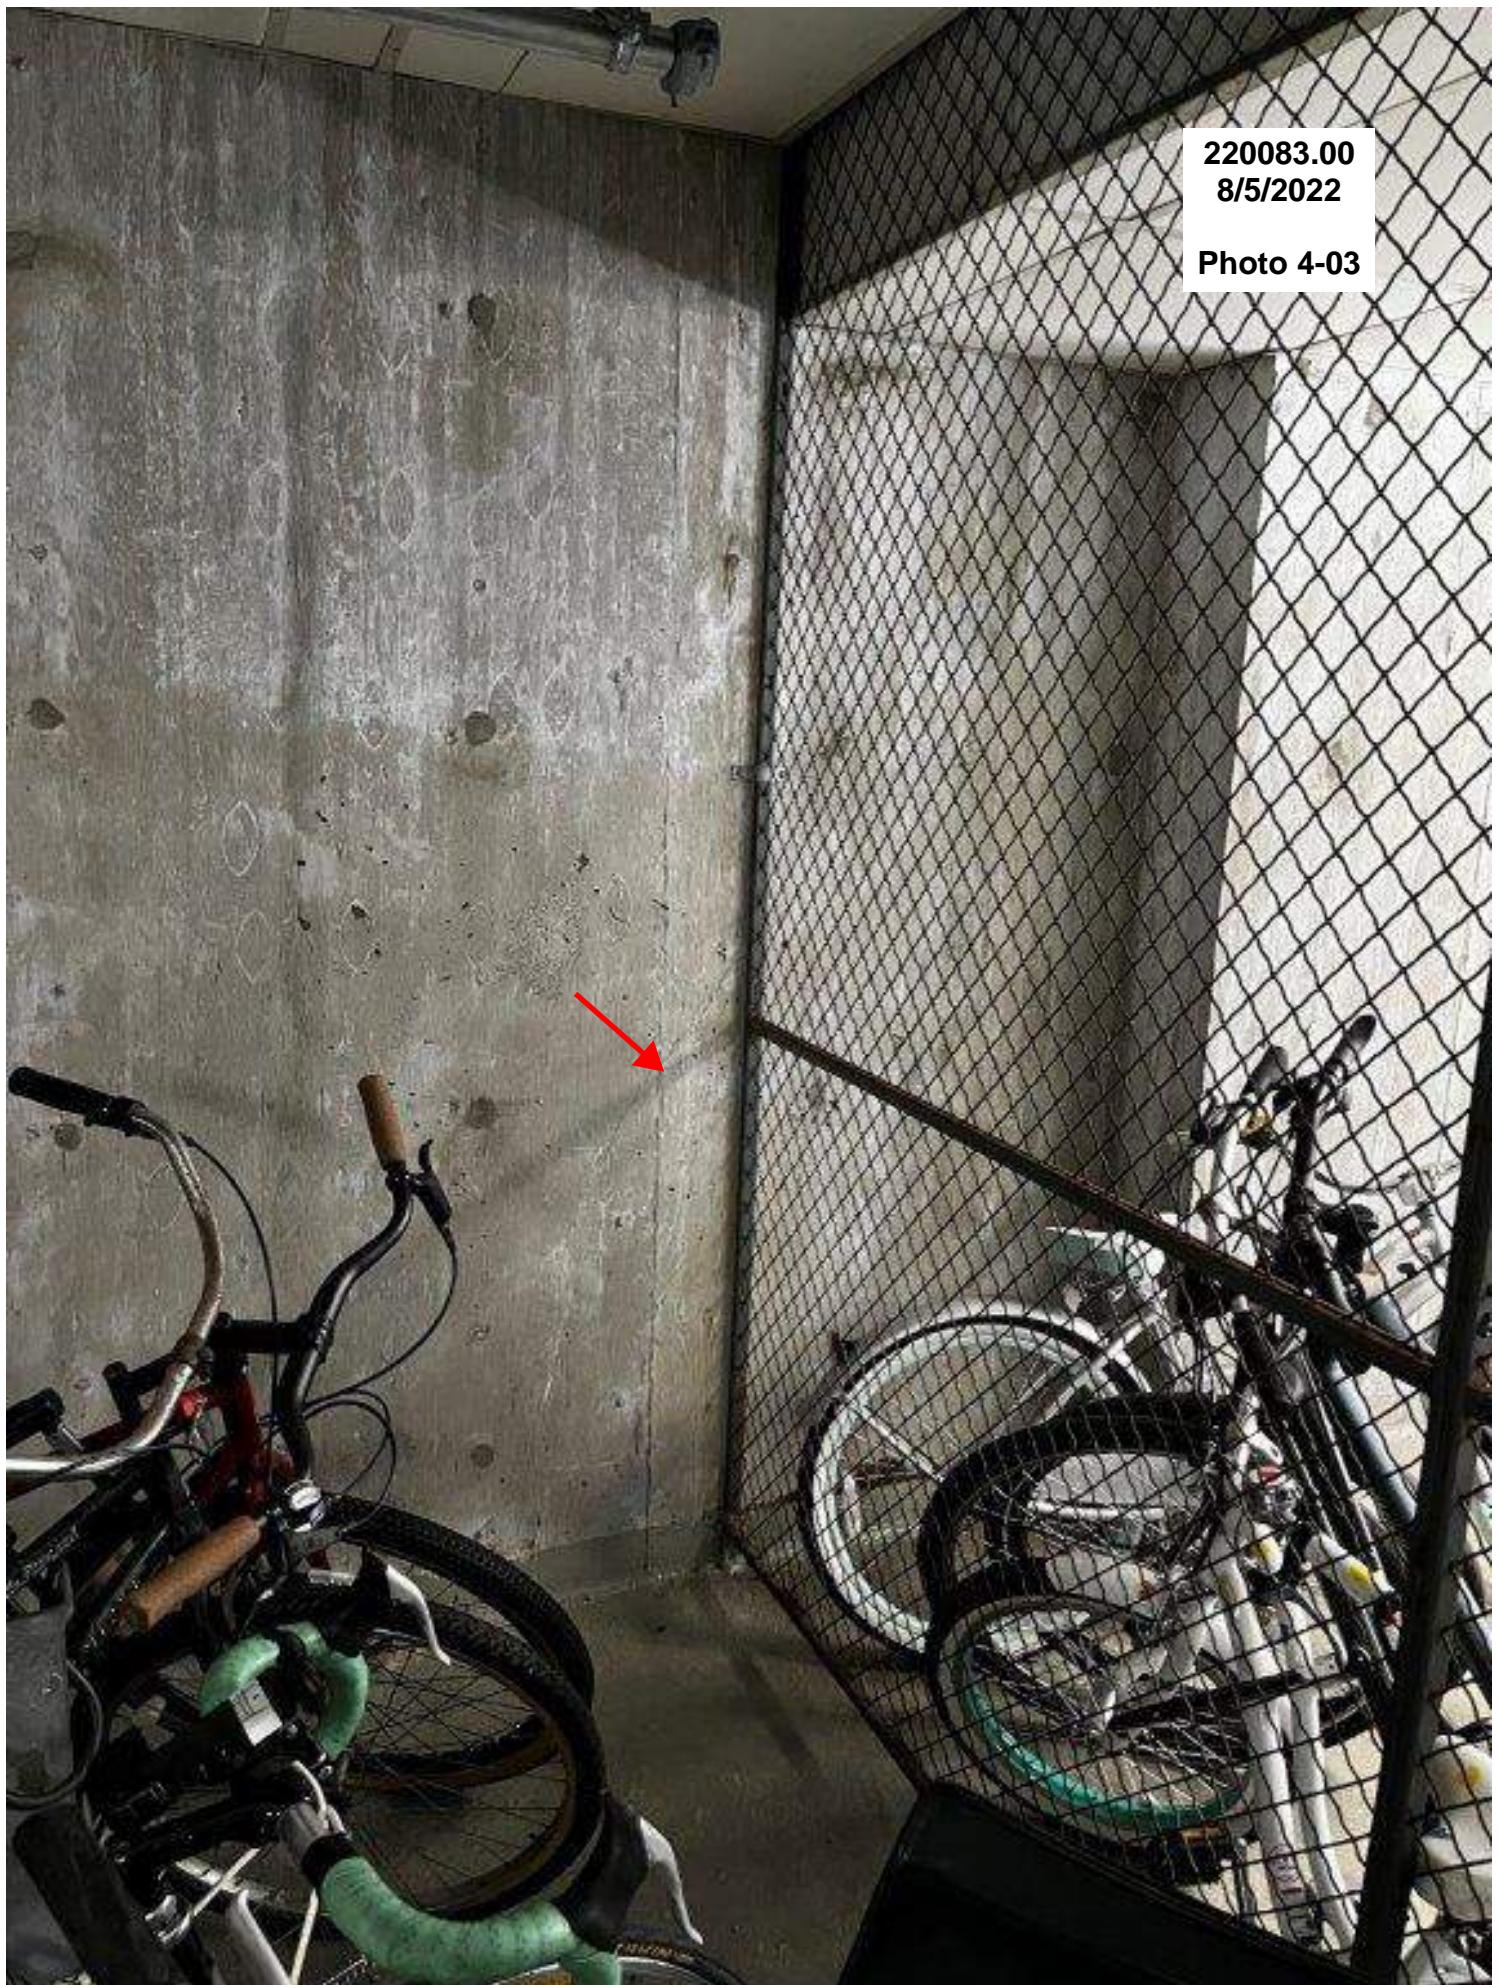
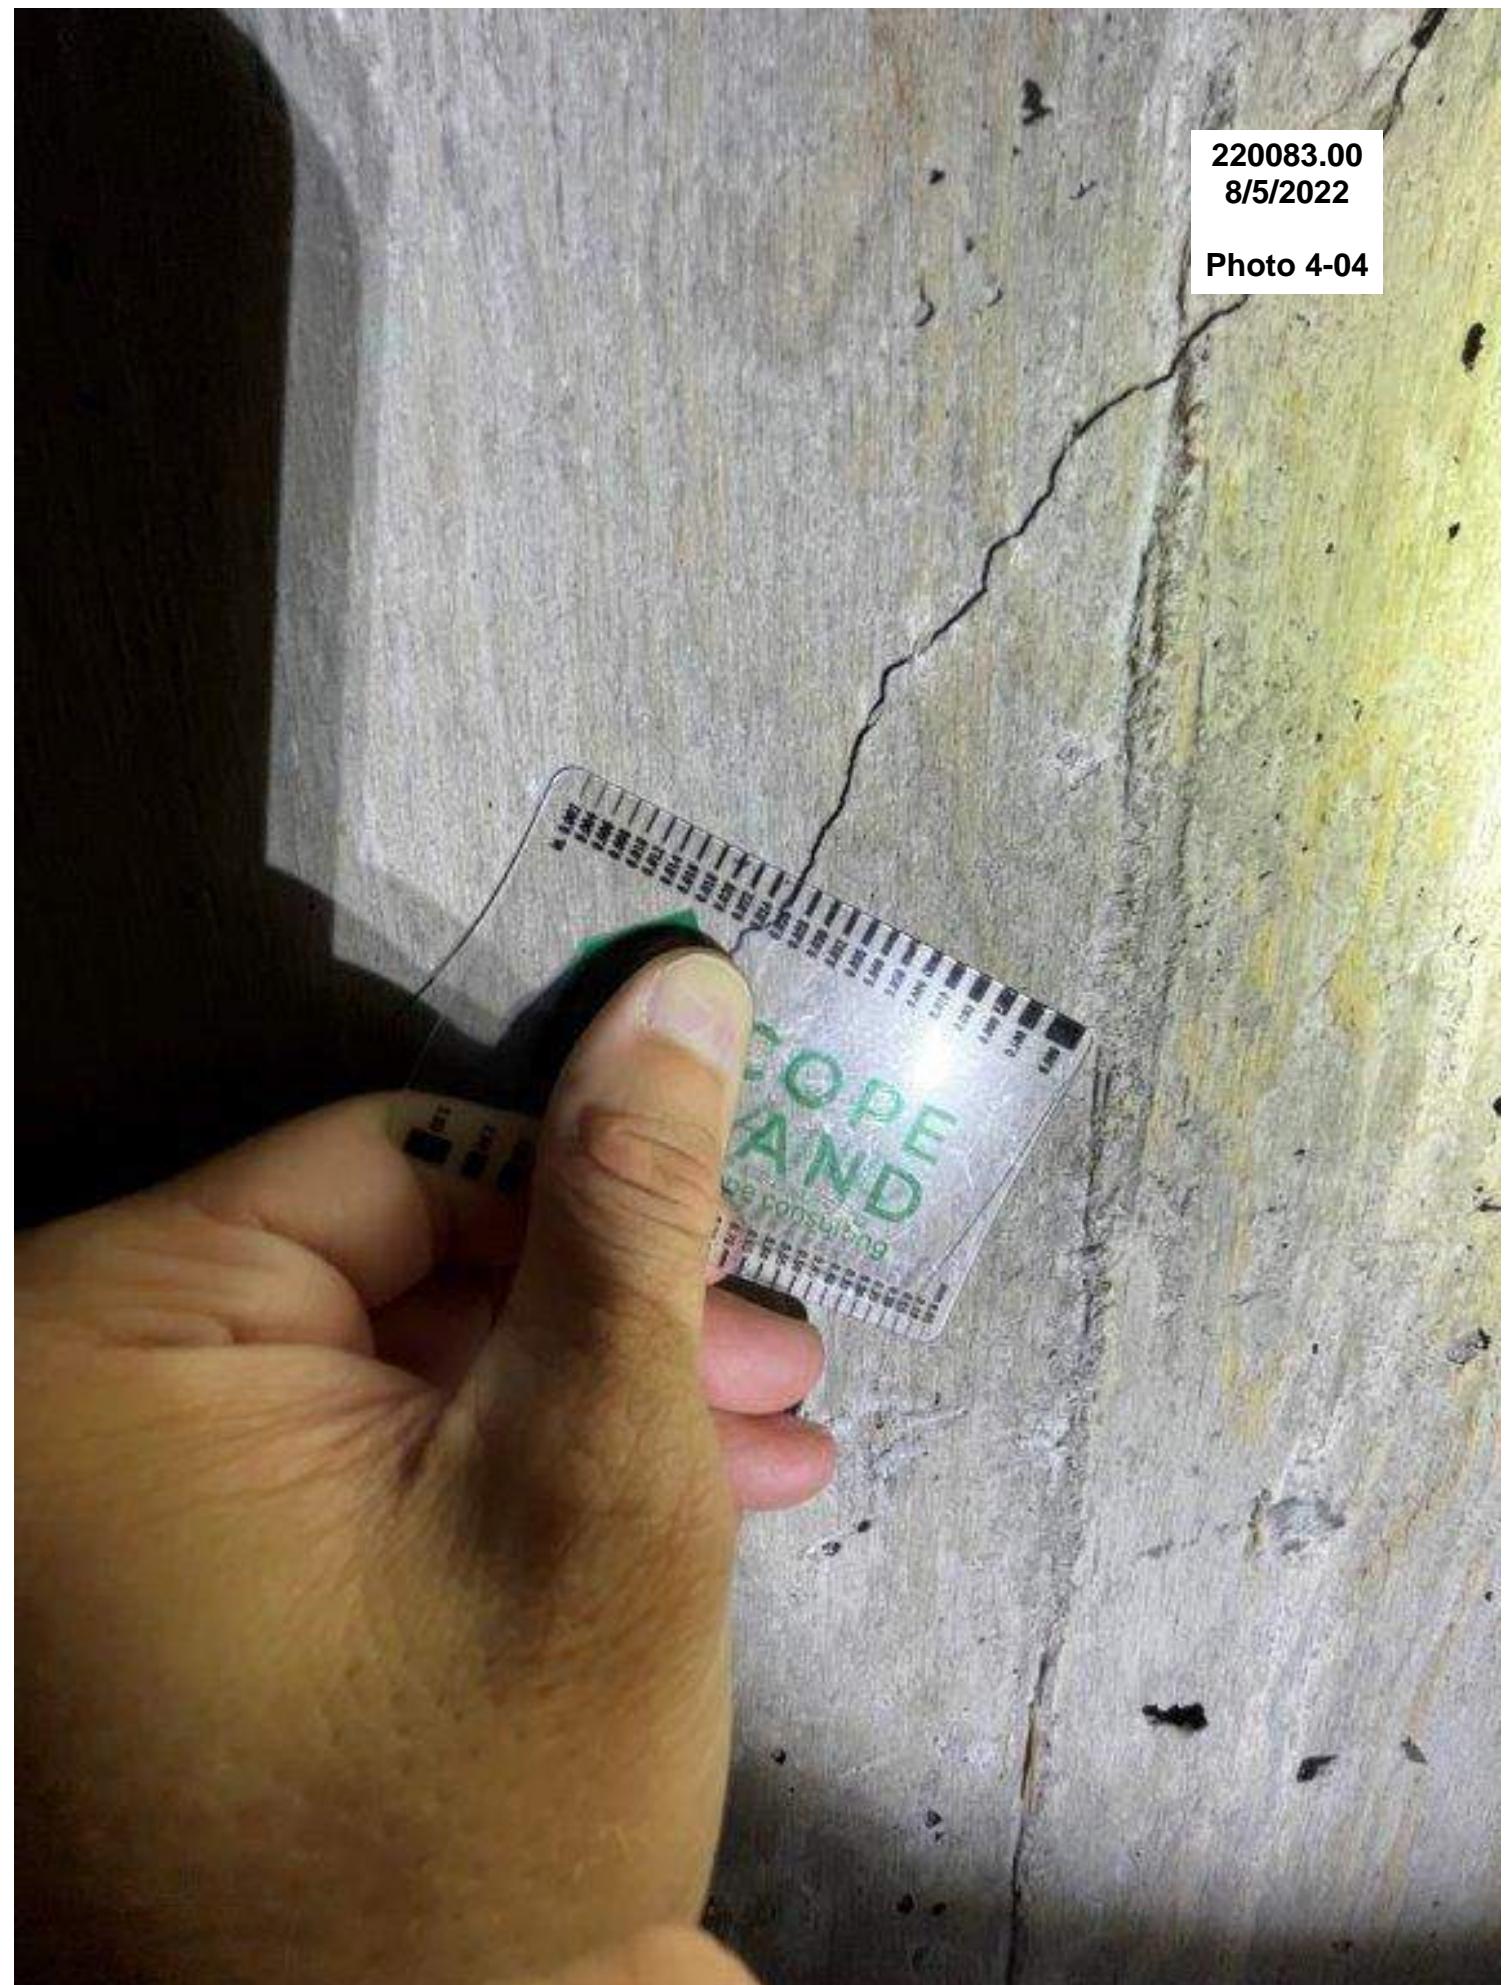
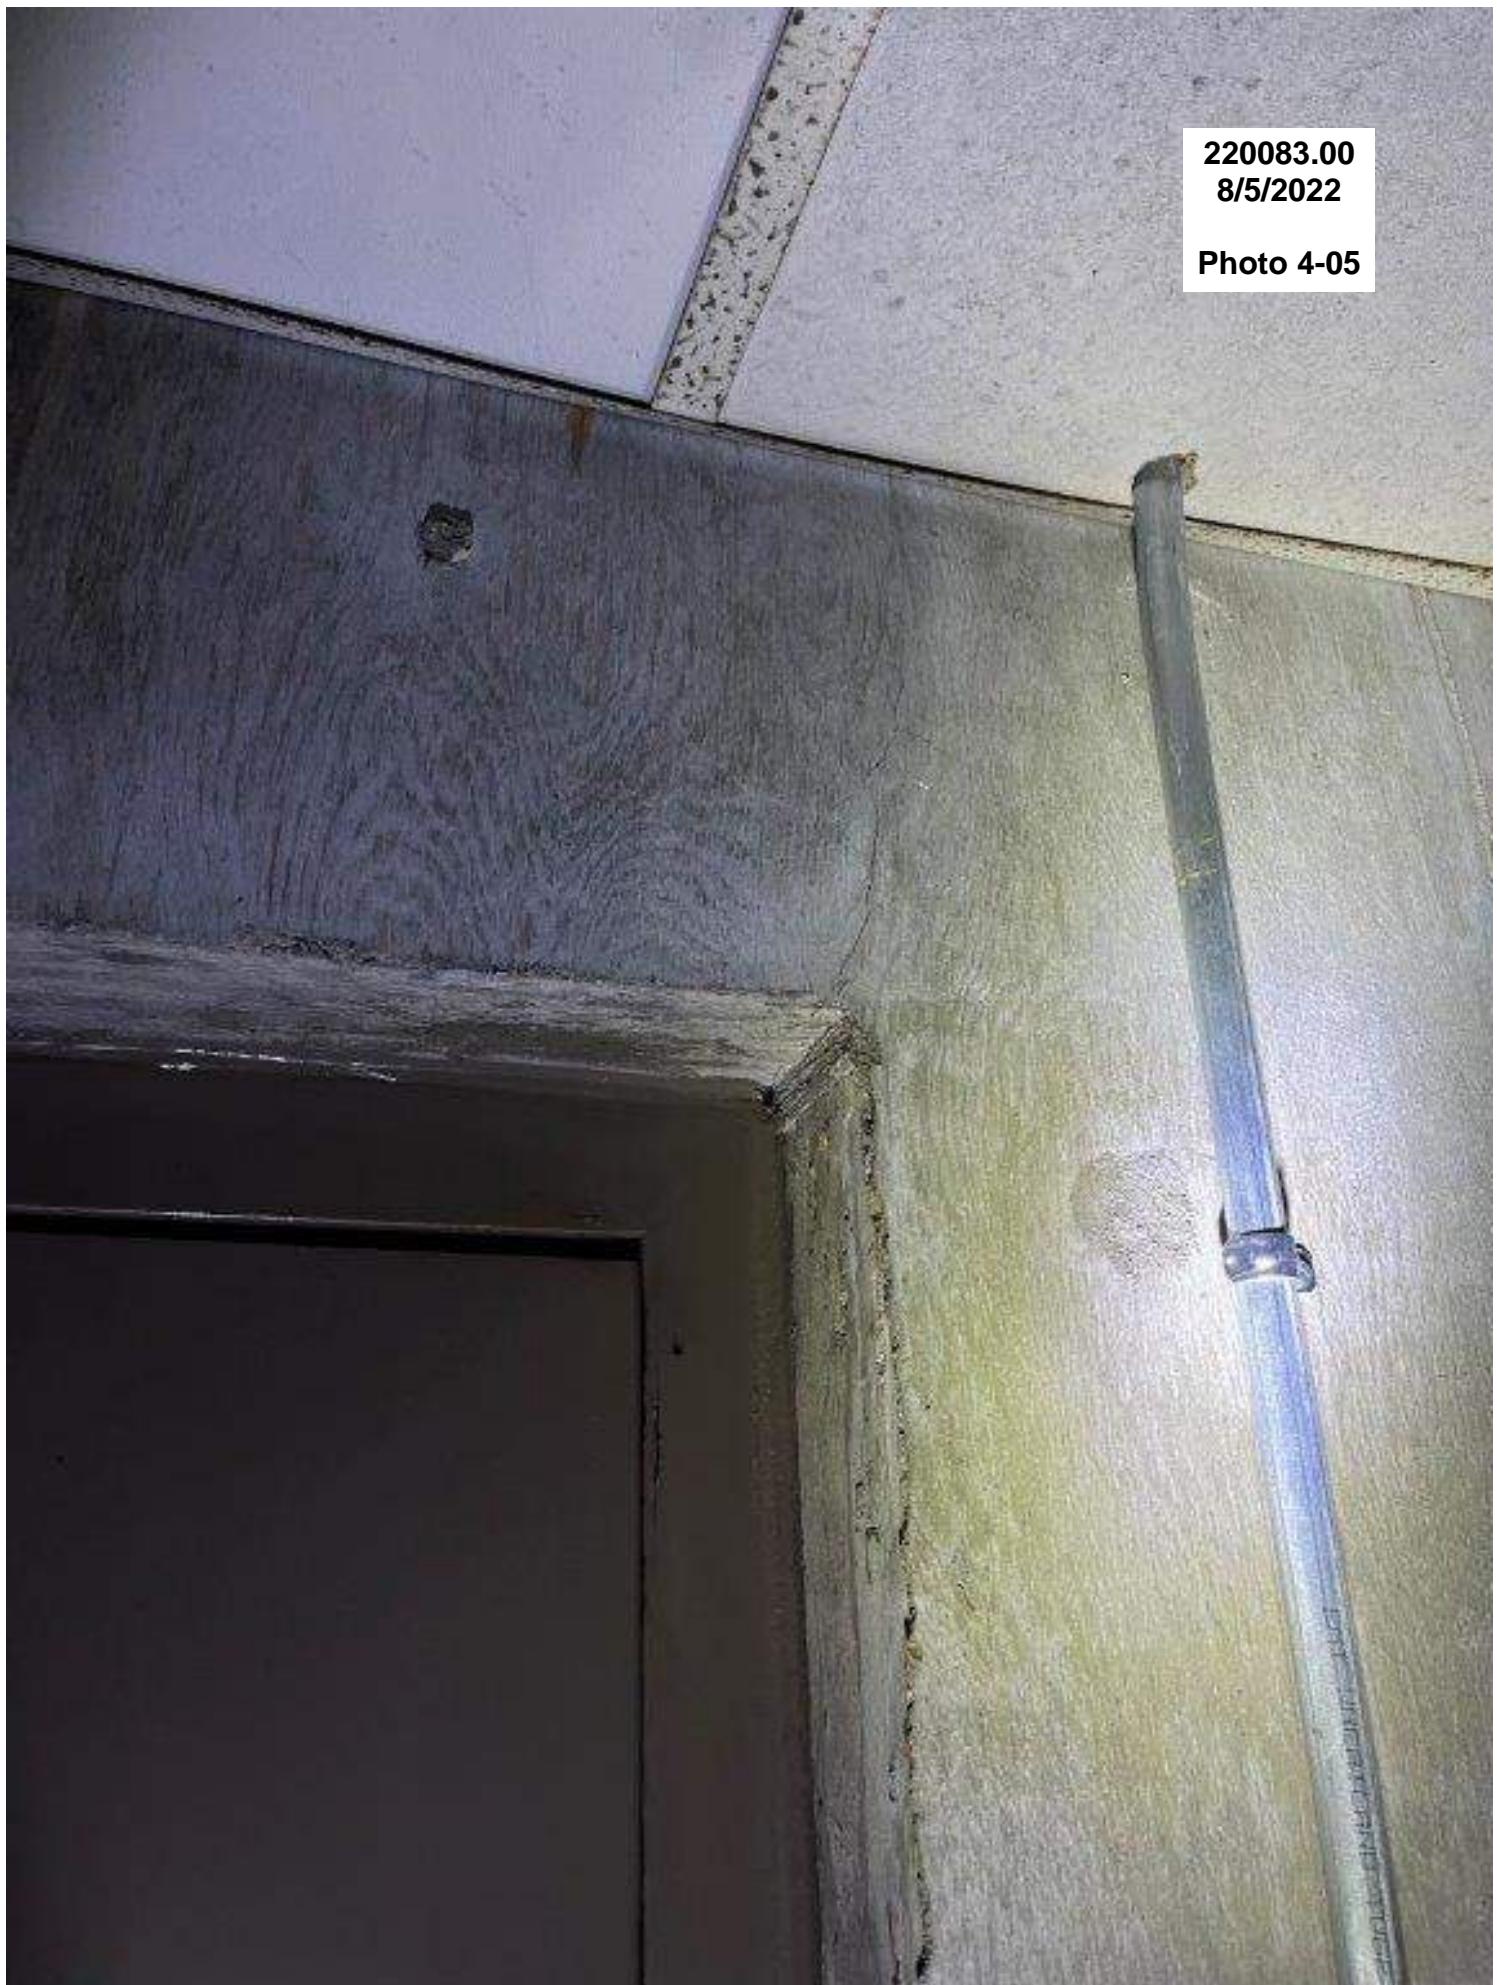
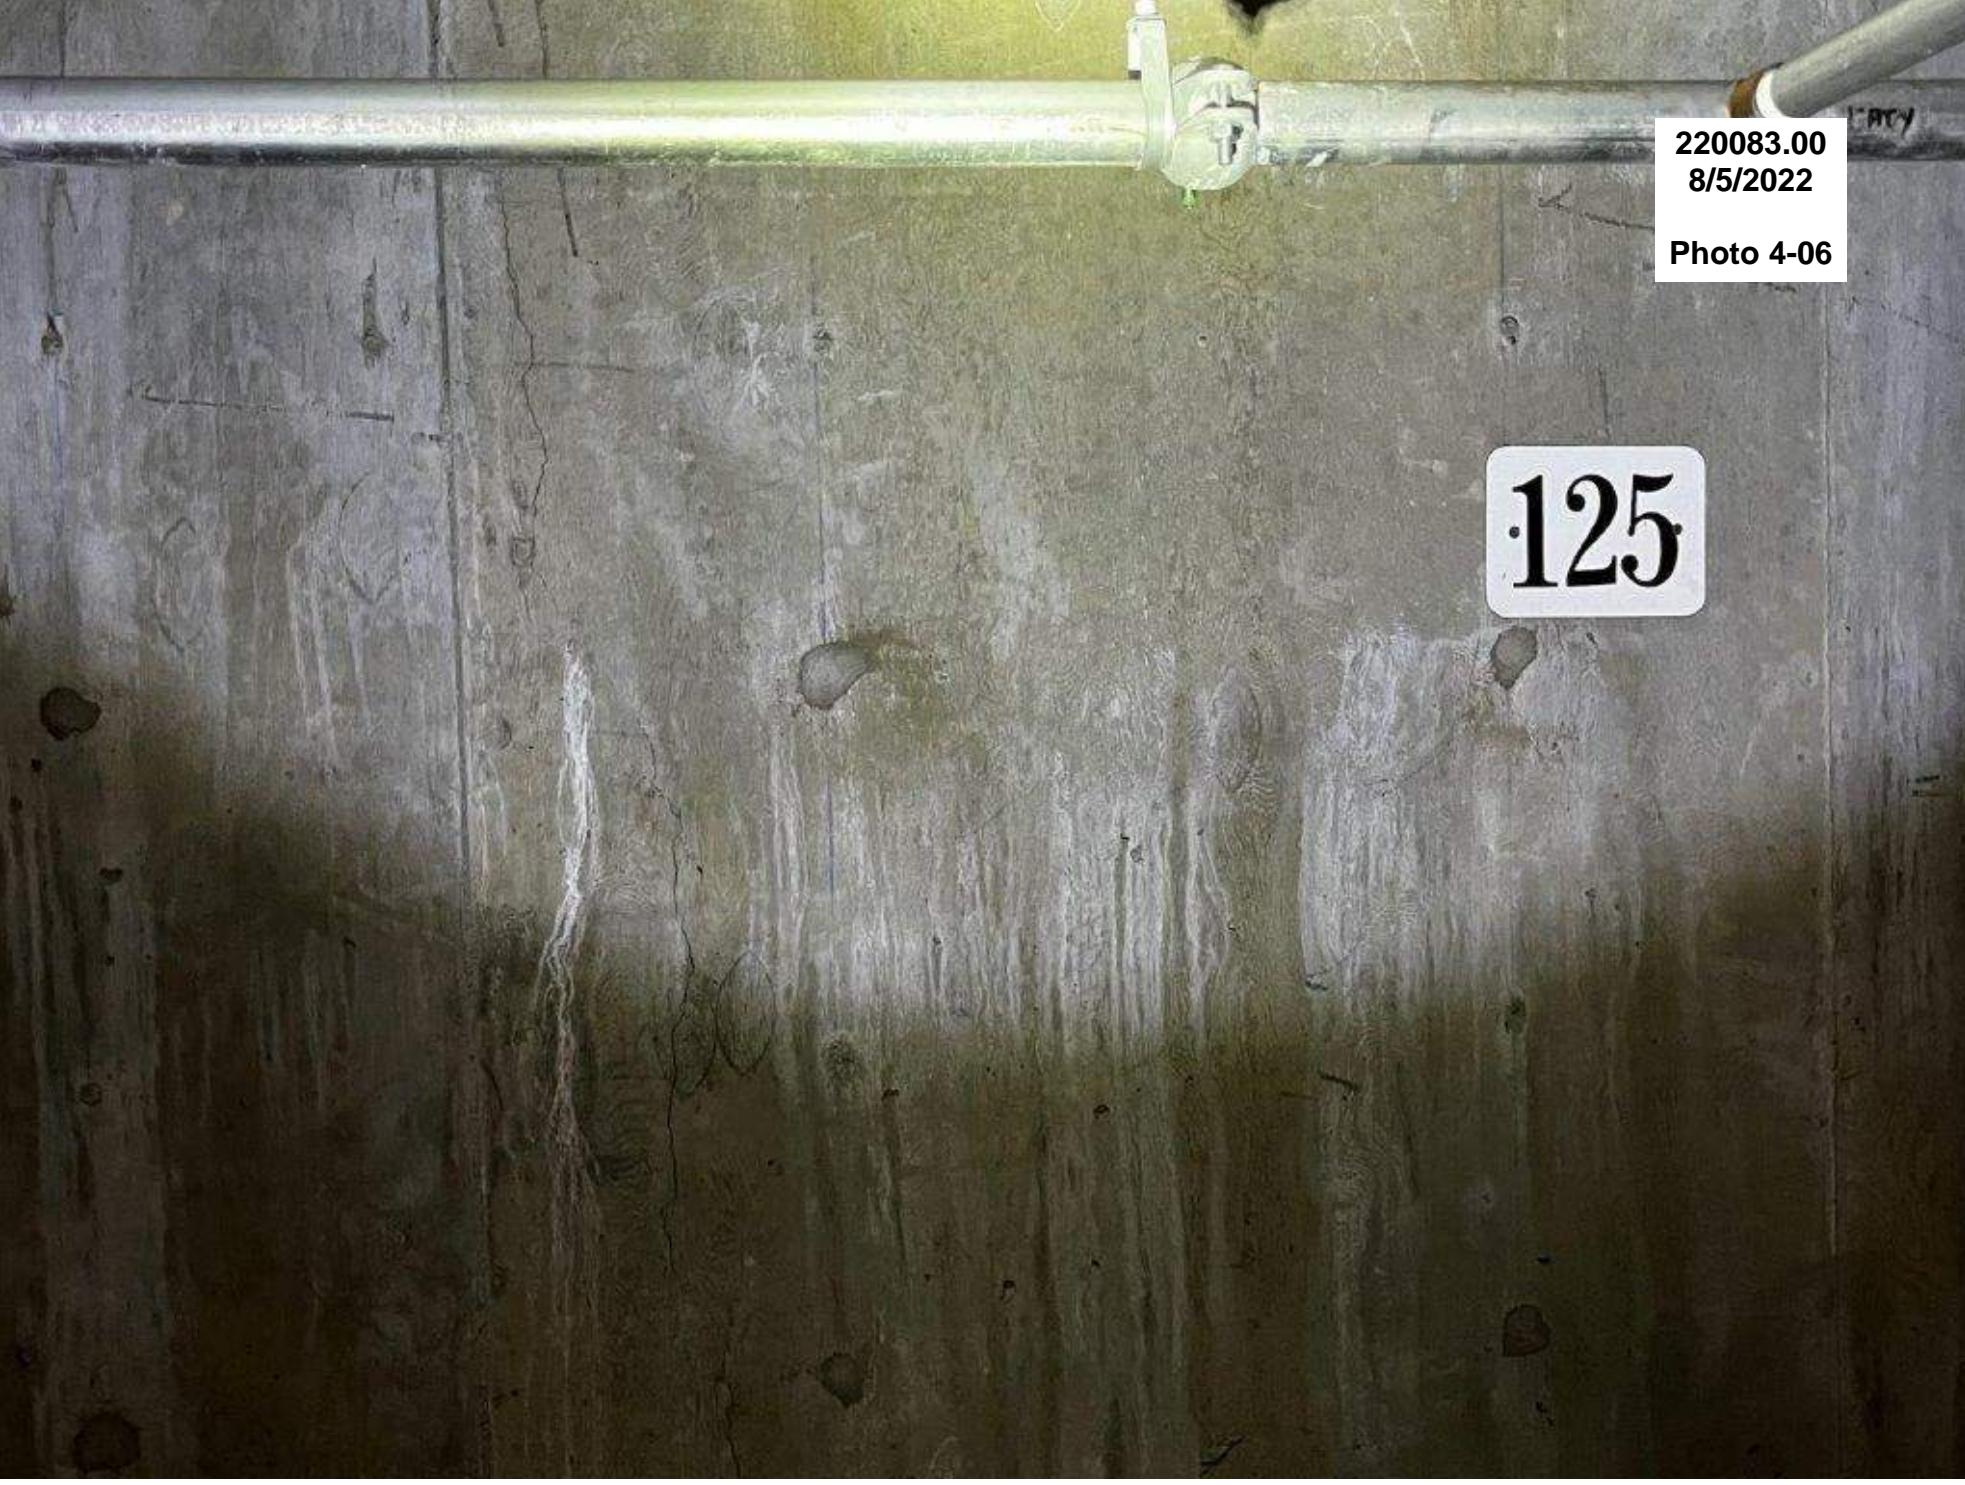
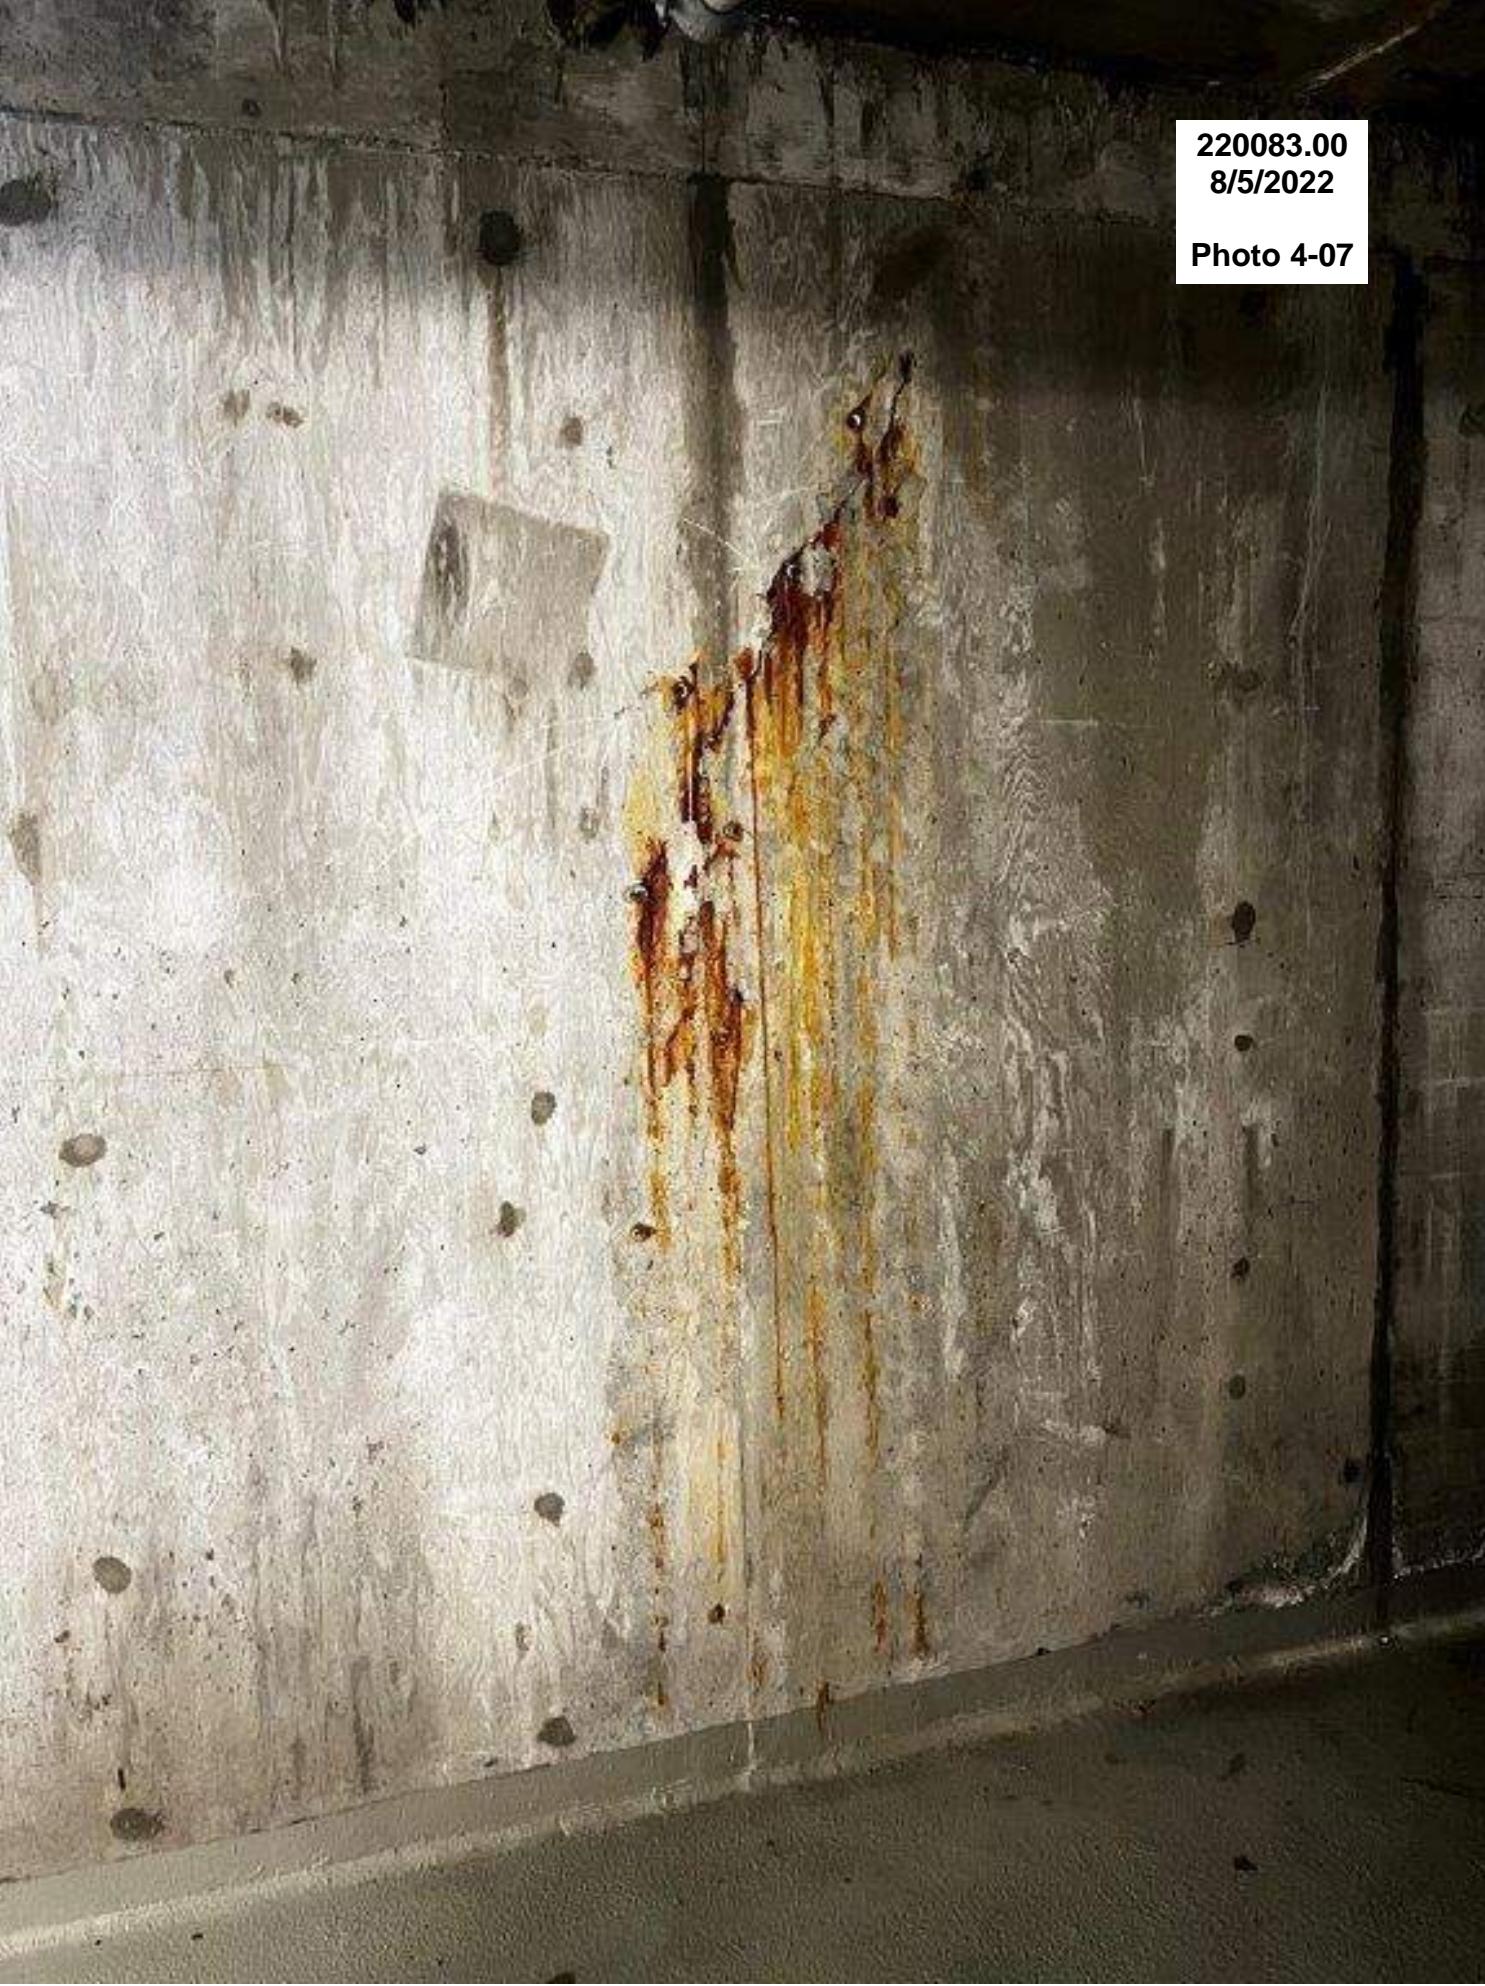
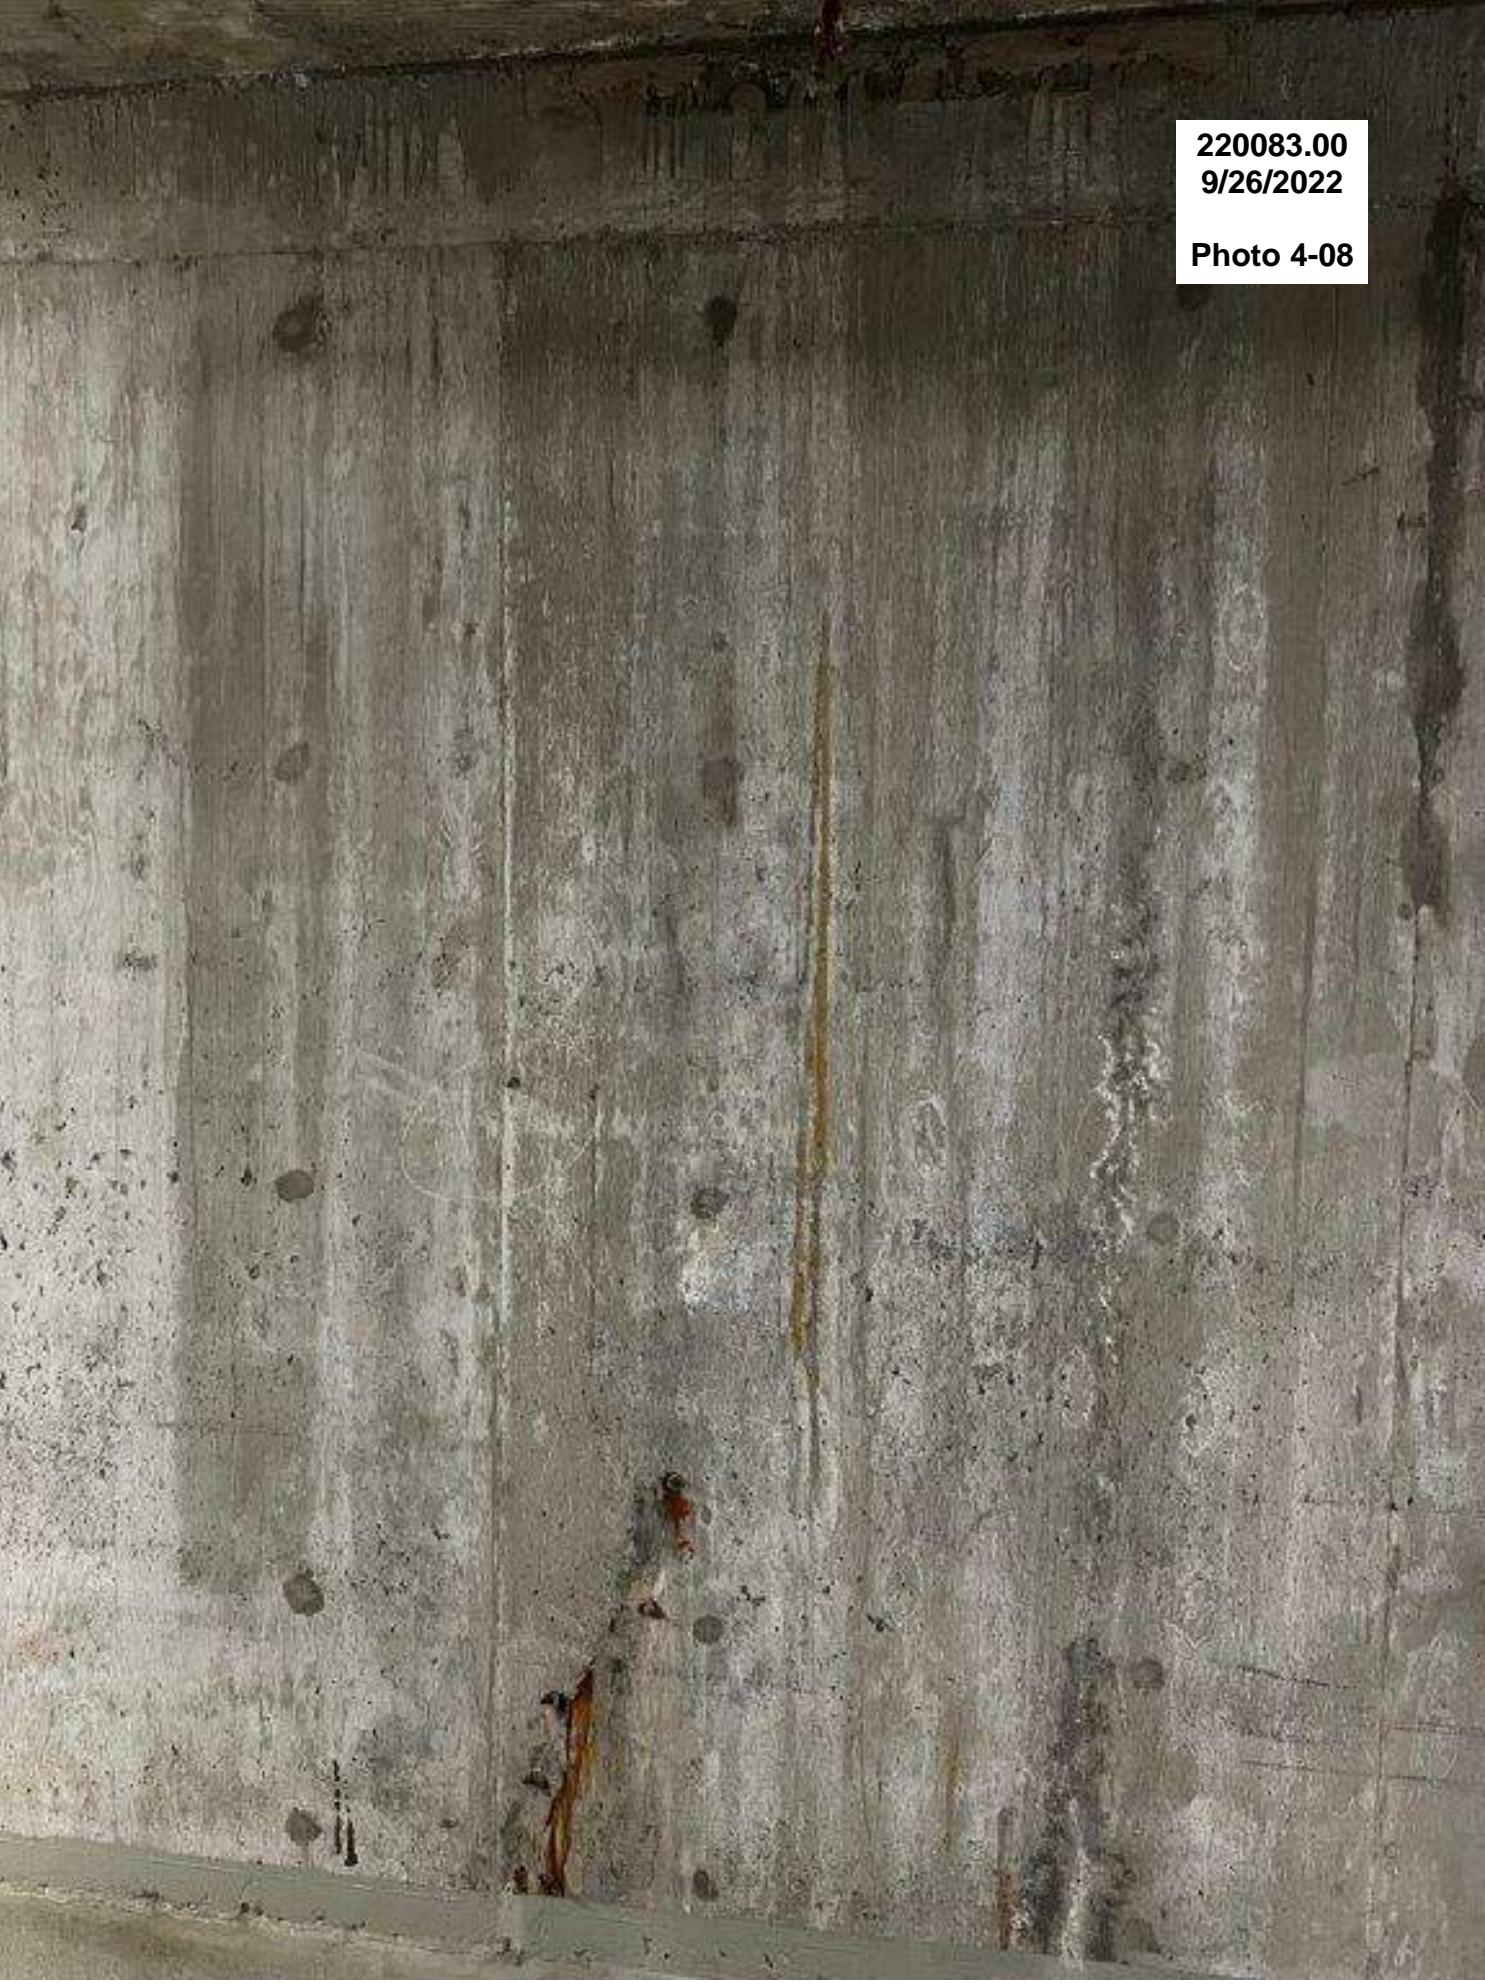
26. Similar to the floor below, there are several diagonal and vertical cracks in the concrete walls of the Upper Garage Level (Photos 4-03 through 4-06). We measured typical crack widths ranging from 0.01 to 0.05 inches (Photo 4-04). Many of the cracks were previously injected (Photos 4-07 and 4-08).
