CopelandBEC Engineering Study Addenda, Notes, and Errata

Bay Square Condominiums

950 Massachusetts Avenue
Cambridge, MA

Building Condition Assessment

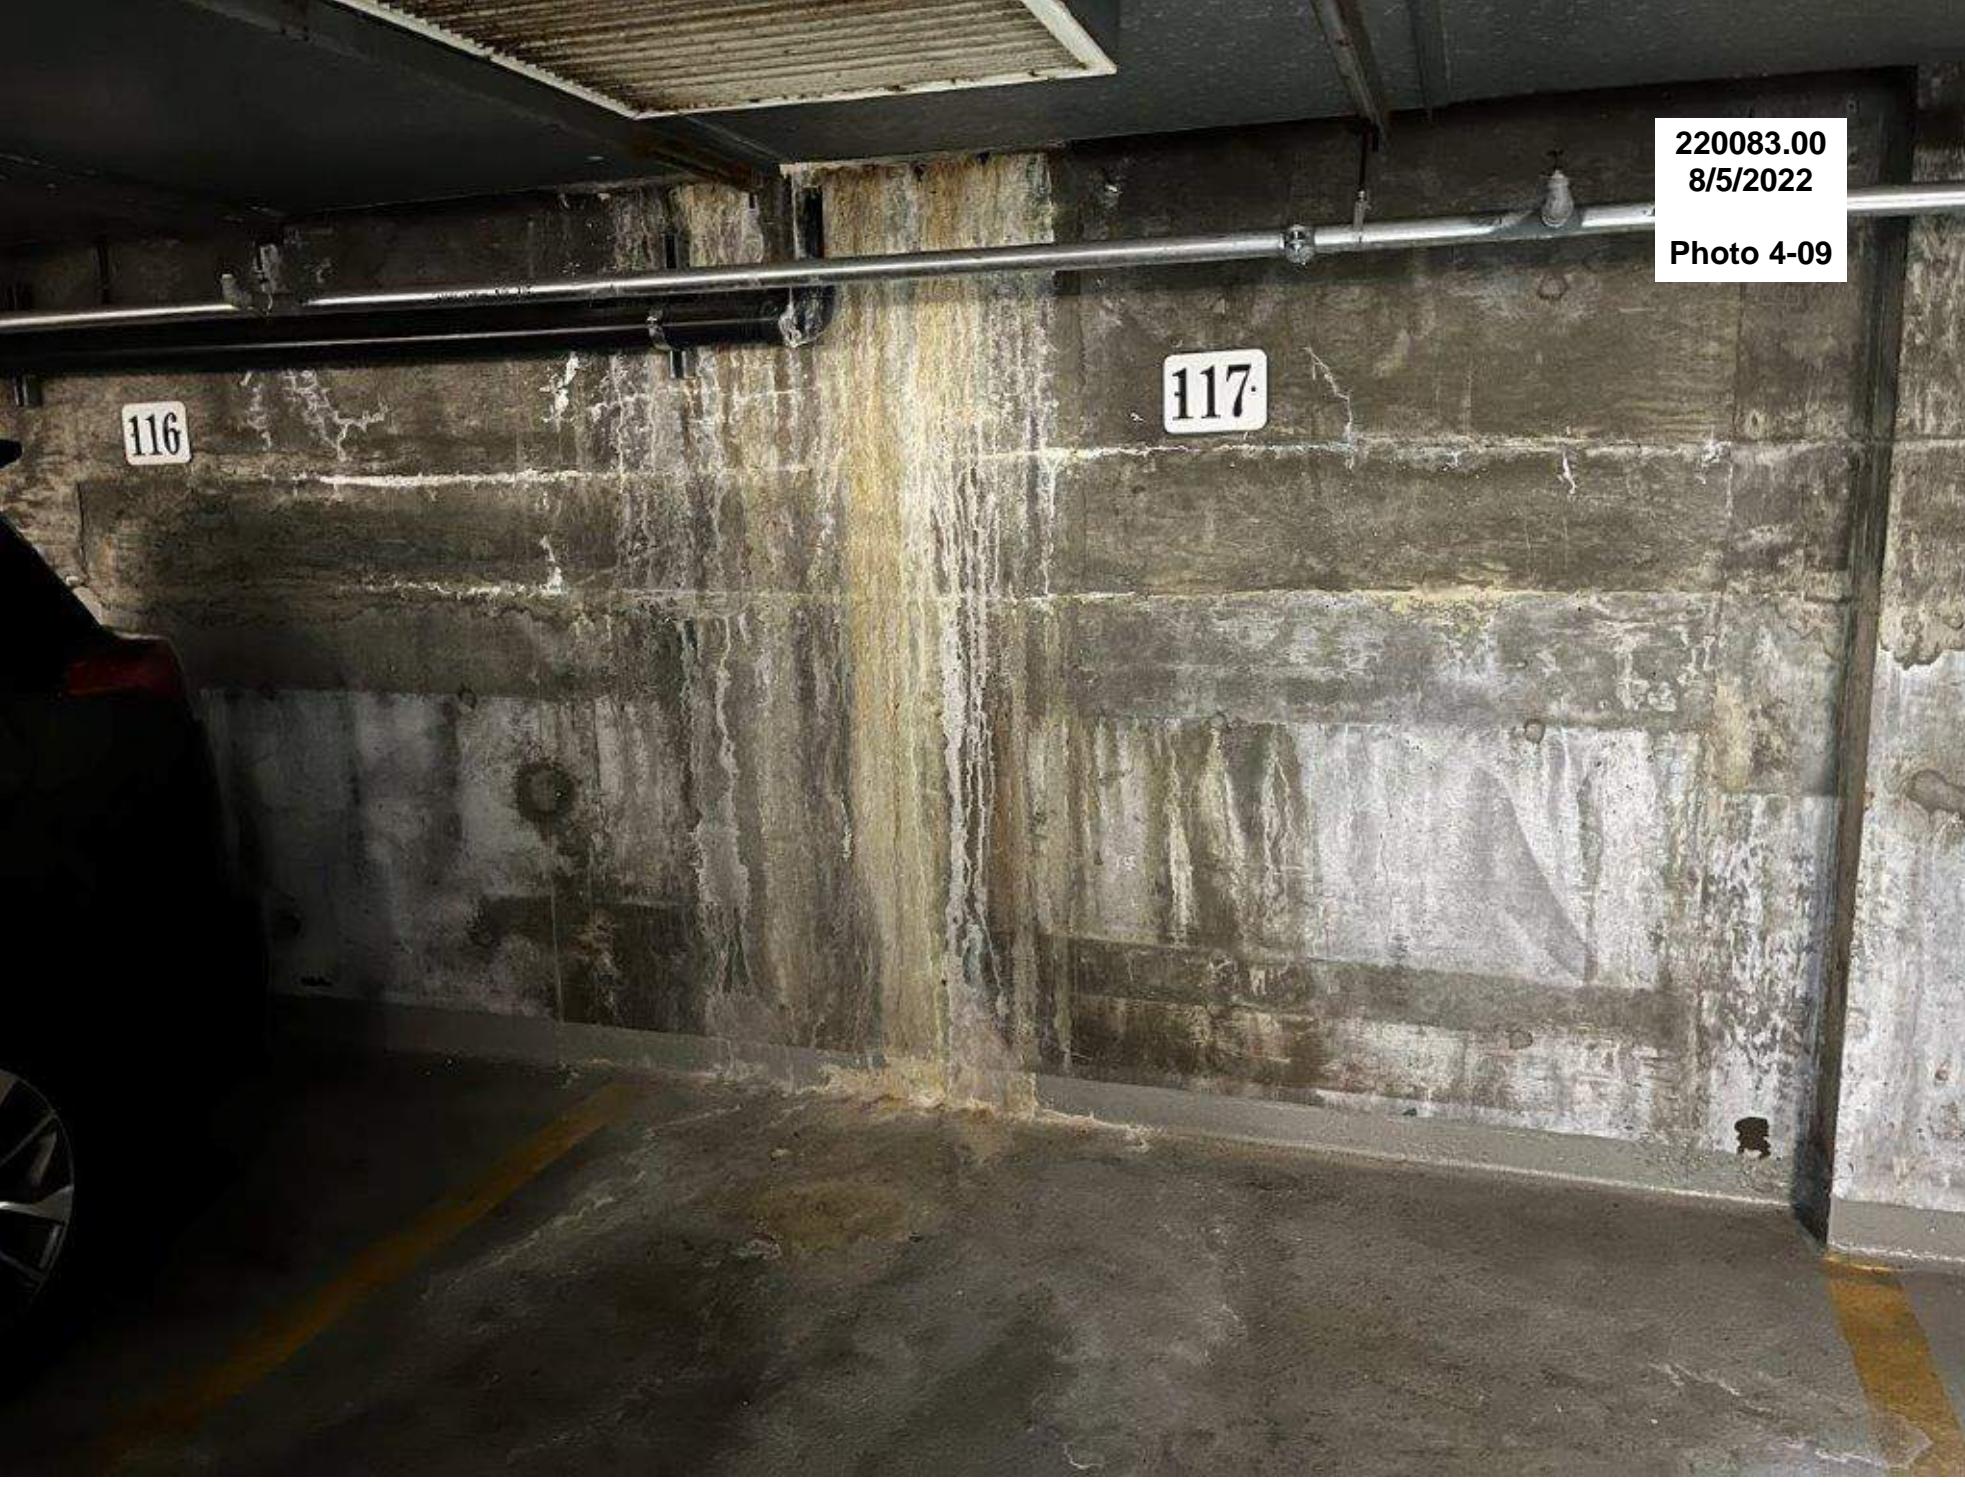
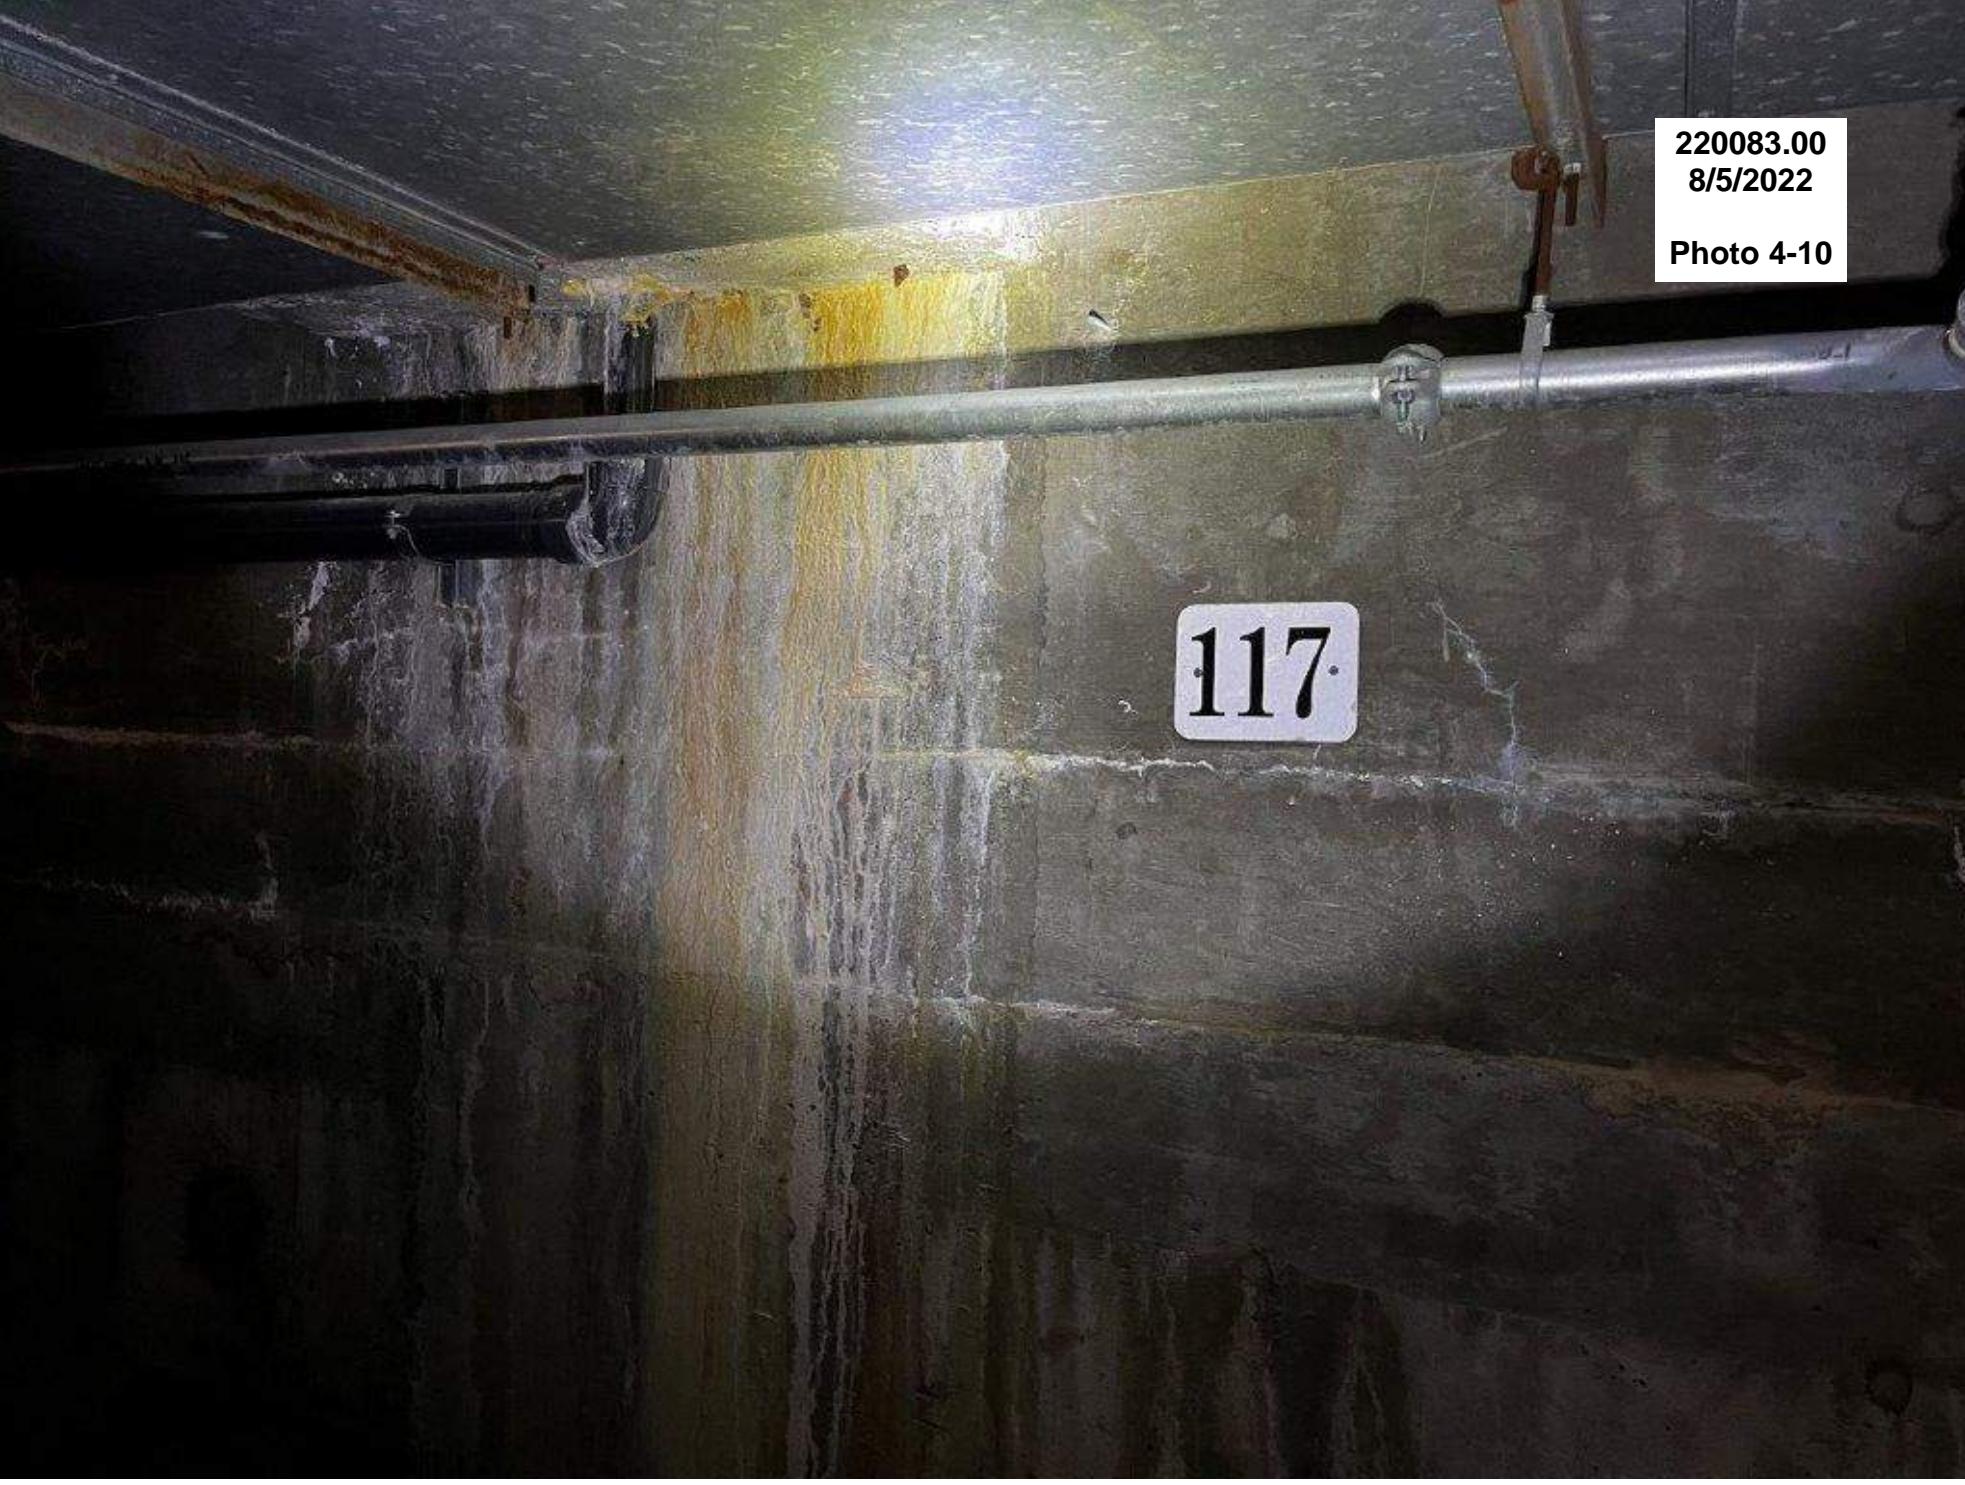
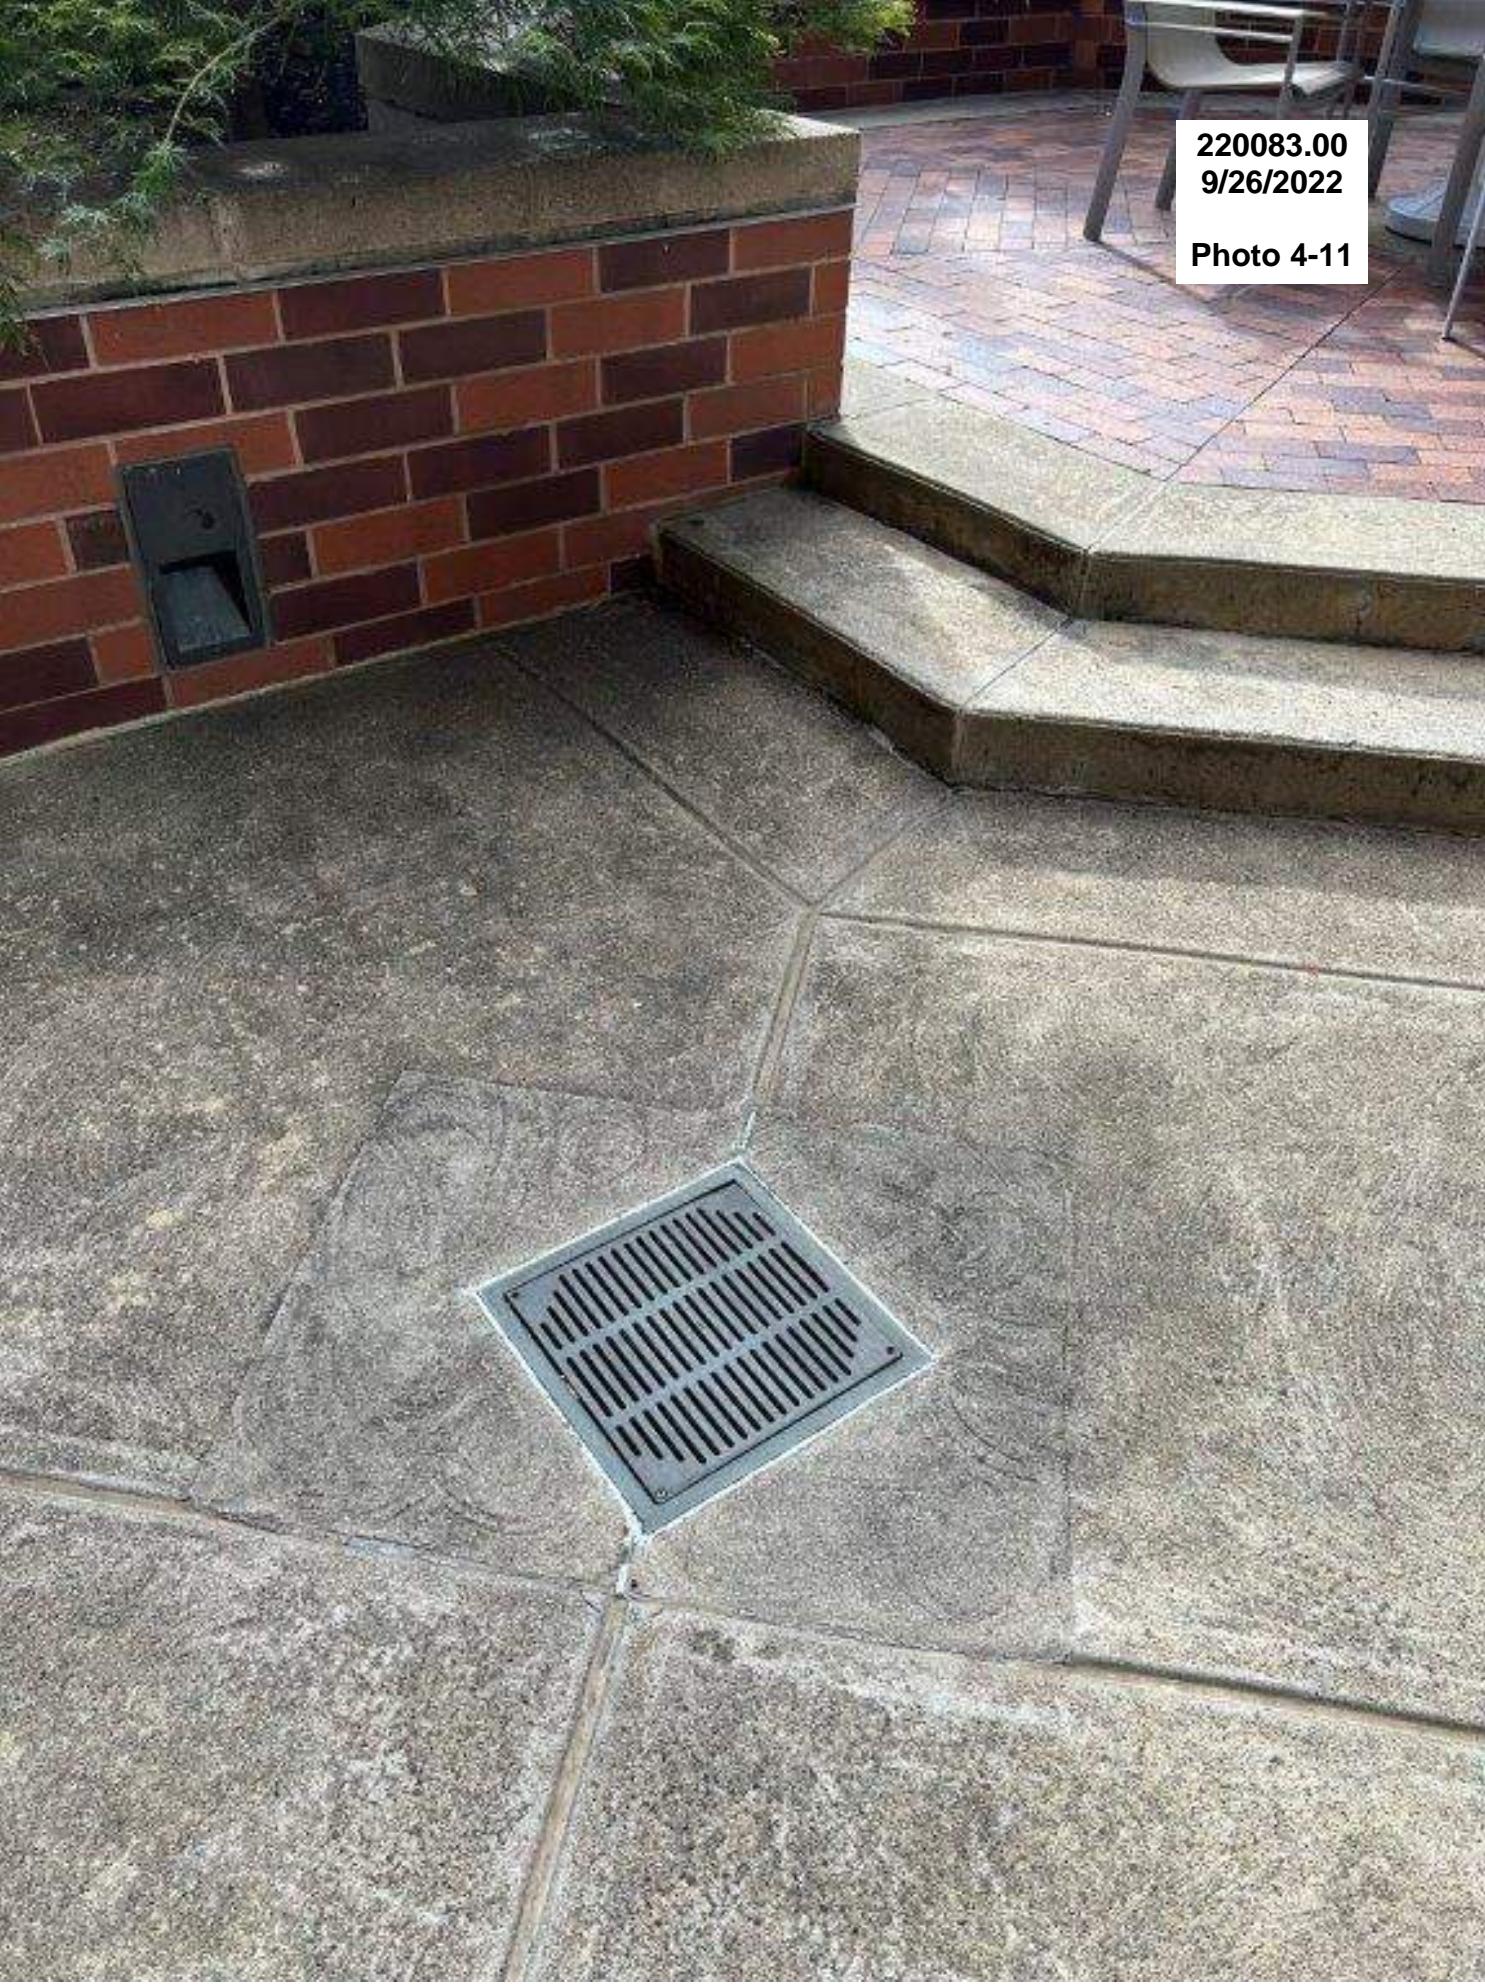
27. Staining and efflorescence are present on the foundation walls at some locations corresponding to piping and drains from above (Photos 4-09 through 4-11).
