CopelandBEC Engineering Study Addenda, Notes, and Errata

Bay Square Condominiums

950 Massachusetts Avenue
Cambridge, MA

Building Condition Assessment

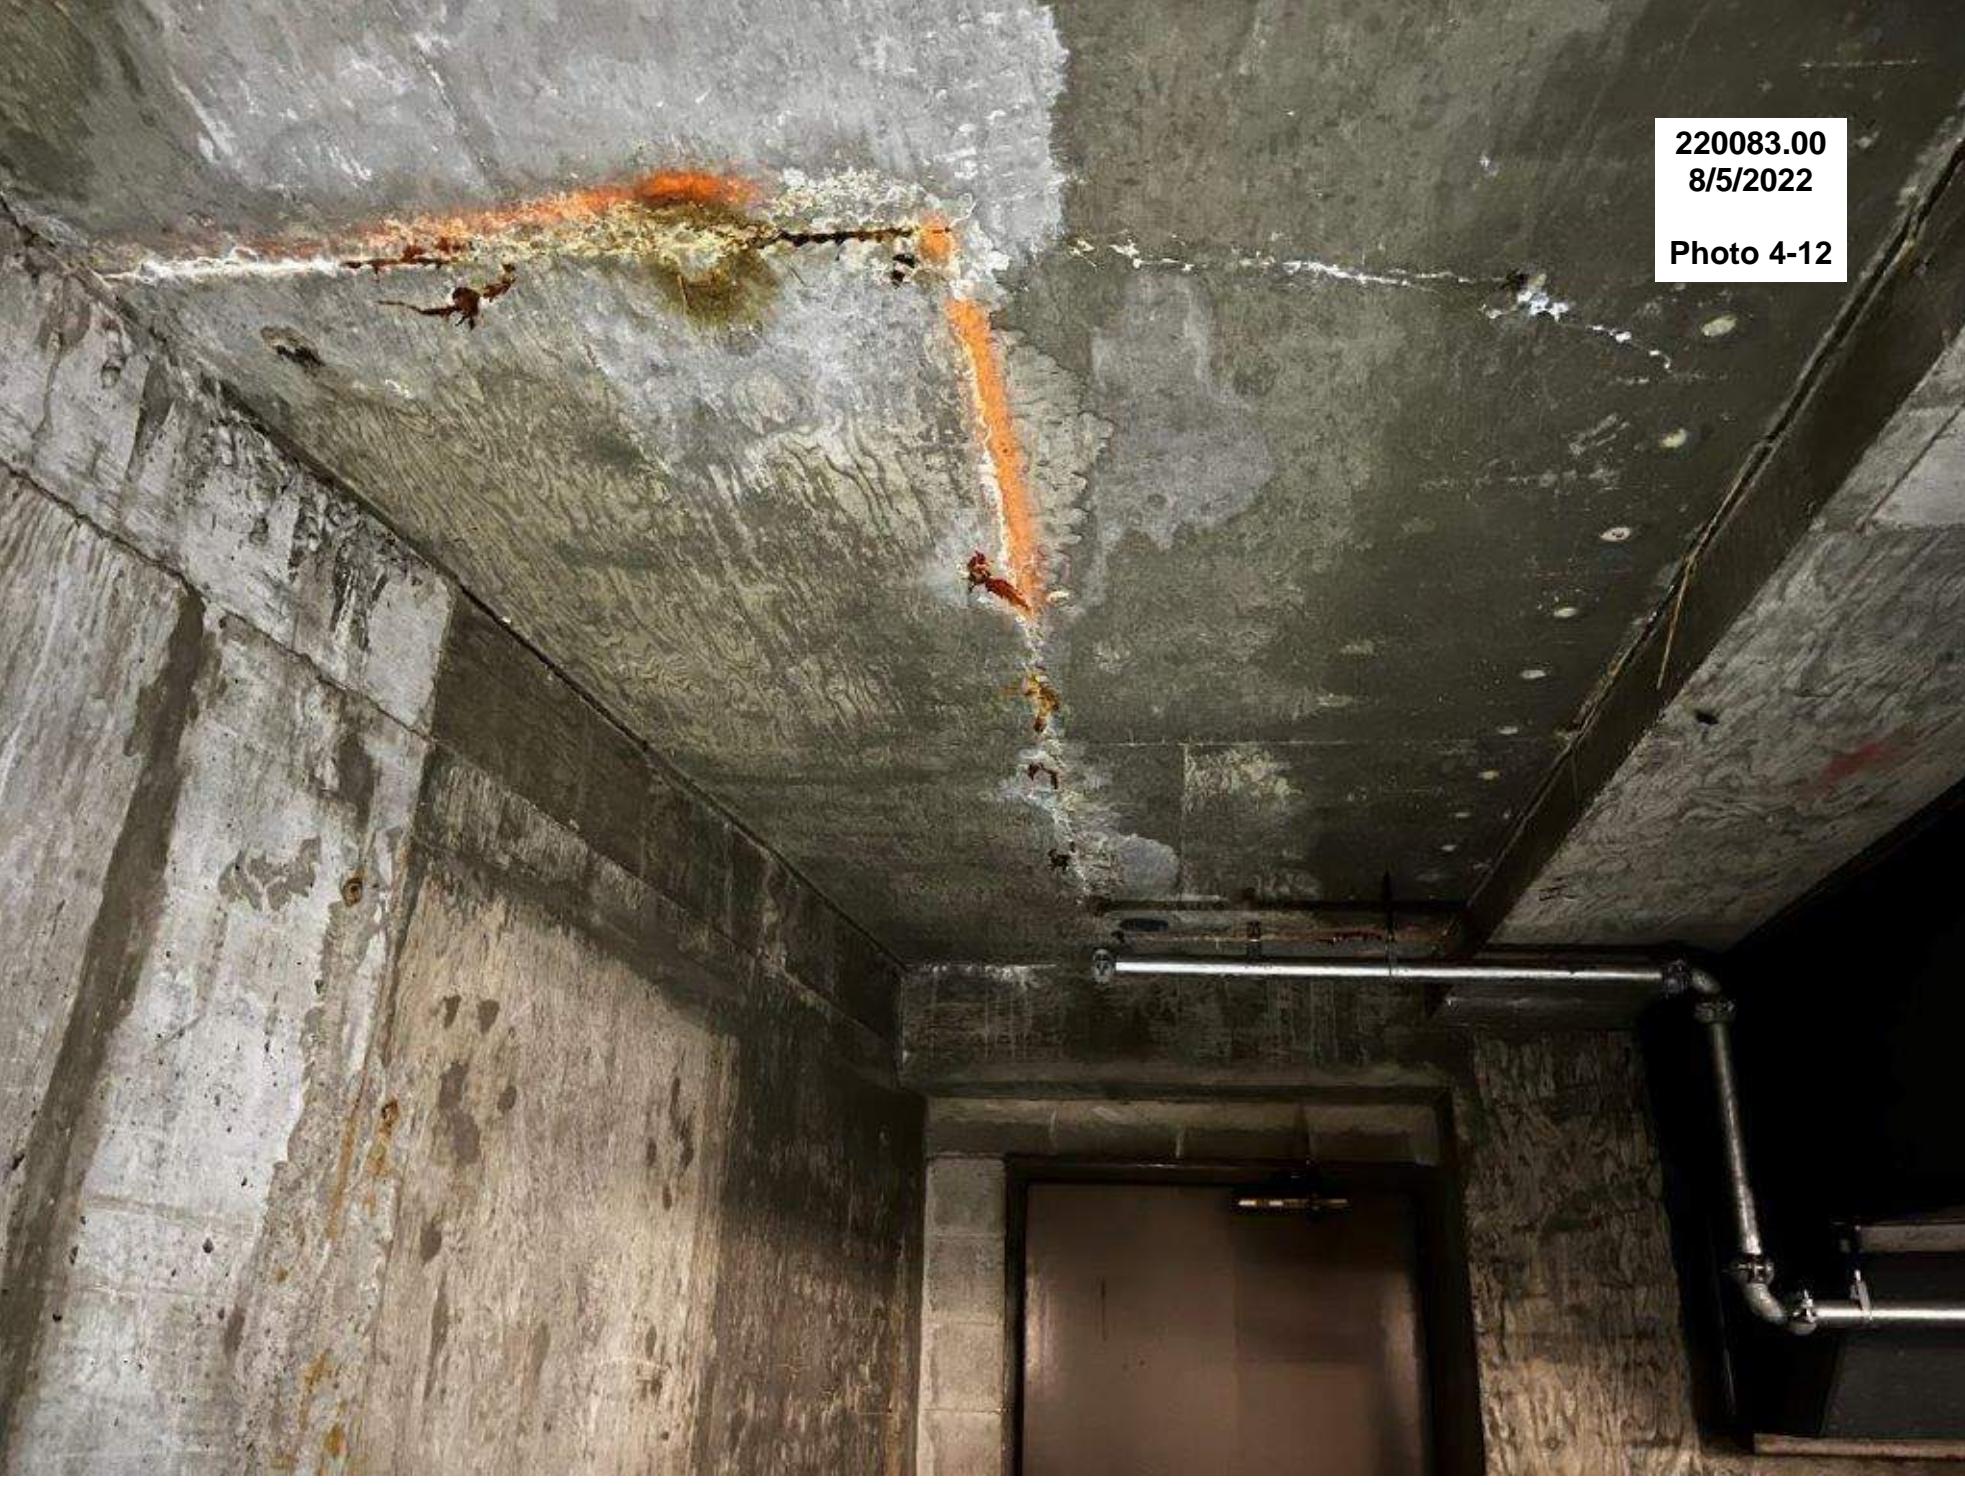
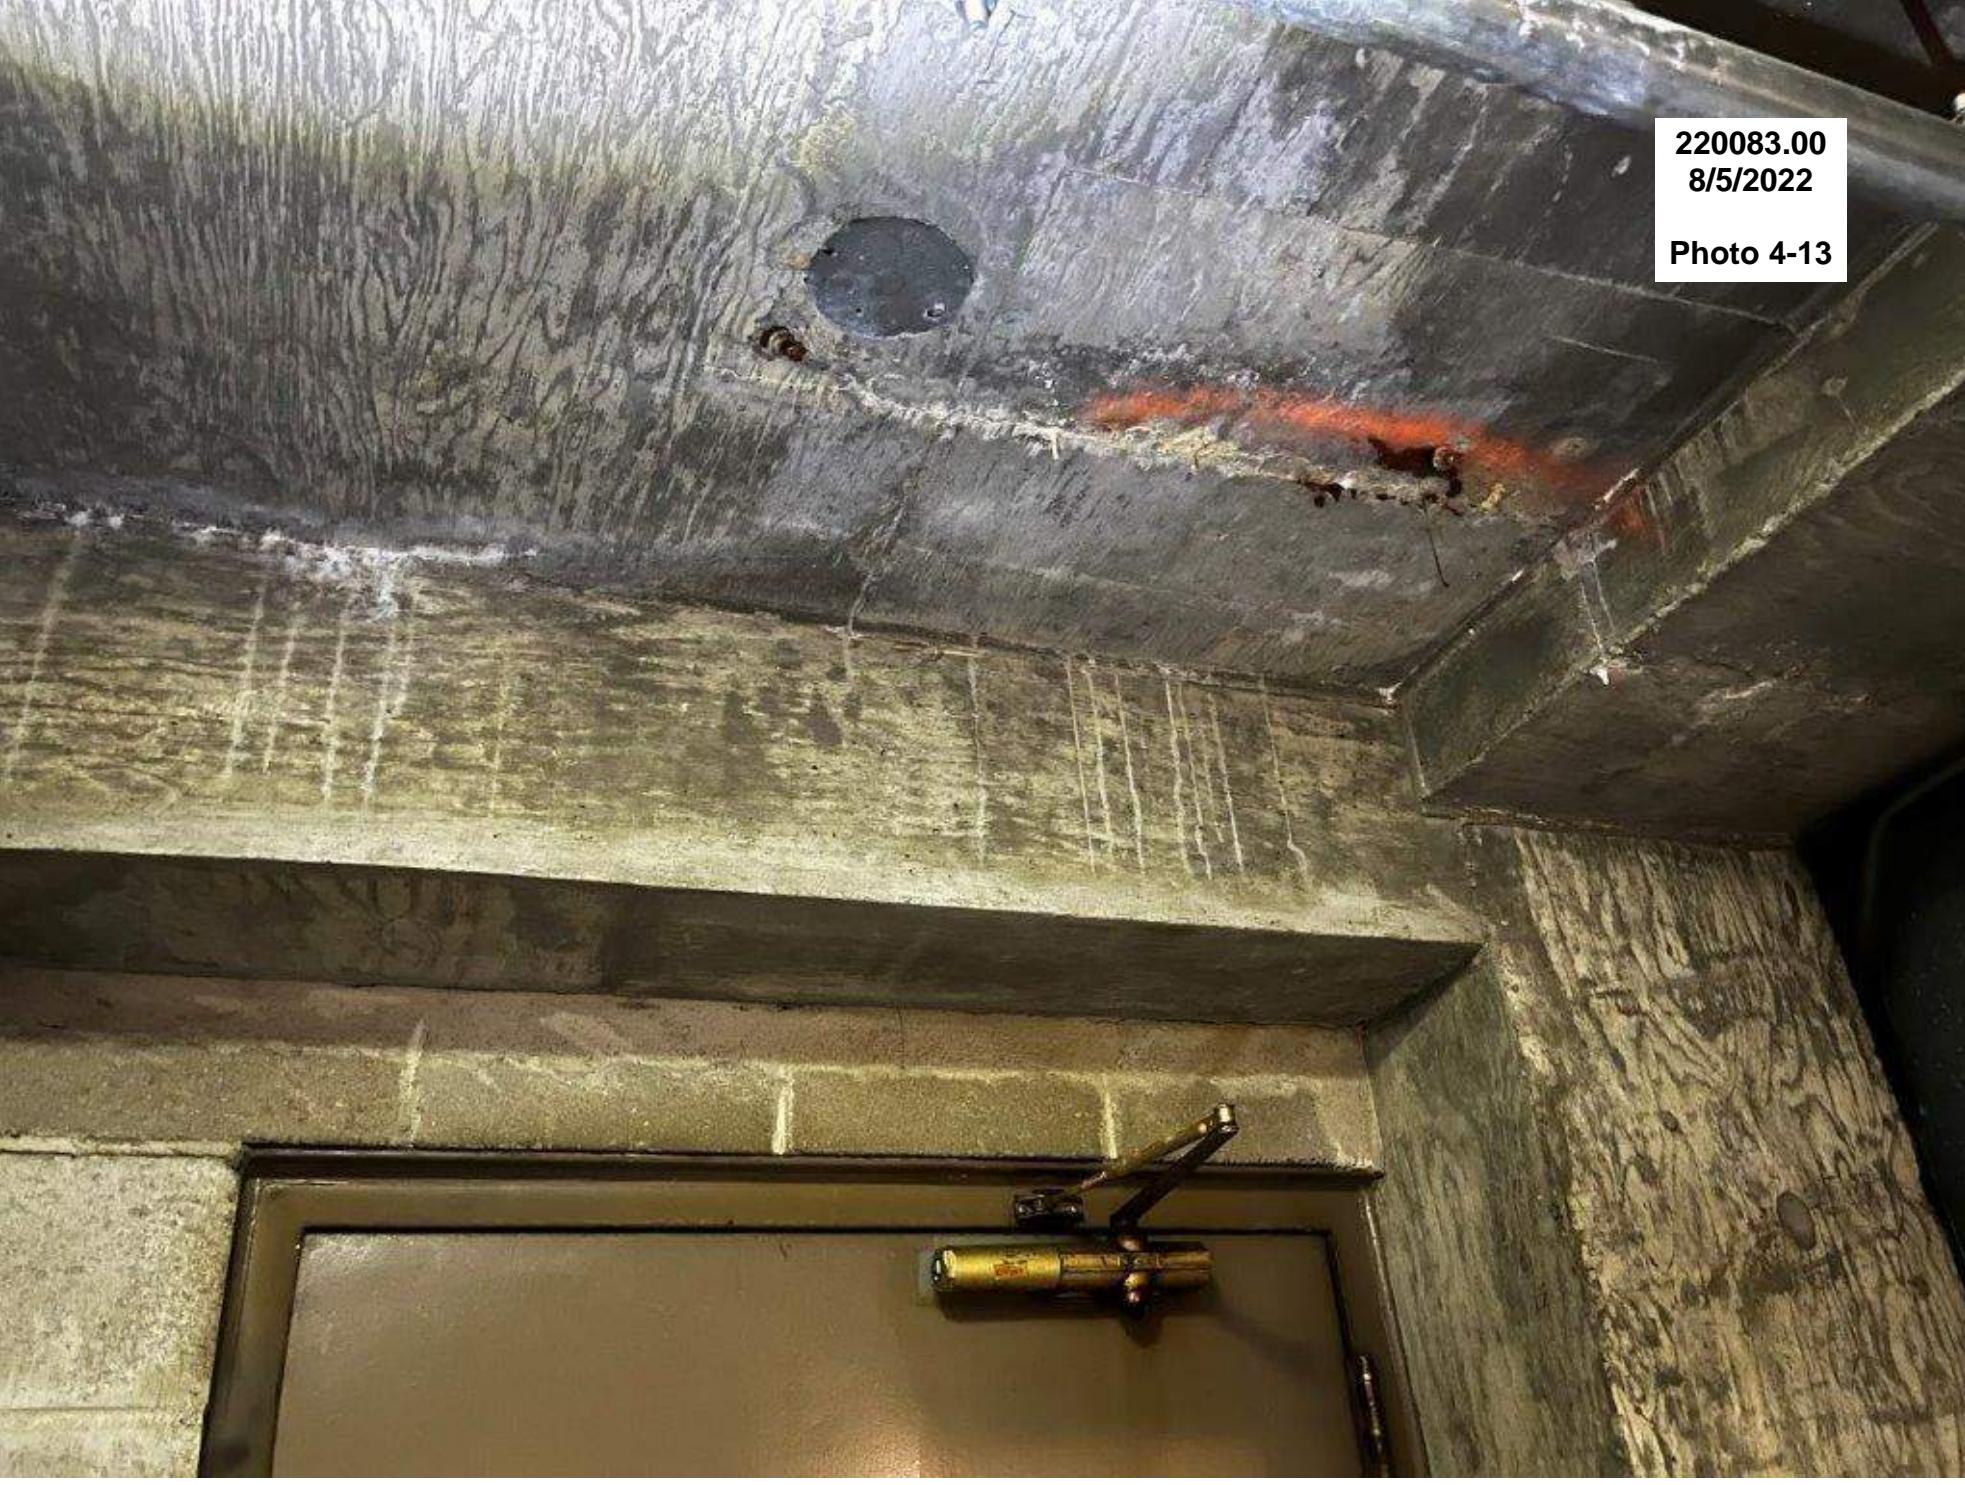
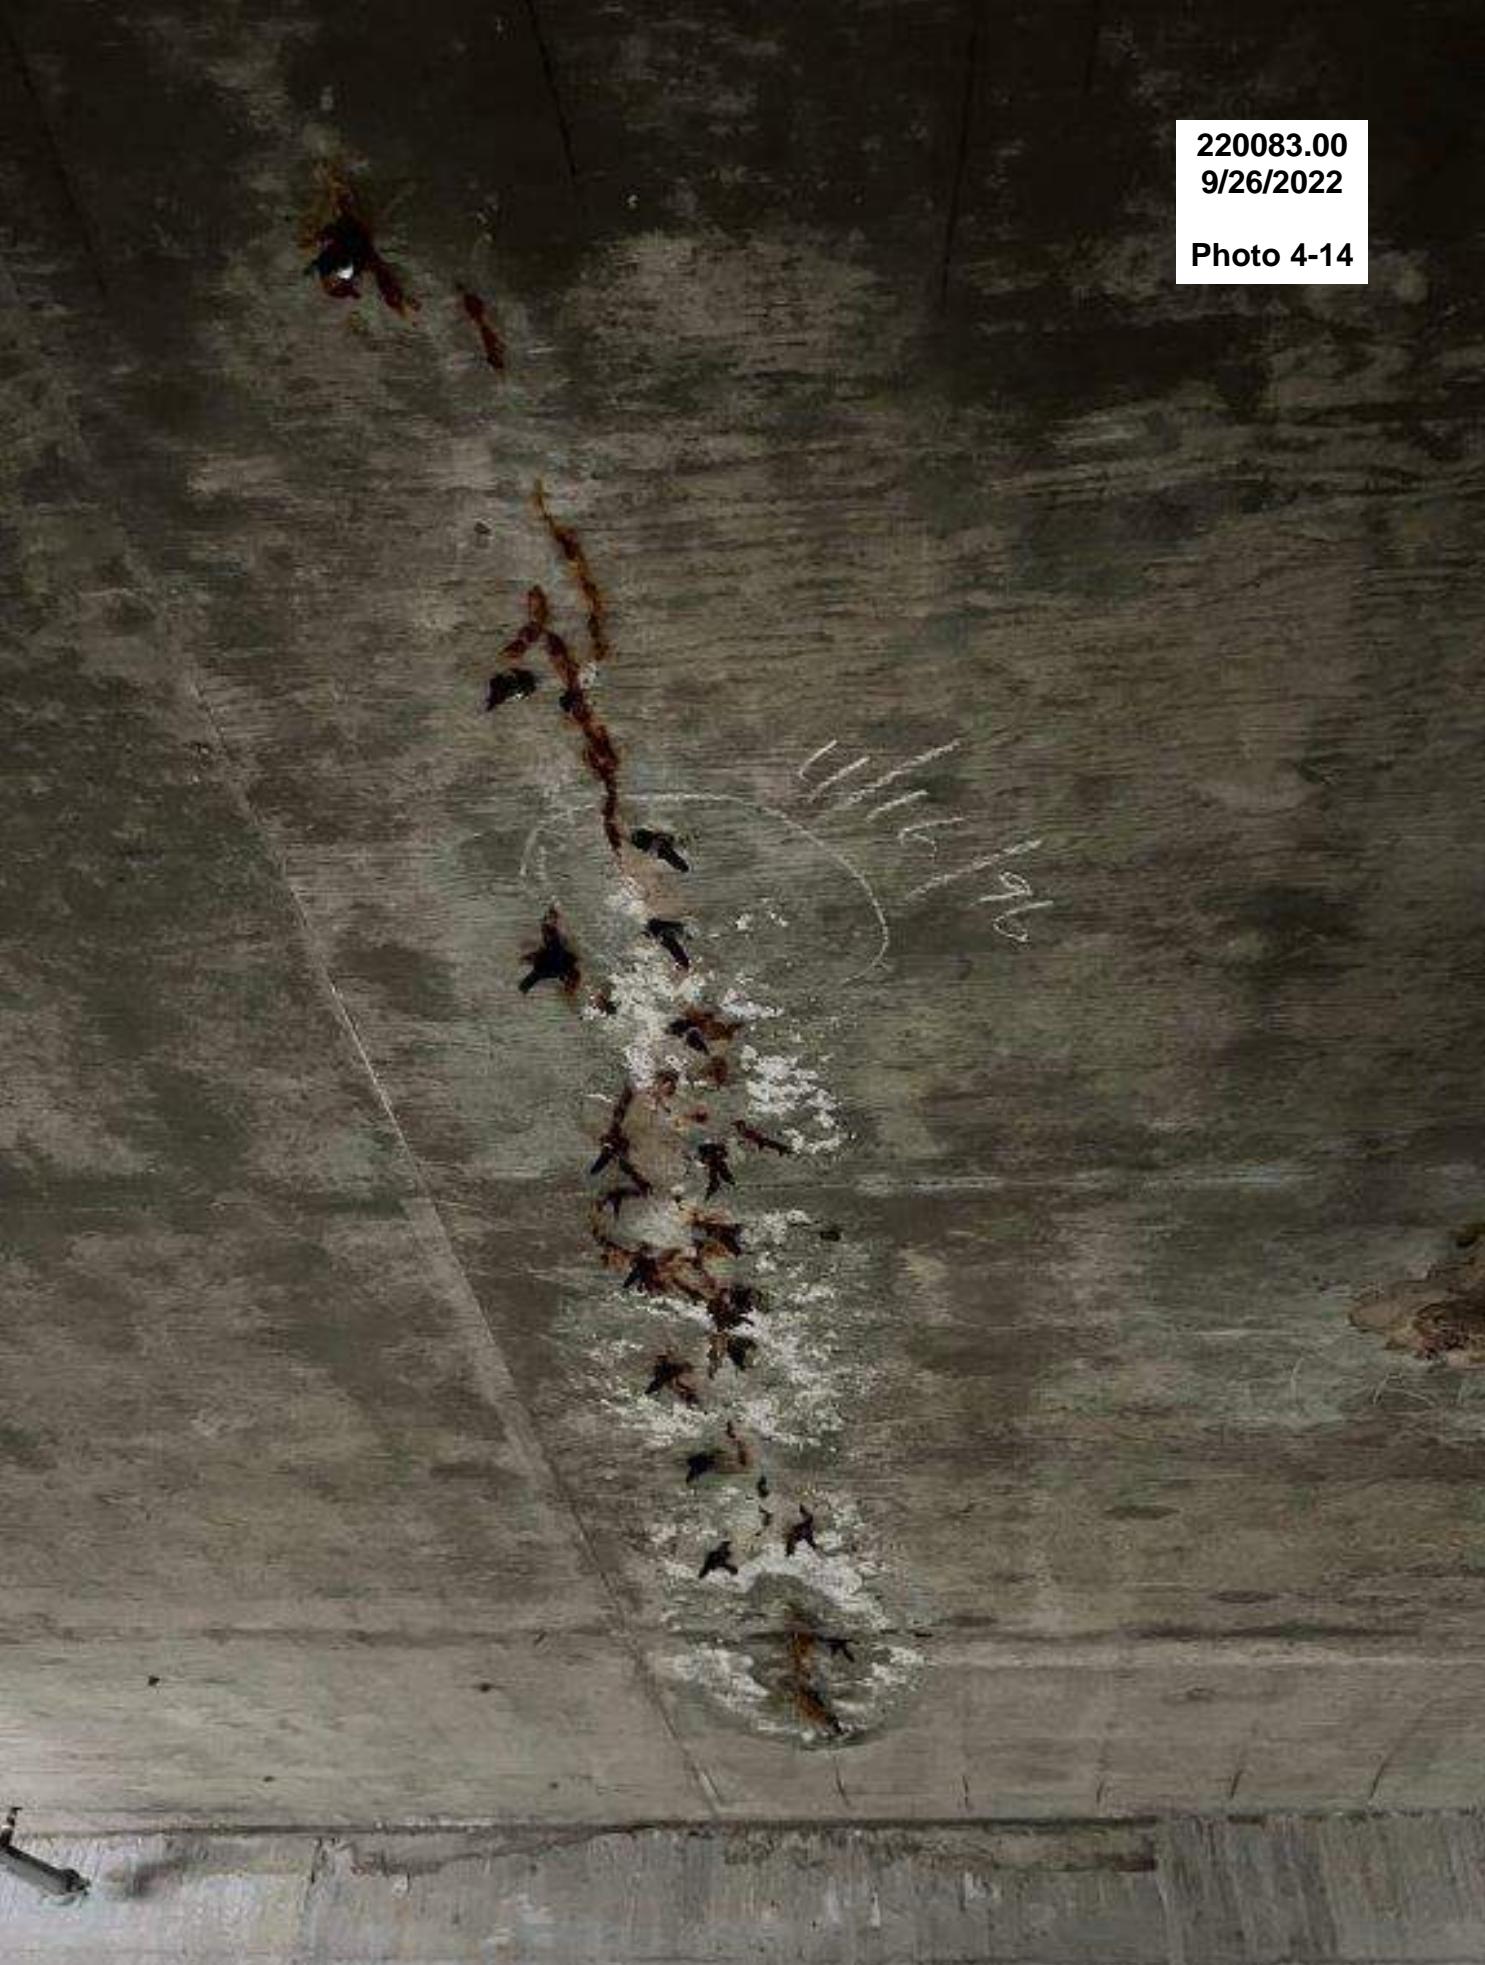
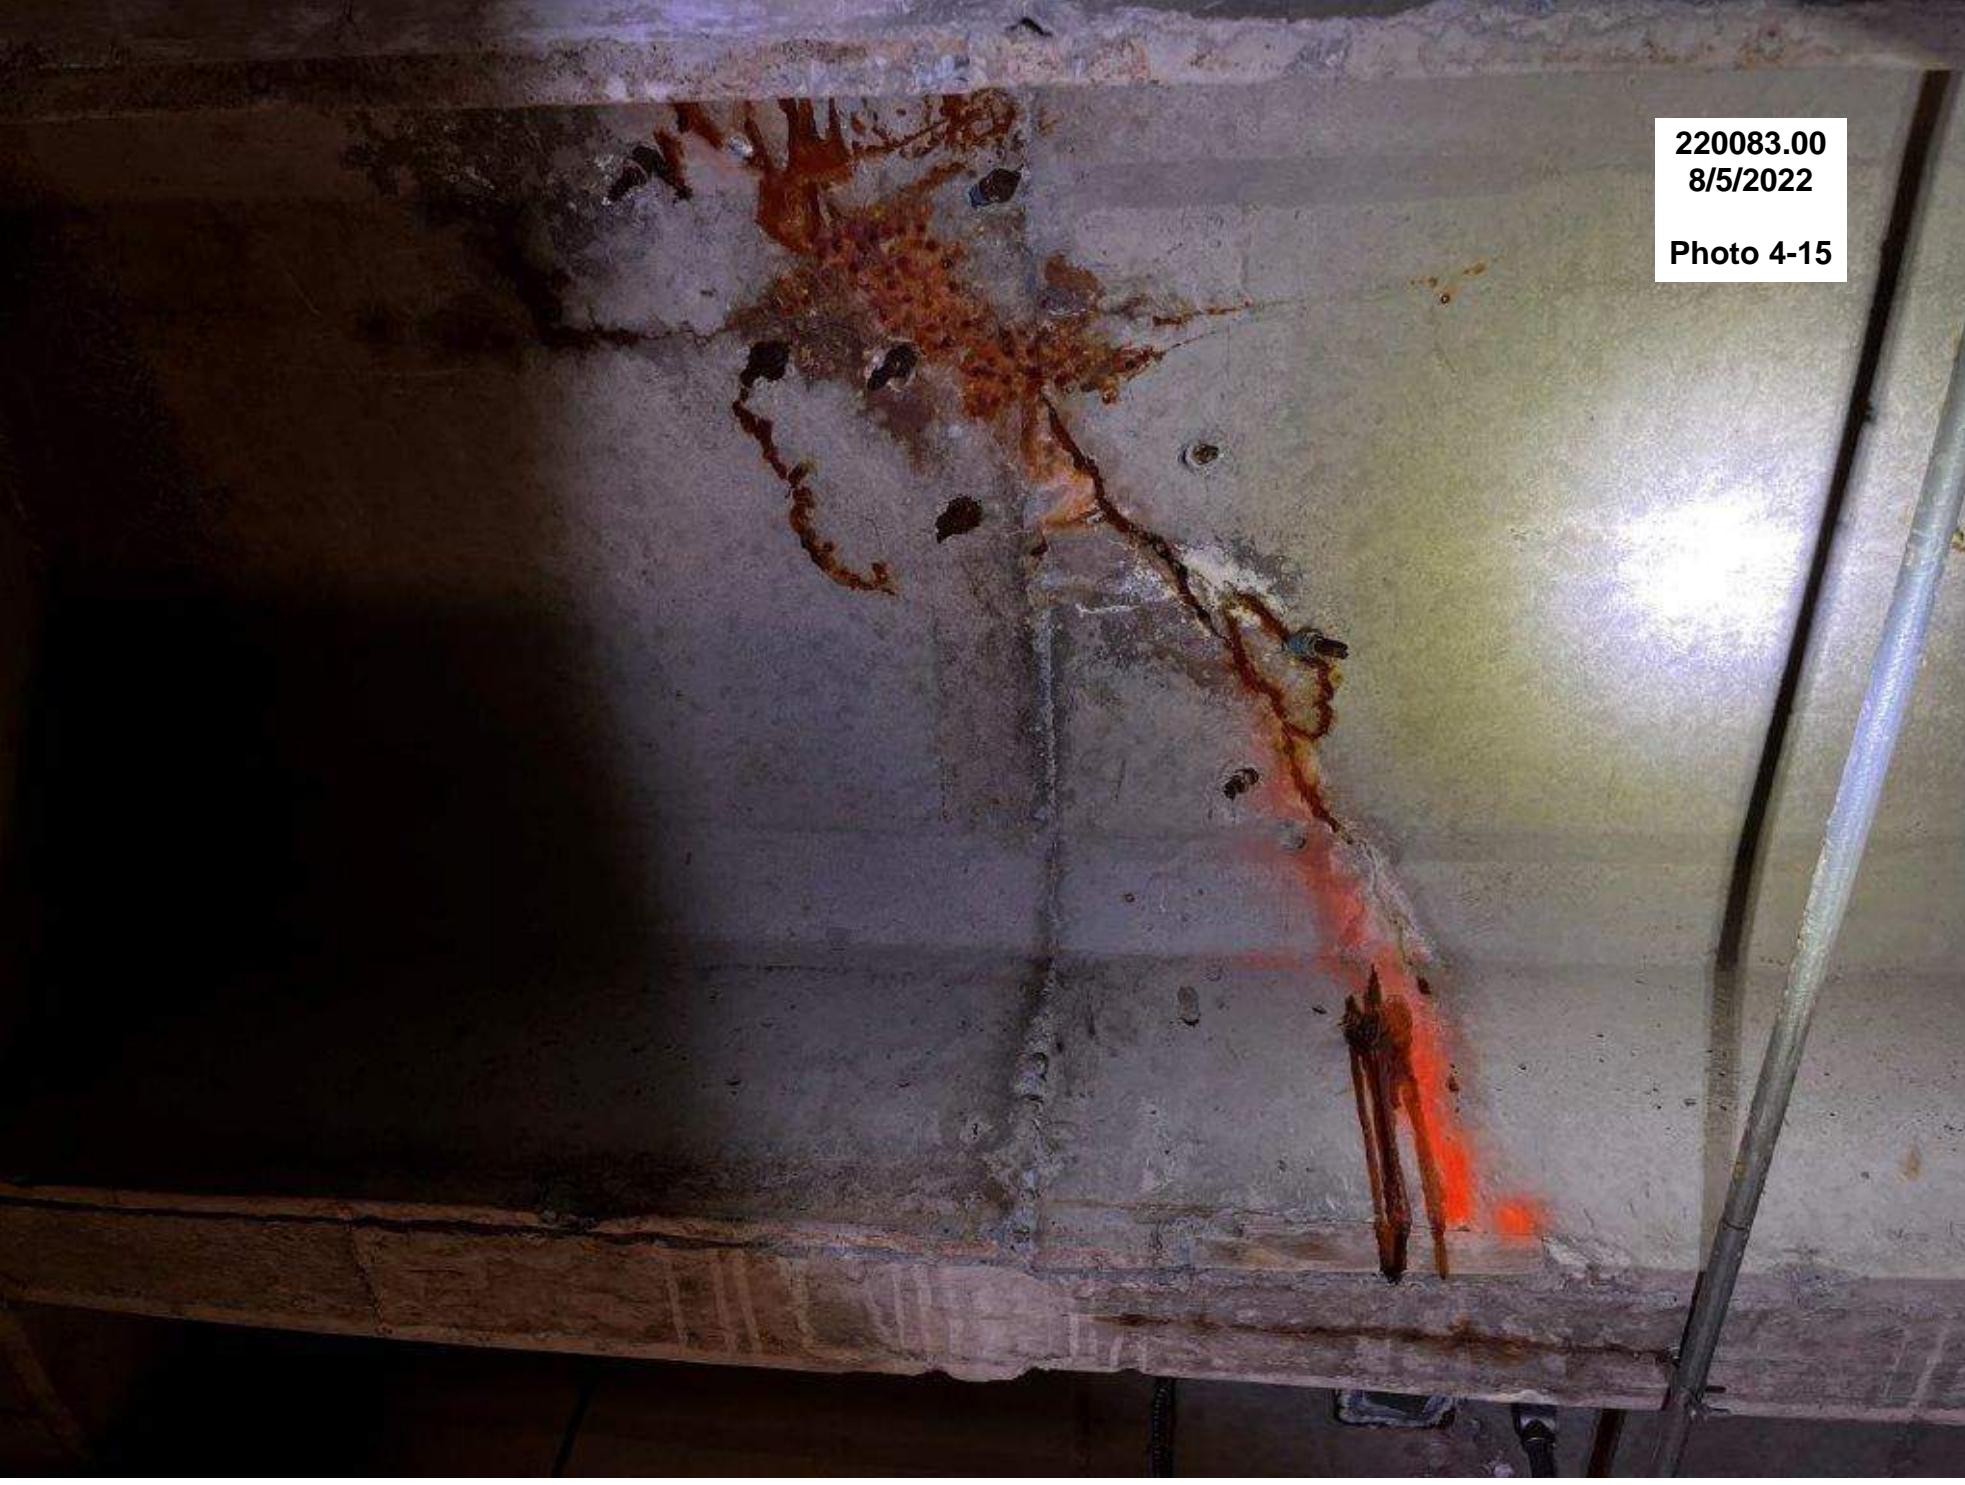
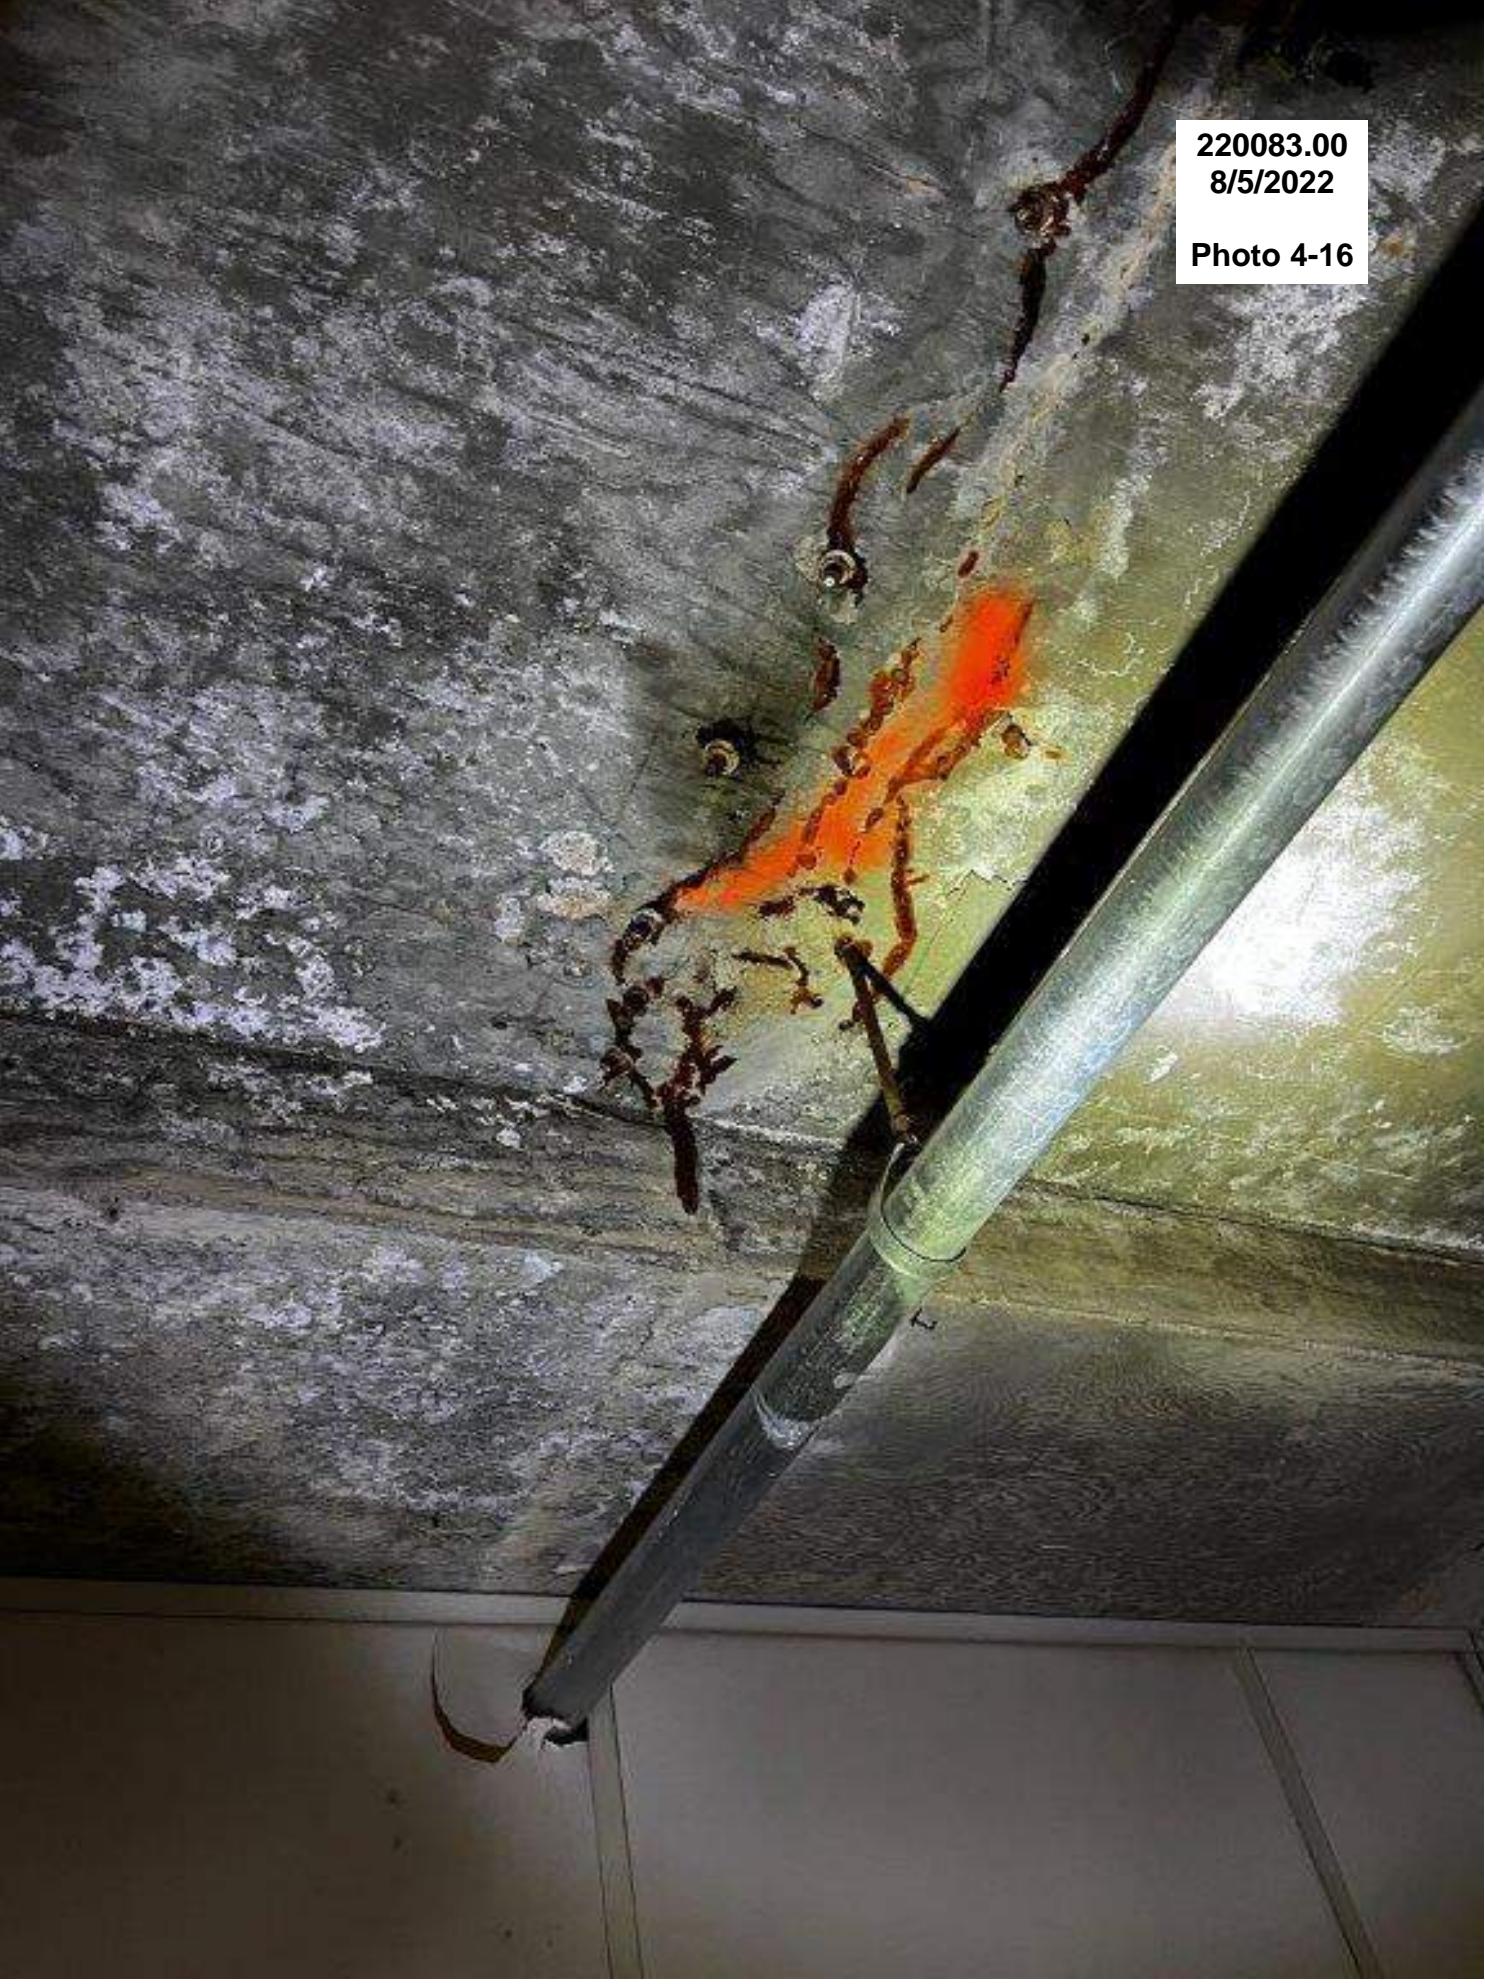
28. Some portions of the floor above are solid, conventionally reinforced concrete slabs instead of rib slabs (Photo 4-12). We observed previously injected cracks (Photo 4-12 through 4-16) and areas of staining (Photo 4-16) at several locations, typically along the east edge of the garage. Some of the cracks appear to have fresh efflorescence and active drips / leaks (Photos 4-17 through 4-19). At some locations, cracks extend from the floor slab onto the concrete ribs and girders below (Photo 4-20, red arrow).

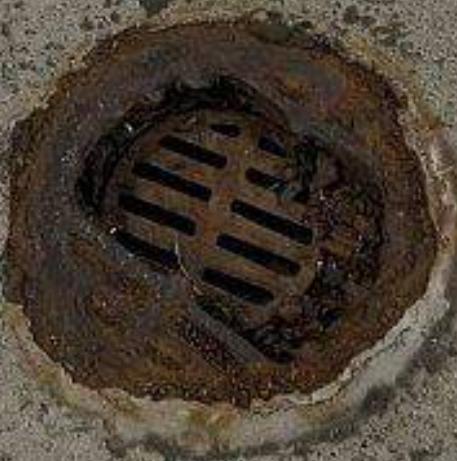
Photo 4-22

29. Removing the ceiling tiles at a few locations revealed that the concealed construction above is similar to the construction elsewhere in the garage (i.e., a concrete joist / rib slab, Photo 4-21).
30. The floor drains at this Level are typically corroded, and the coating is worn around the drains (Photo 4-22).

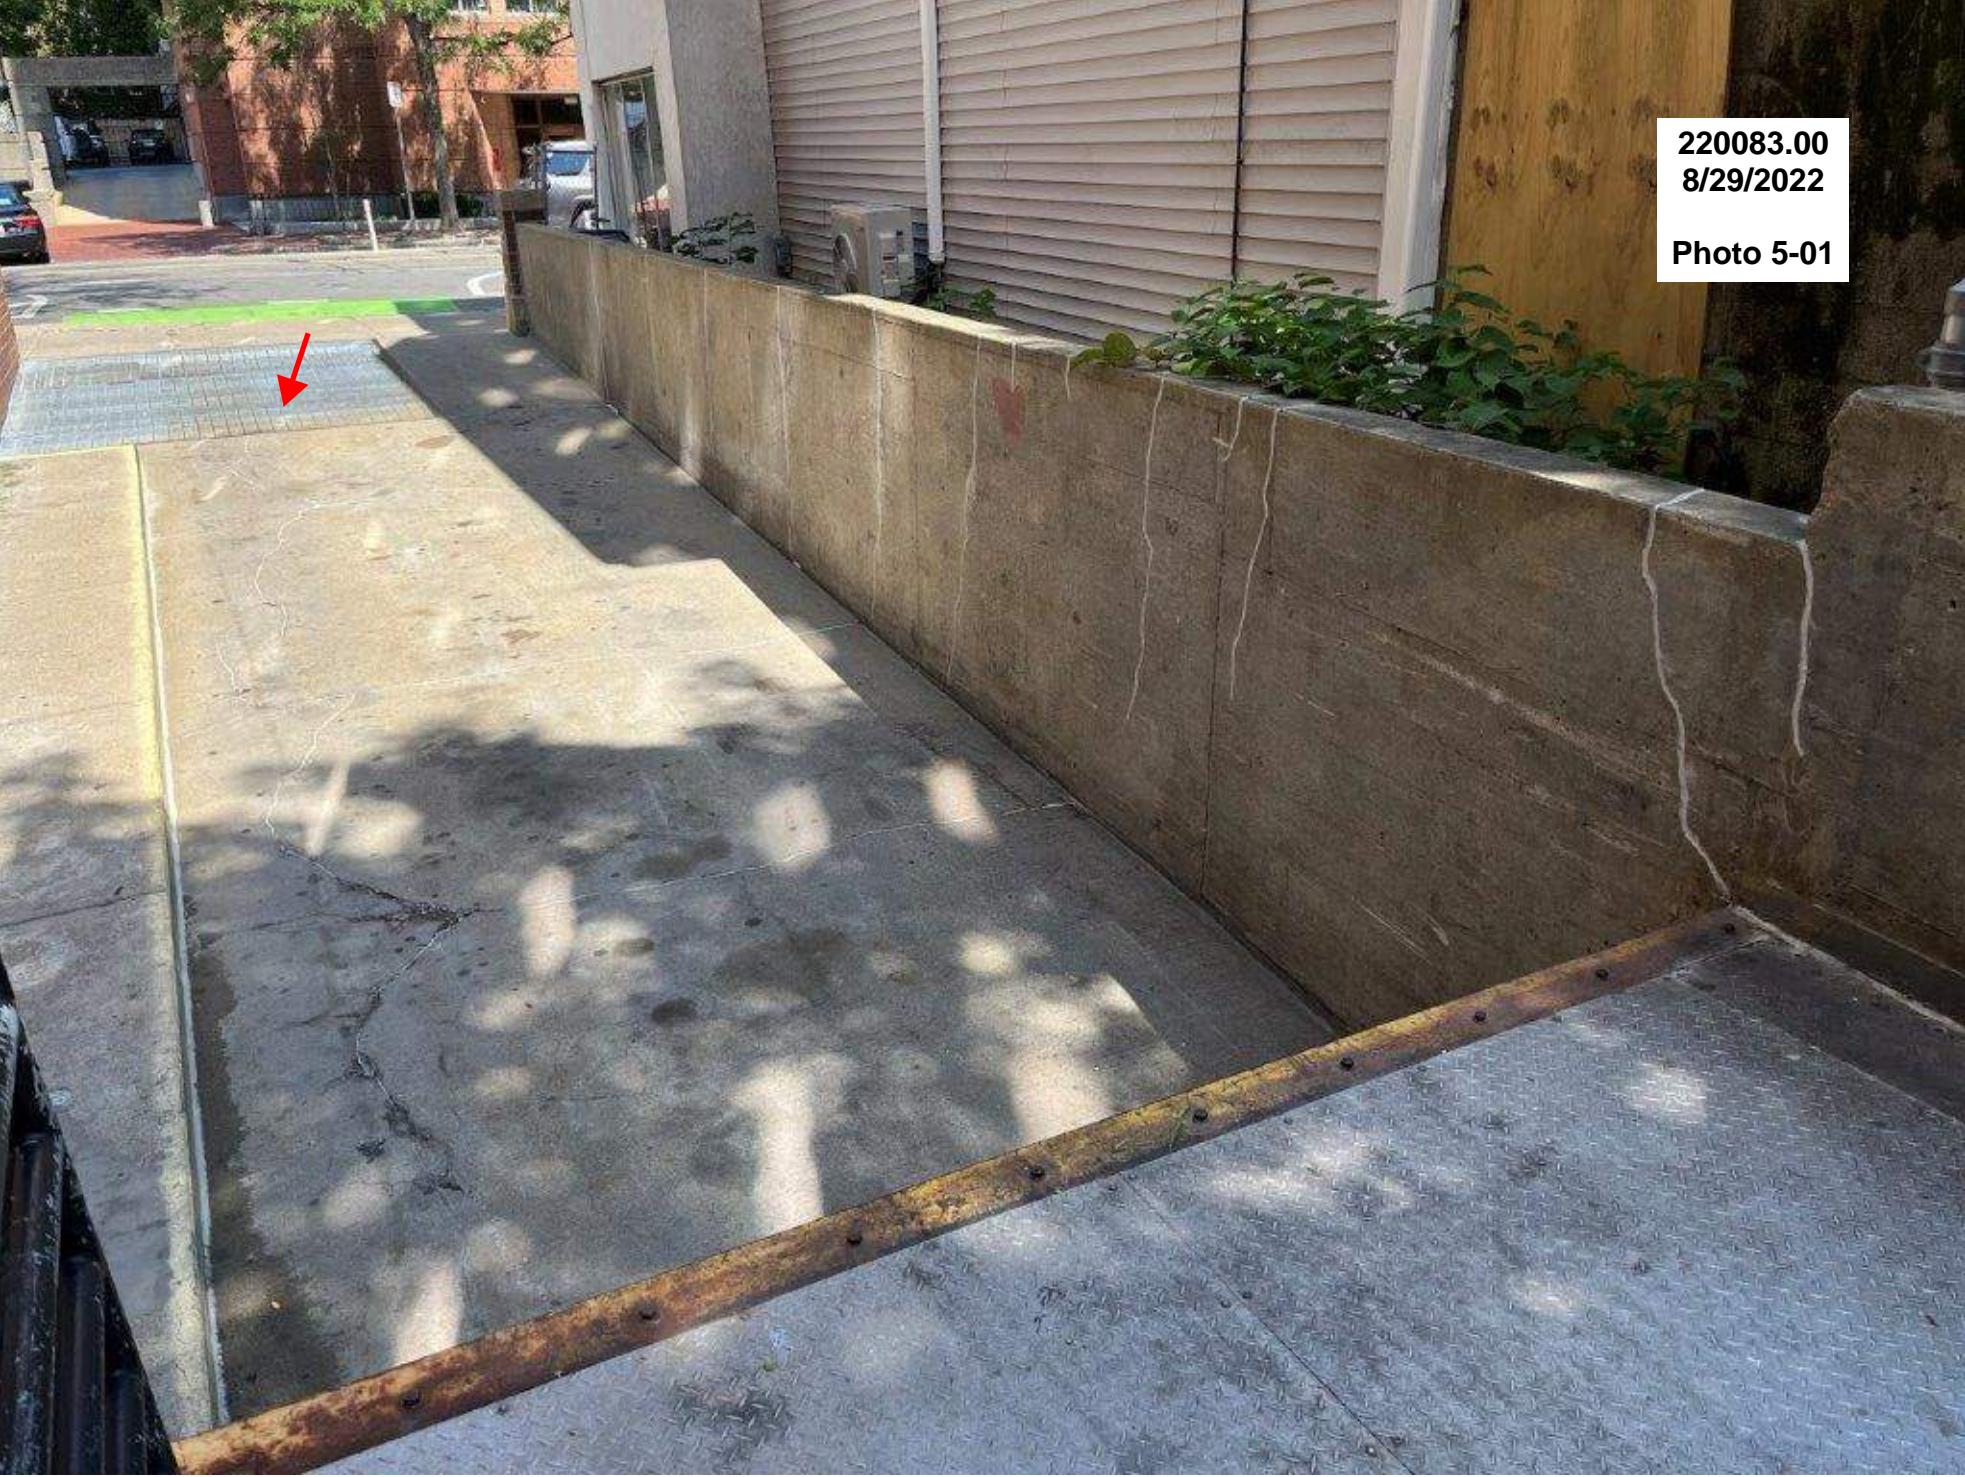
Photo 5-01

31. The loading dock structure along the east side of the building consists of a lower section at sidewalk grade along Massachusetts Avenue (Photo 5-01) and an upper section at the Plaza Level (Photo 5-02). Portions of the dock floor are metal bar grating (Photos 5-01 and 5-15a, red arrows) and support conditions beneath the grating could not be directly observed.

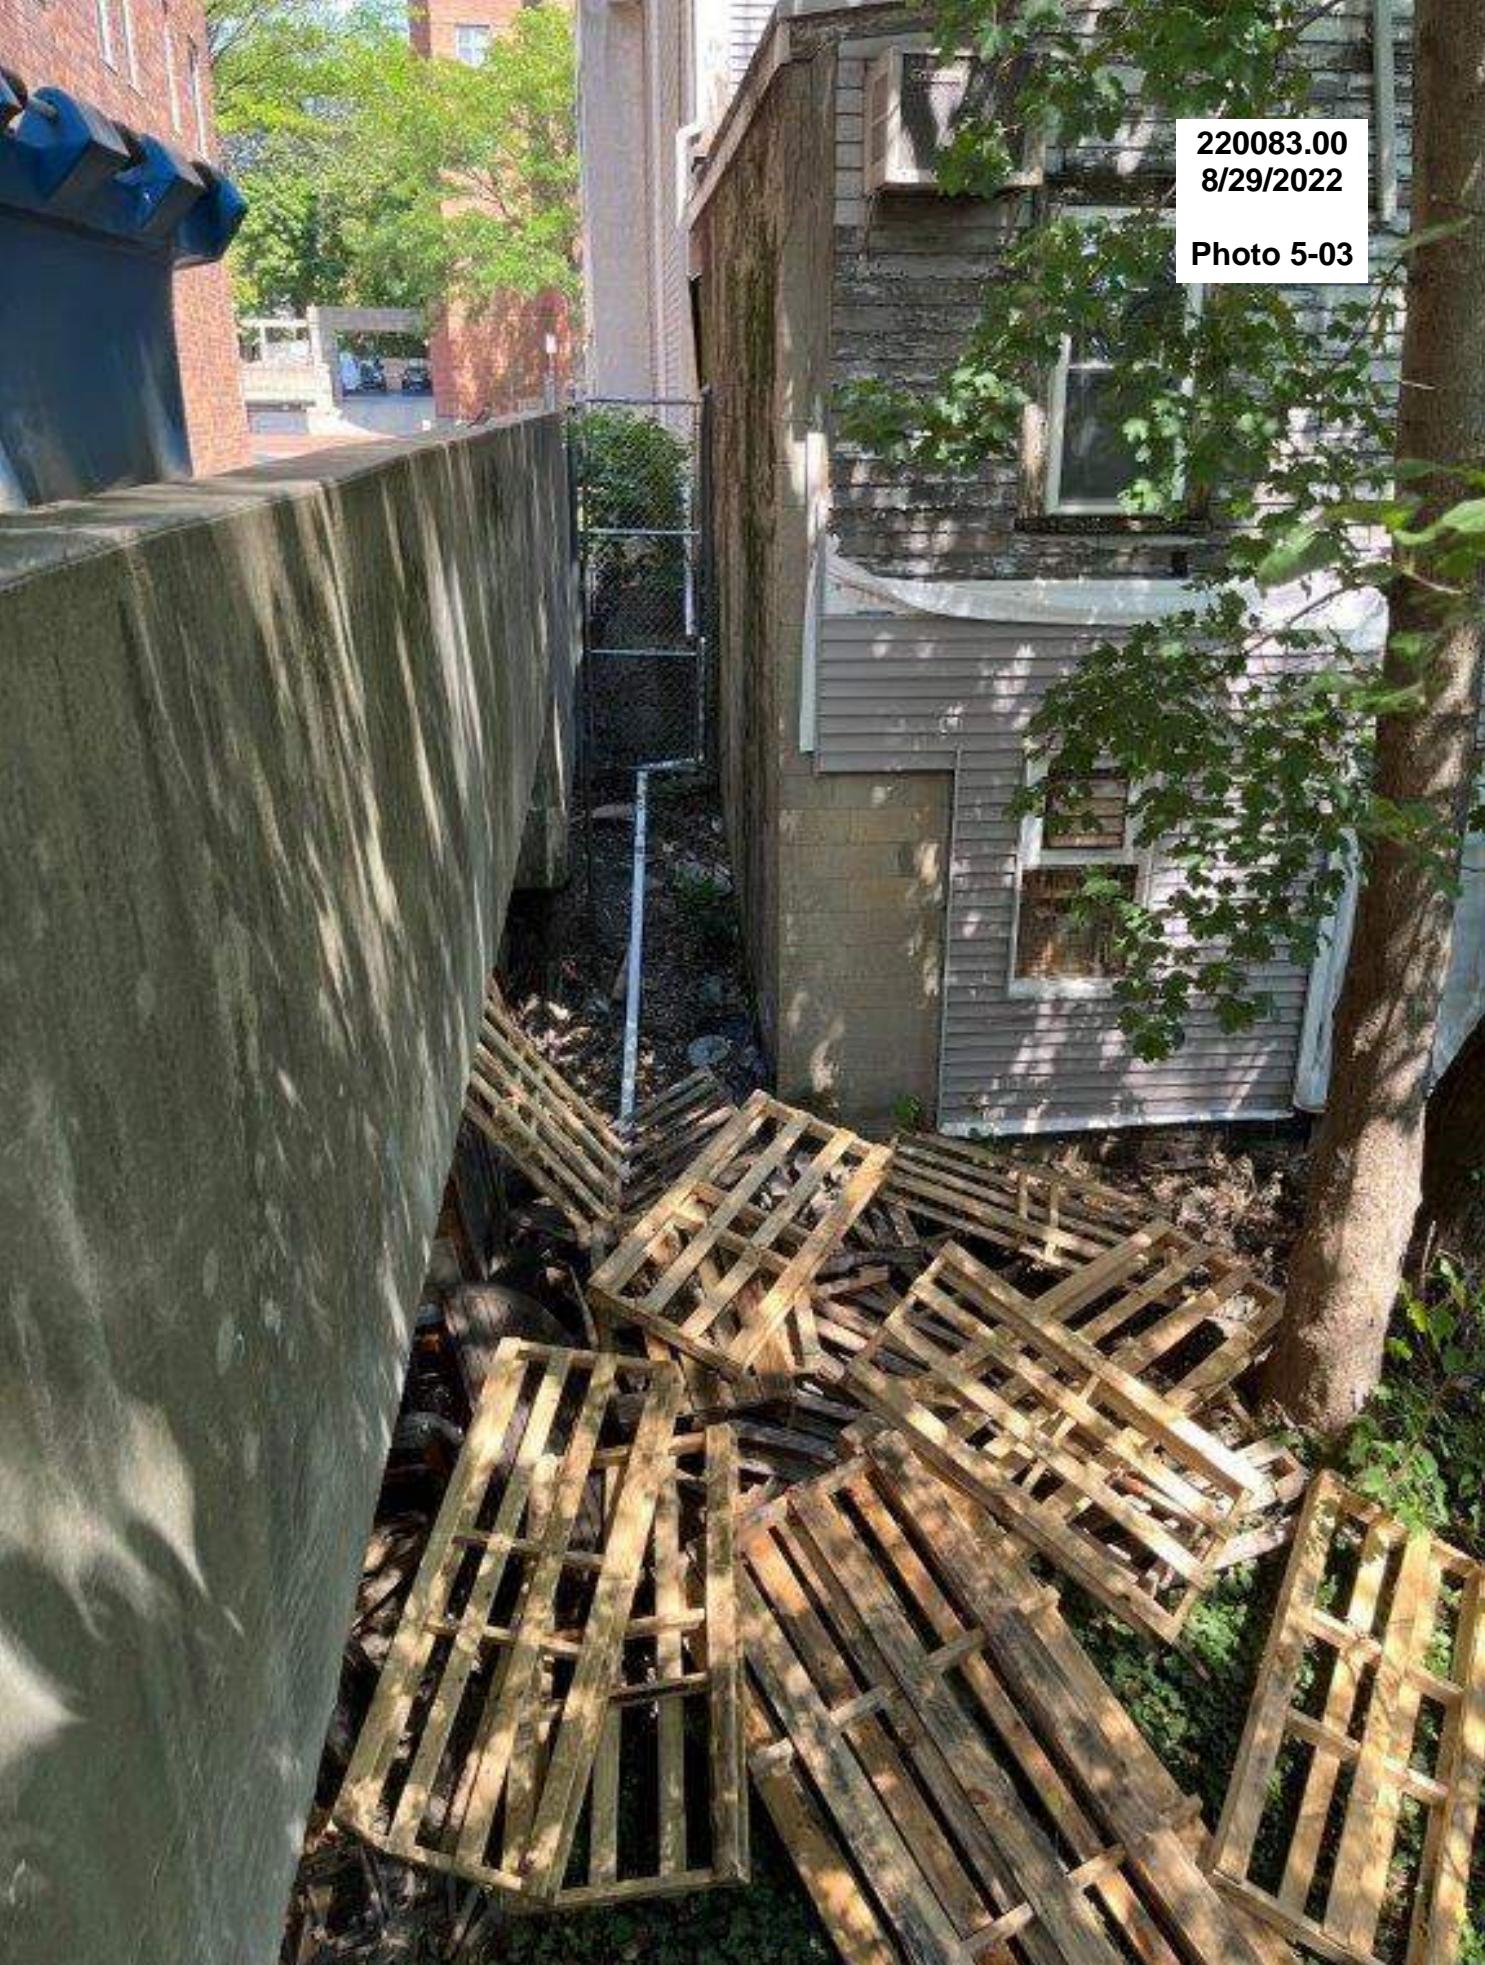
Photo 5-03

32. The loading dock is located right along the property line, and a portion of the dock structure “cantilevers” over a lower area along the eastern edge of the property which abuts the back yard of the adjacent site to the east (Photo 5-03).
