CopelandBEC Engineering Study Addenda, Notes, and Errata

Bay Square Condominiums

950 Massachusetts Avenue
Cambridge, MA

Building Condition Assessment

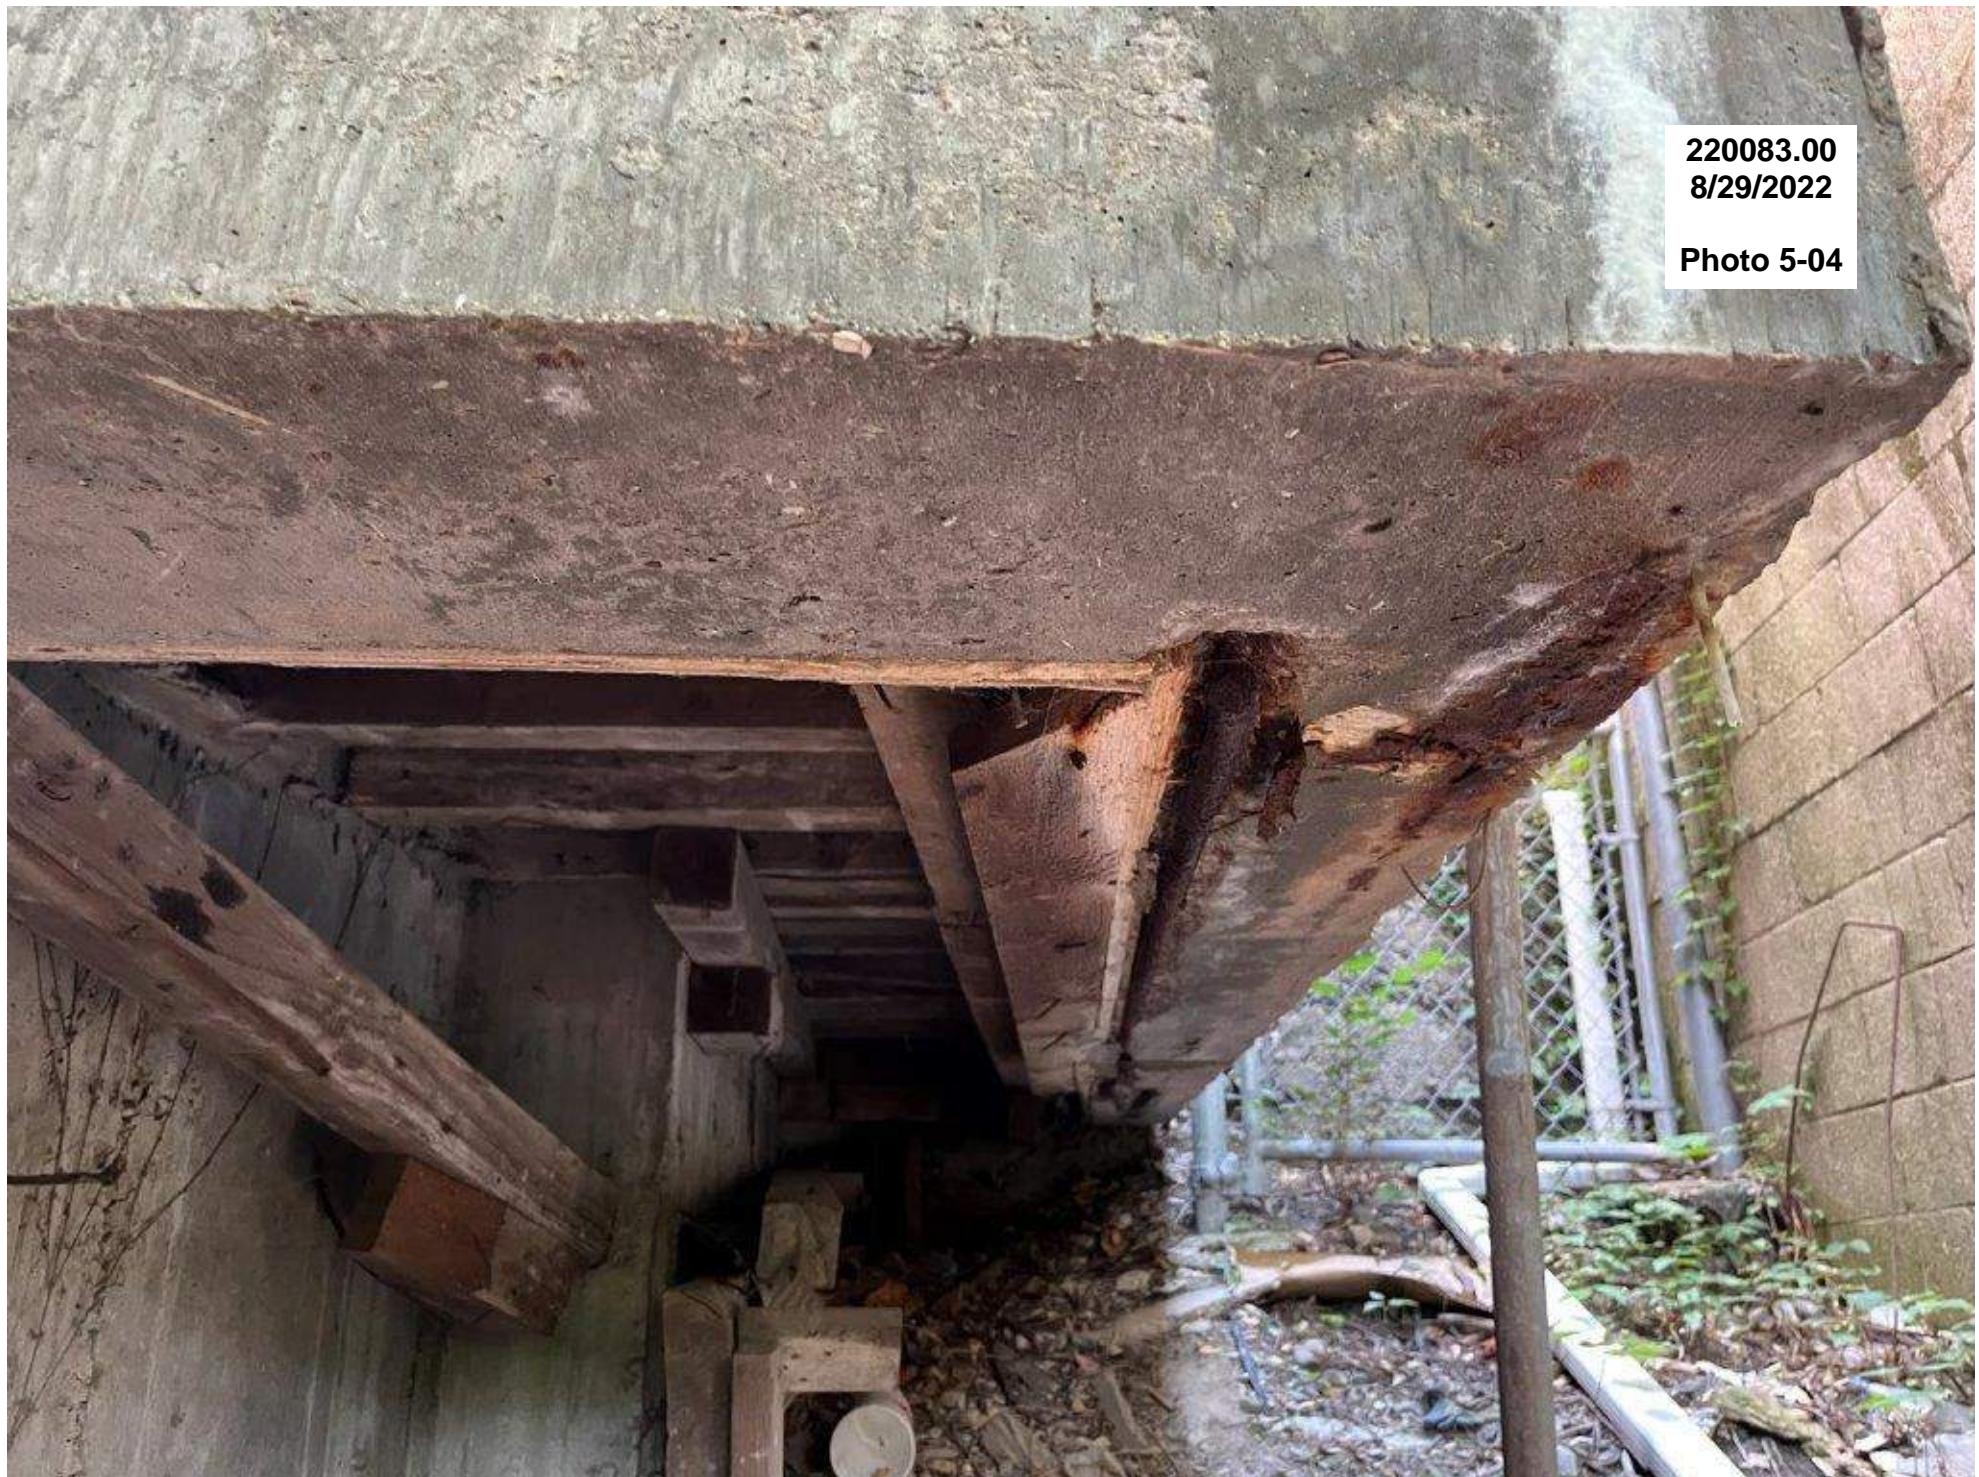
Photo 5-04

33. Portions of the cantilevered concrete wall are heavily weathered and there is corroded, exposed rebar at the bottom of the wall (Photo 5-04).
34. The cast-in-place concrete loading dock structure shows signs of weathering and there are several cracks in the walls of the dock that have previously been repaired by routing out and filling them with sealant (Photos 5-01, 5-02, 5-05 through 5-09). Many of the sealant repairs show signs of adhesive failure (i.e., the sealant is no longer well bonded to the concrete, Photos 5-06 and 5-08, red arrows).

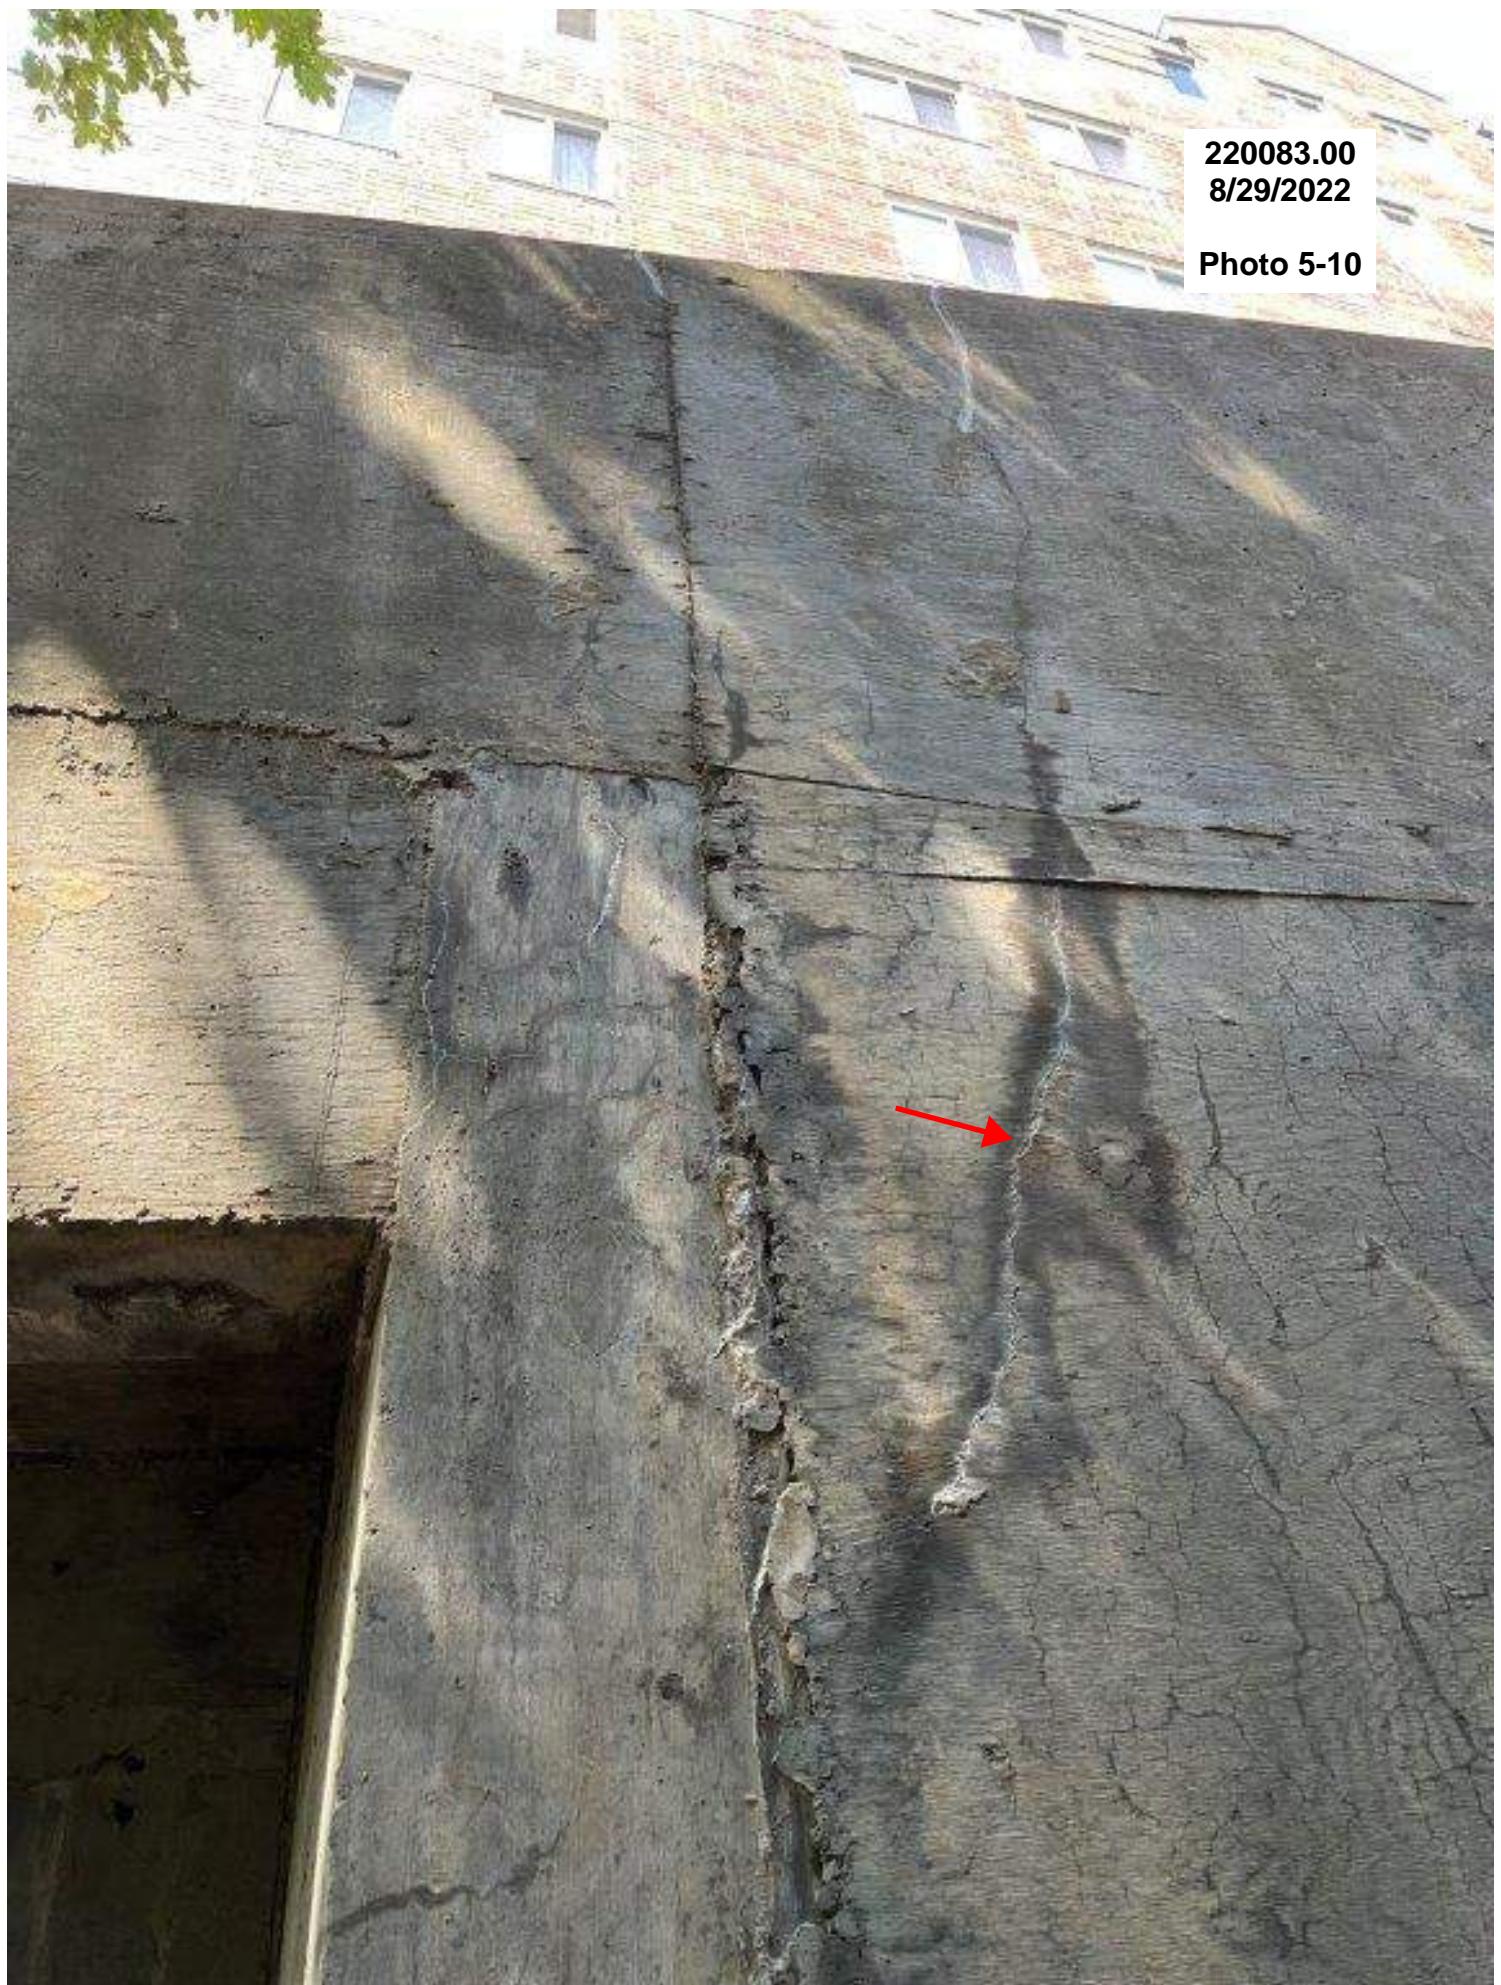
Photo 5-10

35. Some of the cracks have not been repaired / fully repaired (Photo 5-10).
36. There are several cracks and spalls in the concrete floor slabs and at the dock stair (Photos 5-11 through 5-15). Some weathered / freeze-thaw deteriorated concrete is present in the sidewalk along the west edge of the dock (Photo 5-11, red arrow).

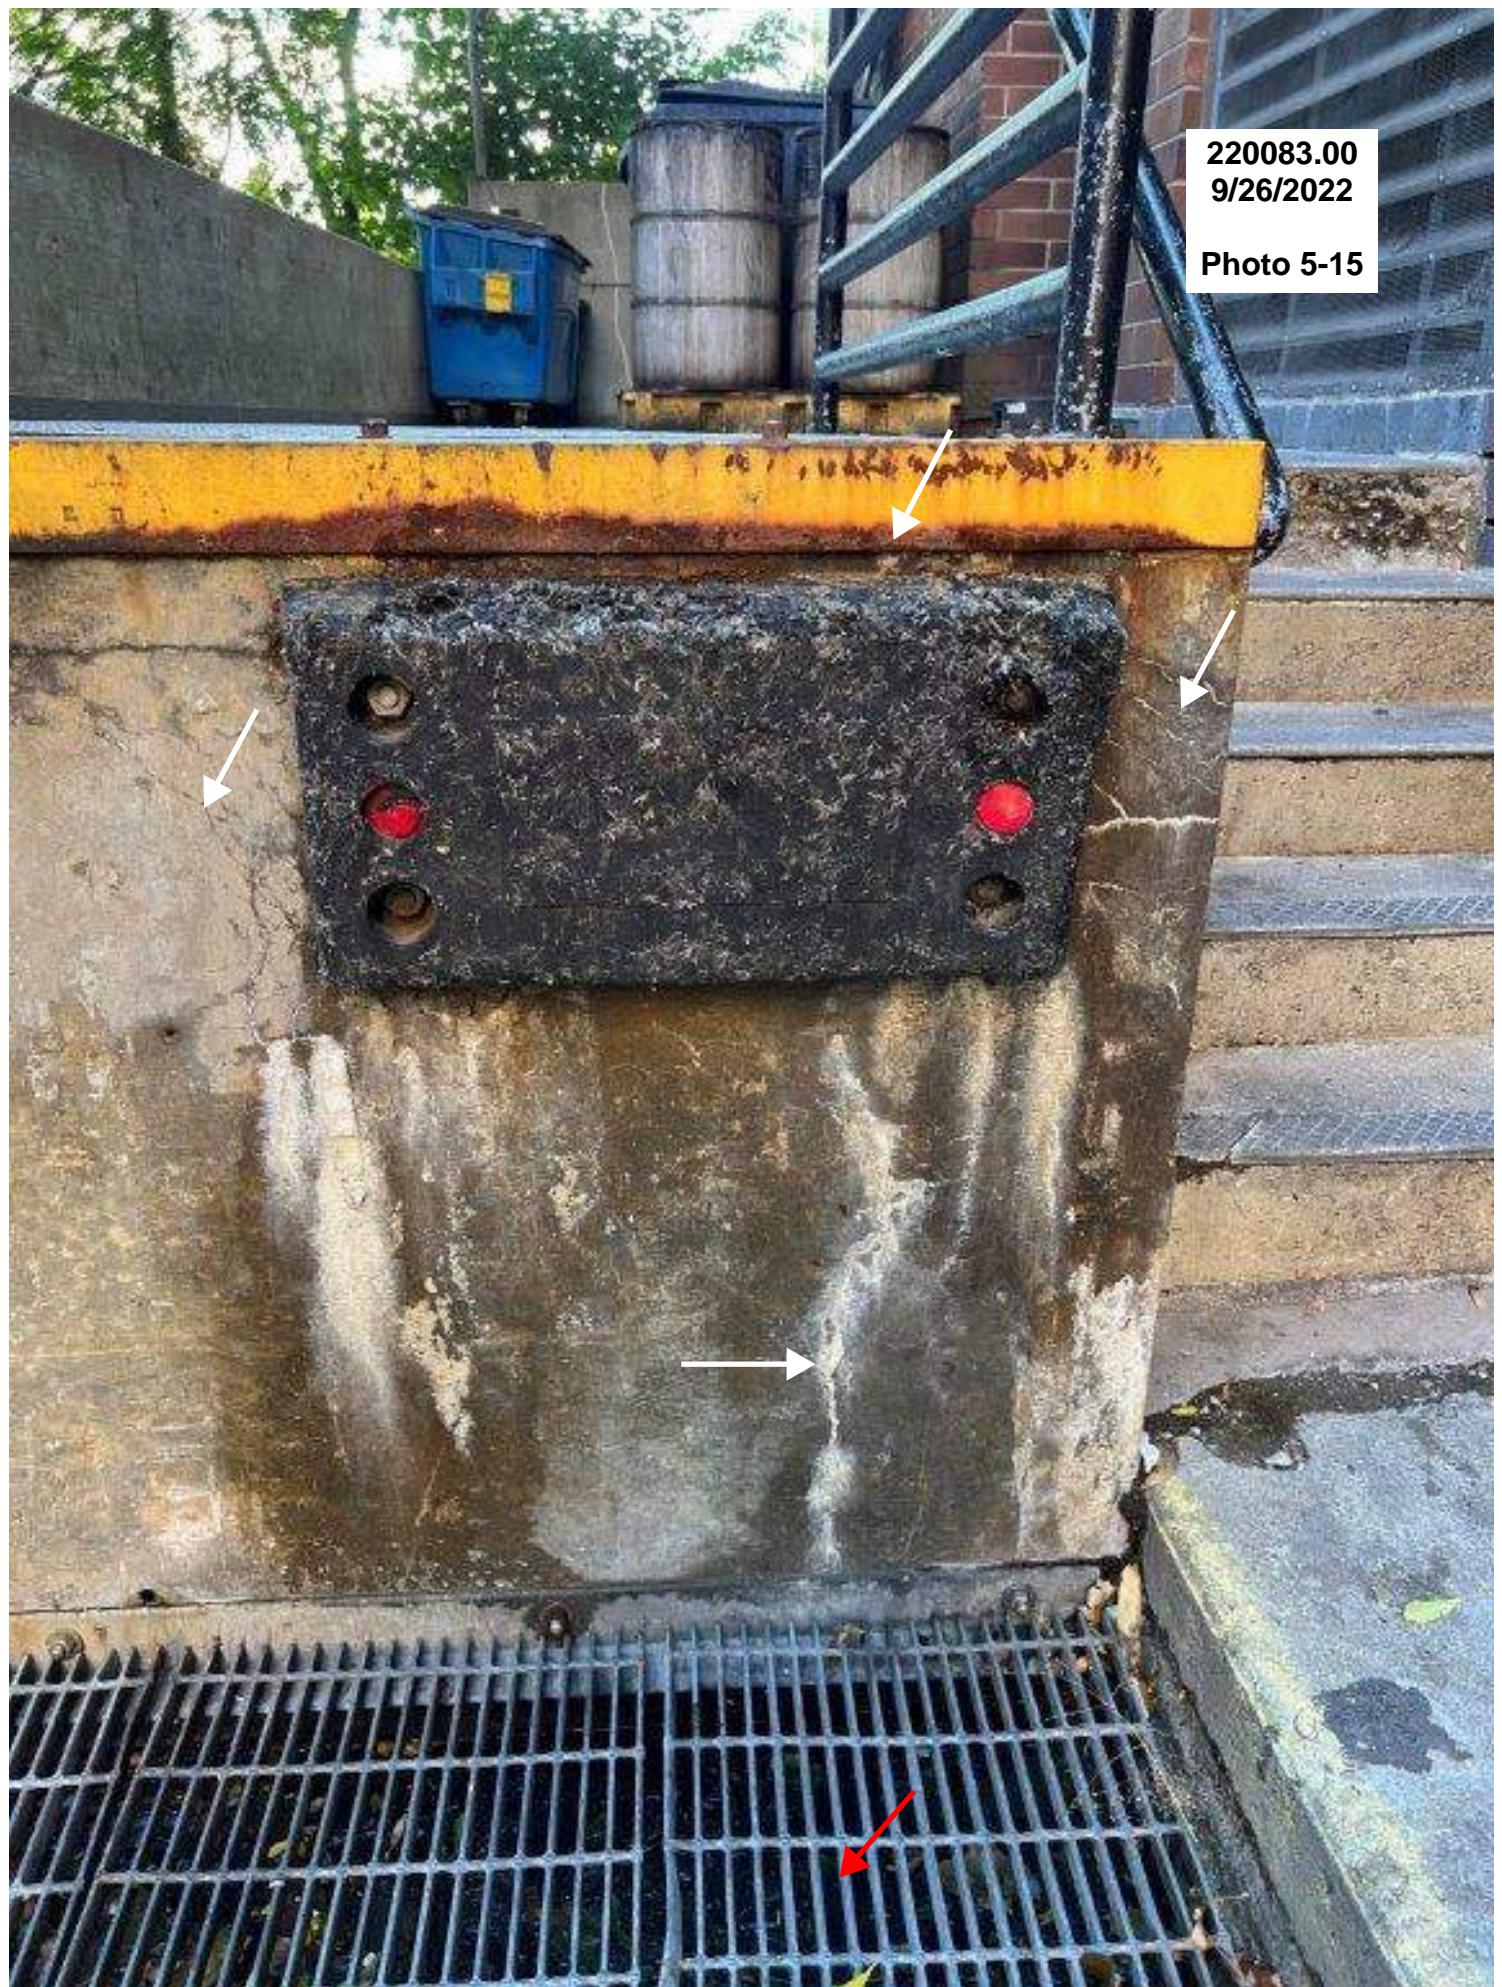
Photo 5-15

37. Portions of the dividing wall between the upper and lower sections of the dock are heavily weathered and cracked. Staining / efflorescence is visible at many of the cracks, and the perimeter dock angles are lightly to moderately corroded (Photo 5-15, white arrows).

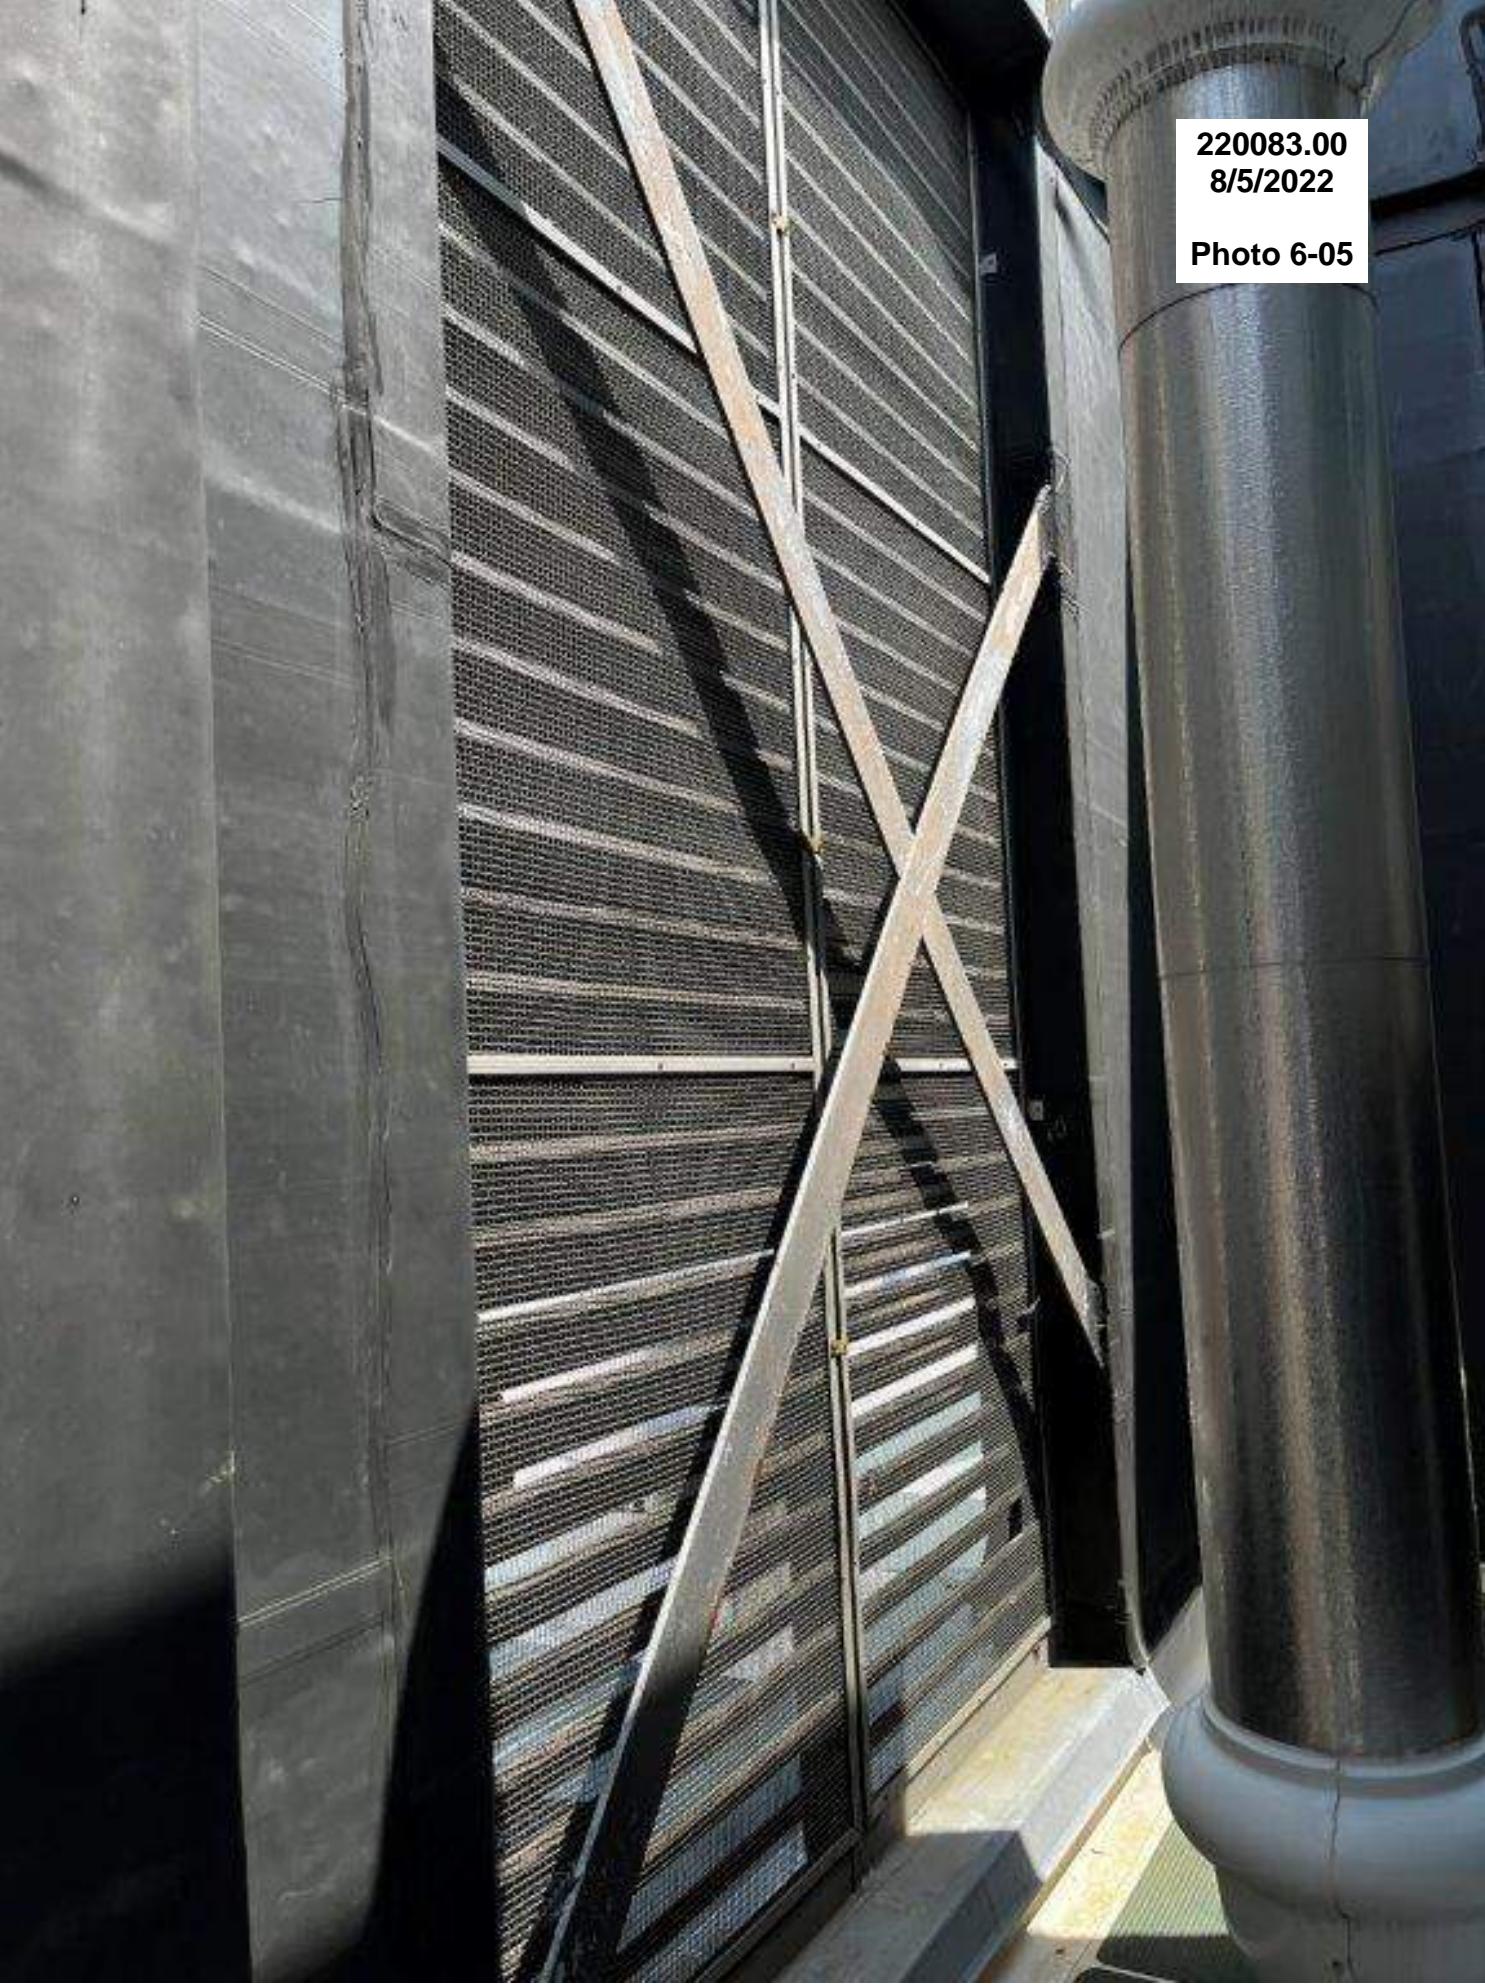
Photo 6-05

39. There are low roof patio and rooftop garden areas over the stepped down portions of the building on the south side (Photos 6-03 and 6-04).
40. Very few structural elements are exposed to view above the roof. Minor paint chipping and some corrosion are present on some of the diagonal bracing members in the mechanical rooms / structures above the main roof (Photos 6-05 and 6-06).

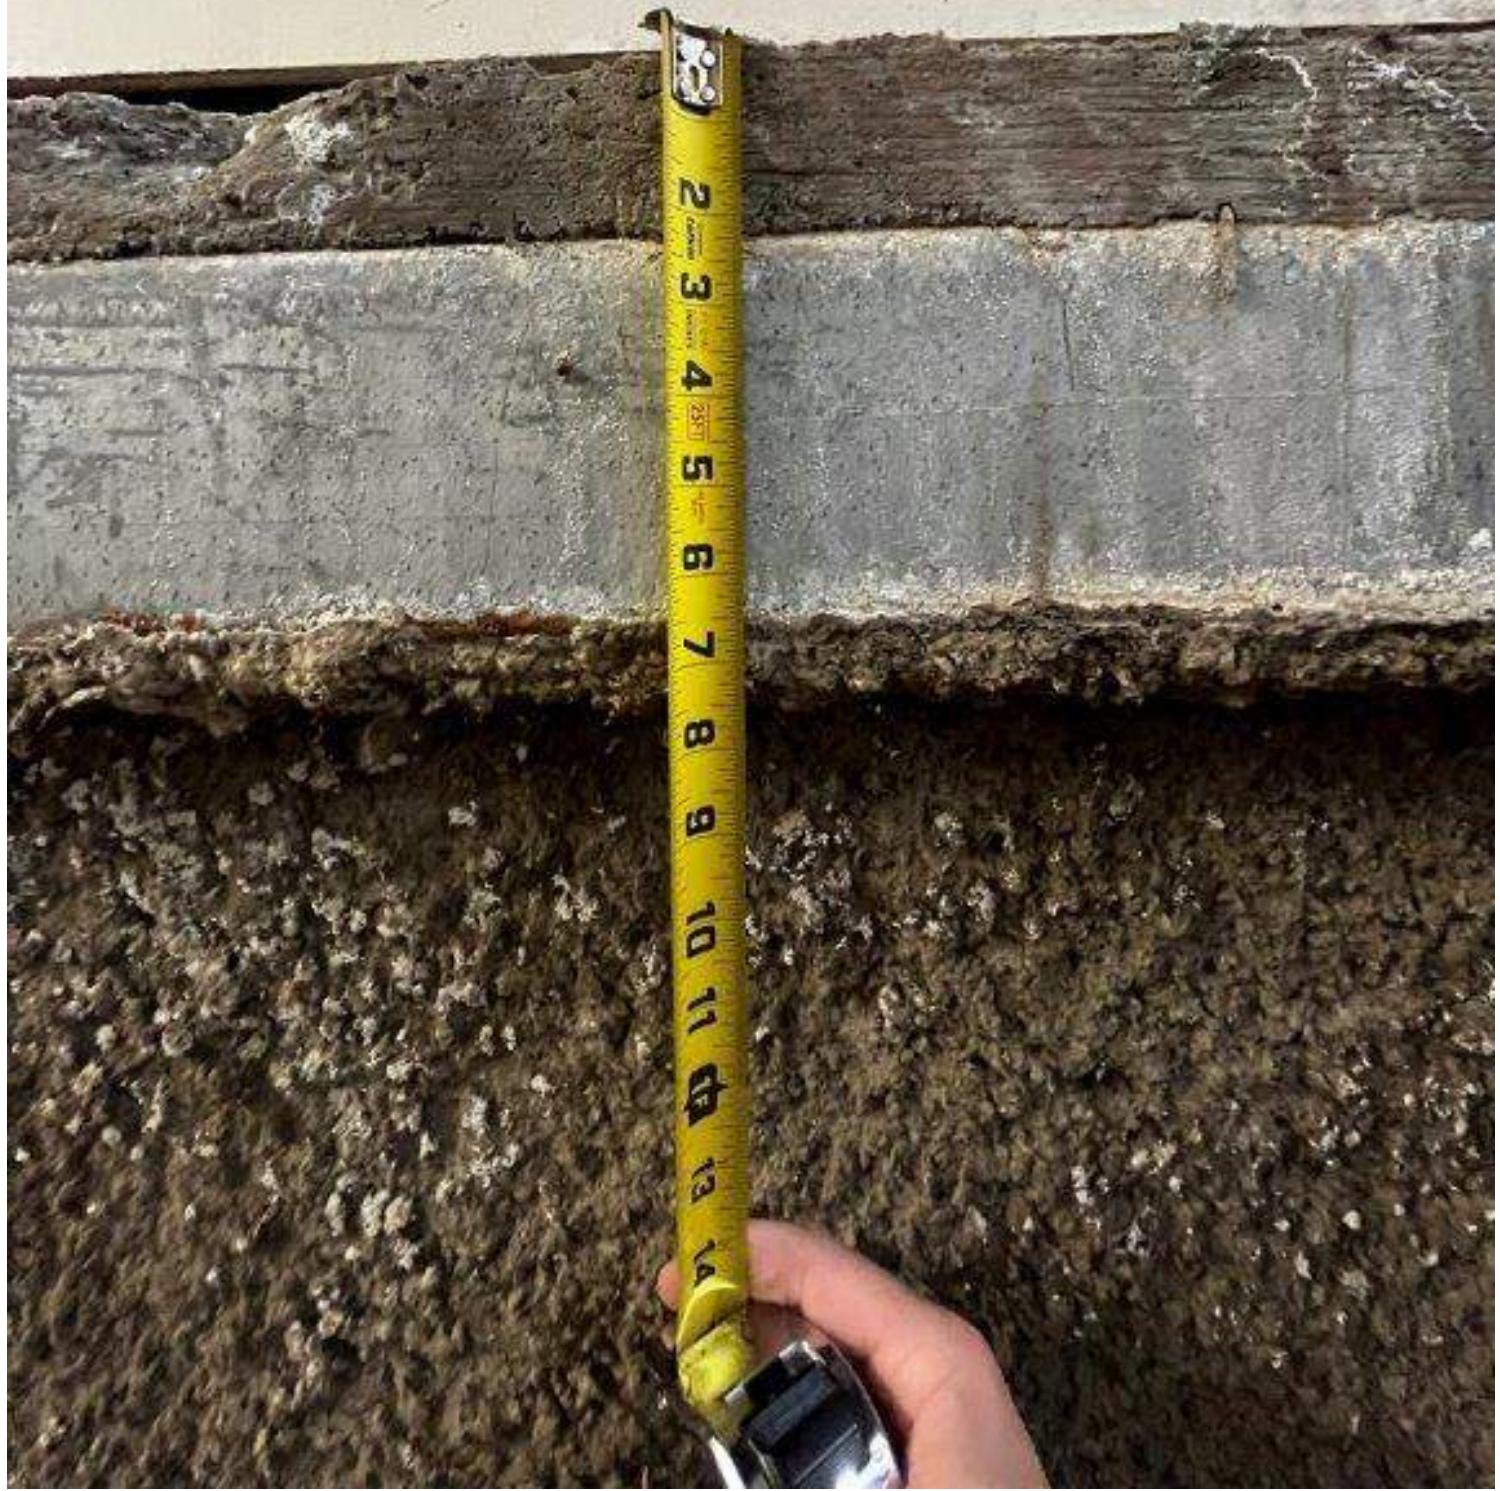
Photo 6-09

41. The main roof structure generally consists of fireproofed structural steel beams supporting a cast-in-place concrete slab on composite metal decking (Photos 6-07 through 6-09). We measured an approx. 2-inch thick, concrete topping over an approx. 5¼ thick (total thickness) concrete slab on metal deck at one location where the edge of slab is exposed (Photo 6-09), but the thicknesses appear to vary.

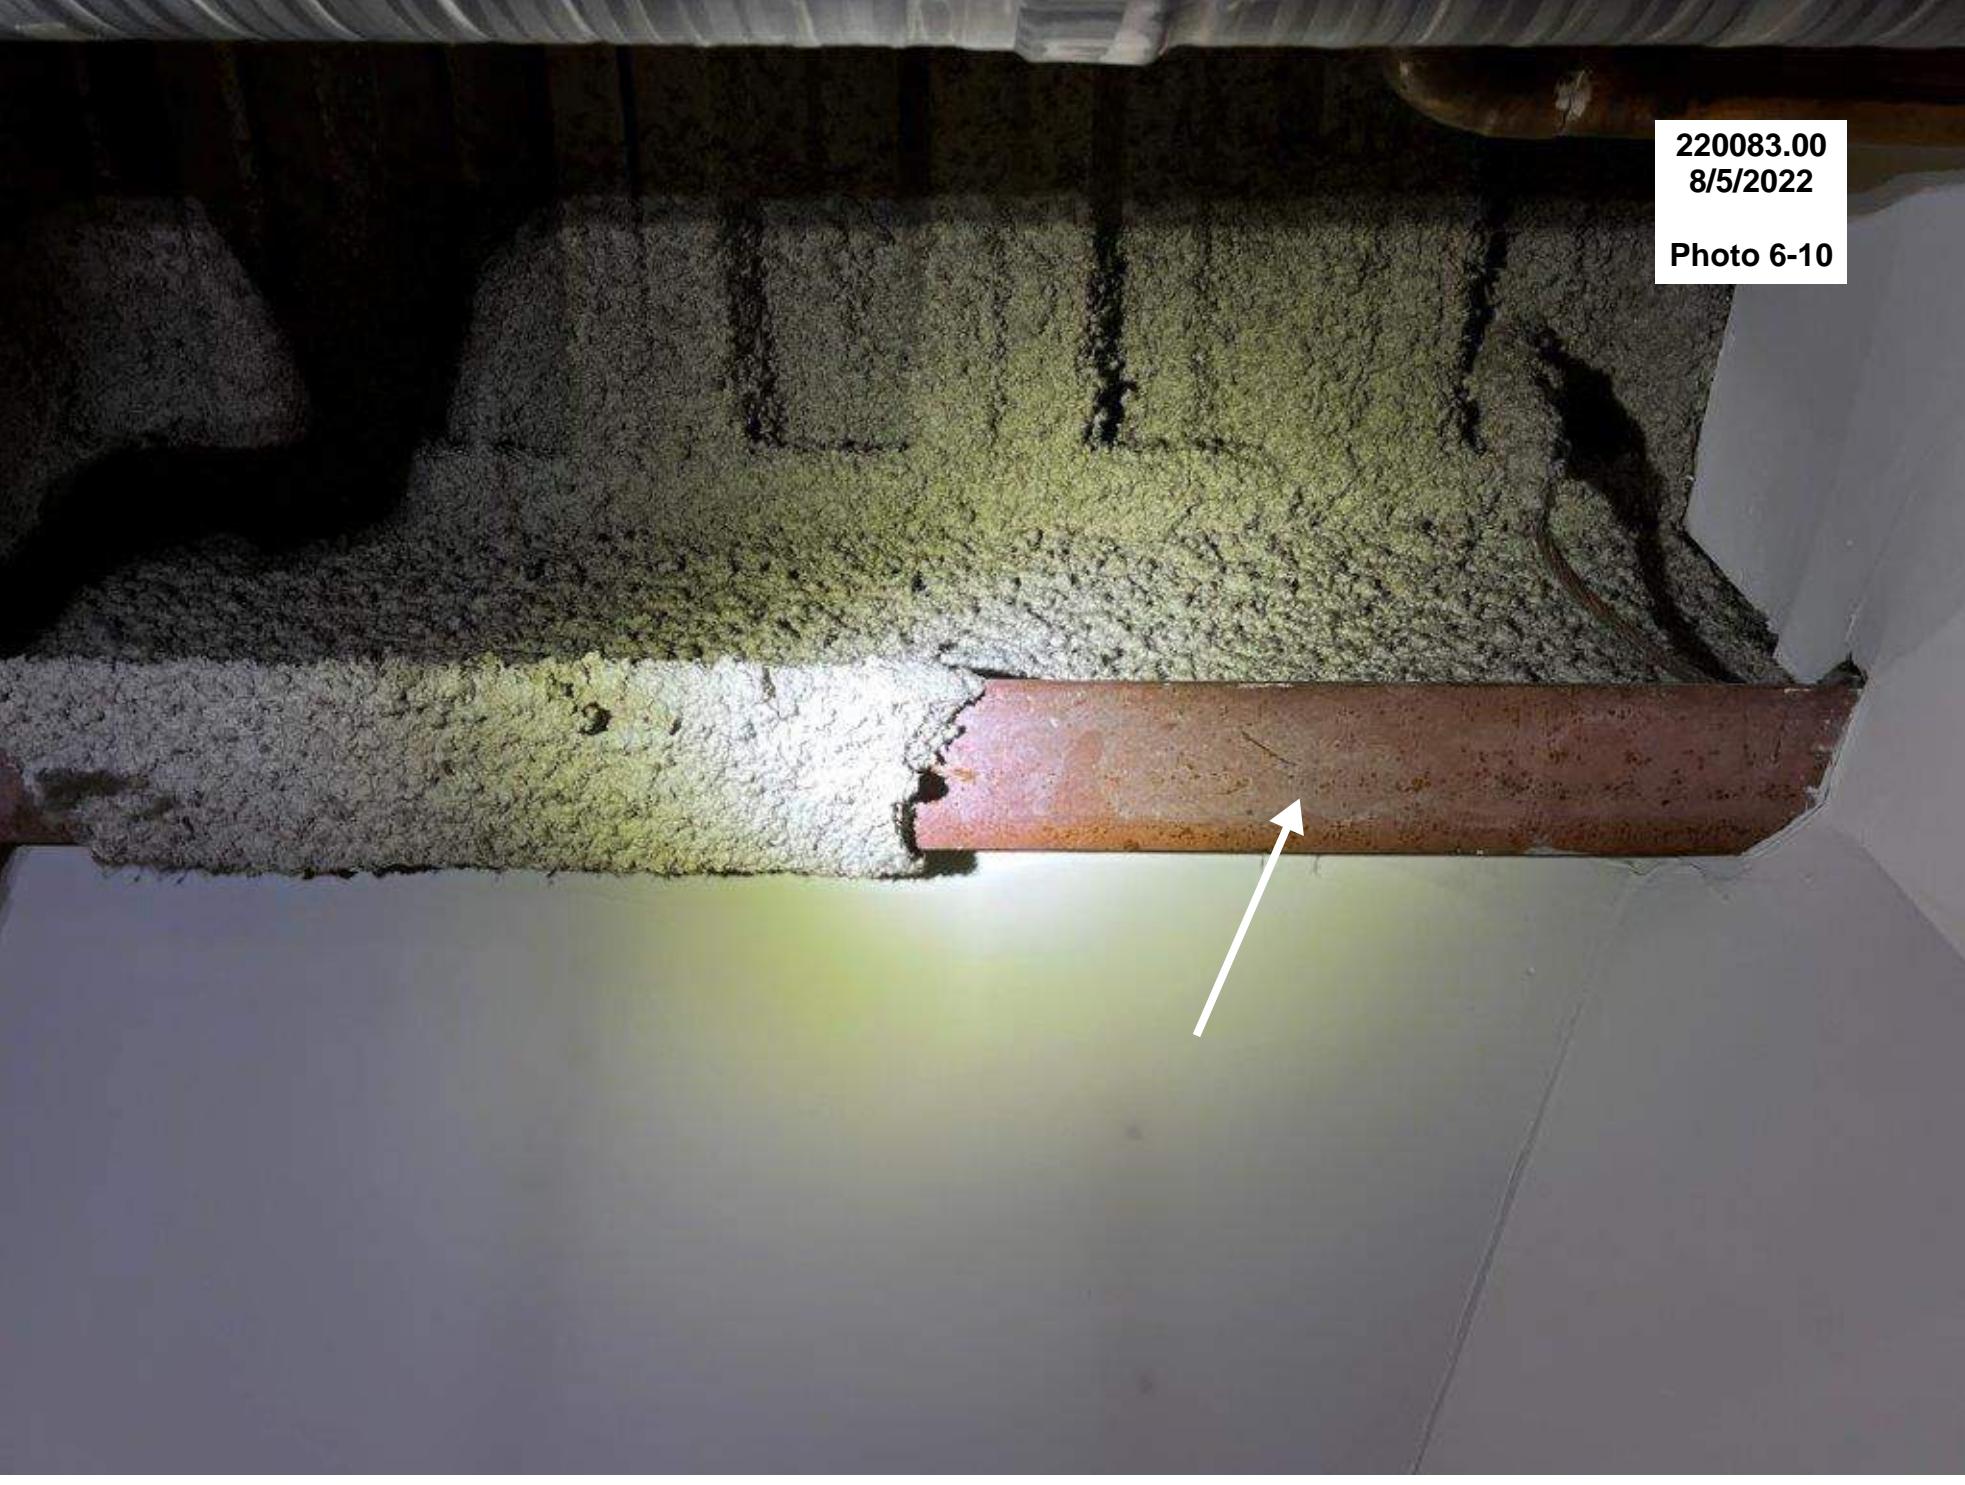
Photo 6-10

42. The spray-applied fireproofing is missing at several locations throughout the mechanical areas below the main roof (Photo 6-10, white arrow).
43. Some minor structural modifications were made to the main roof framing sometime after the original building construction, apparently to accommodate mechanical equipment and

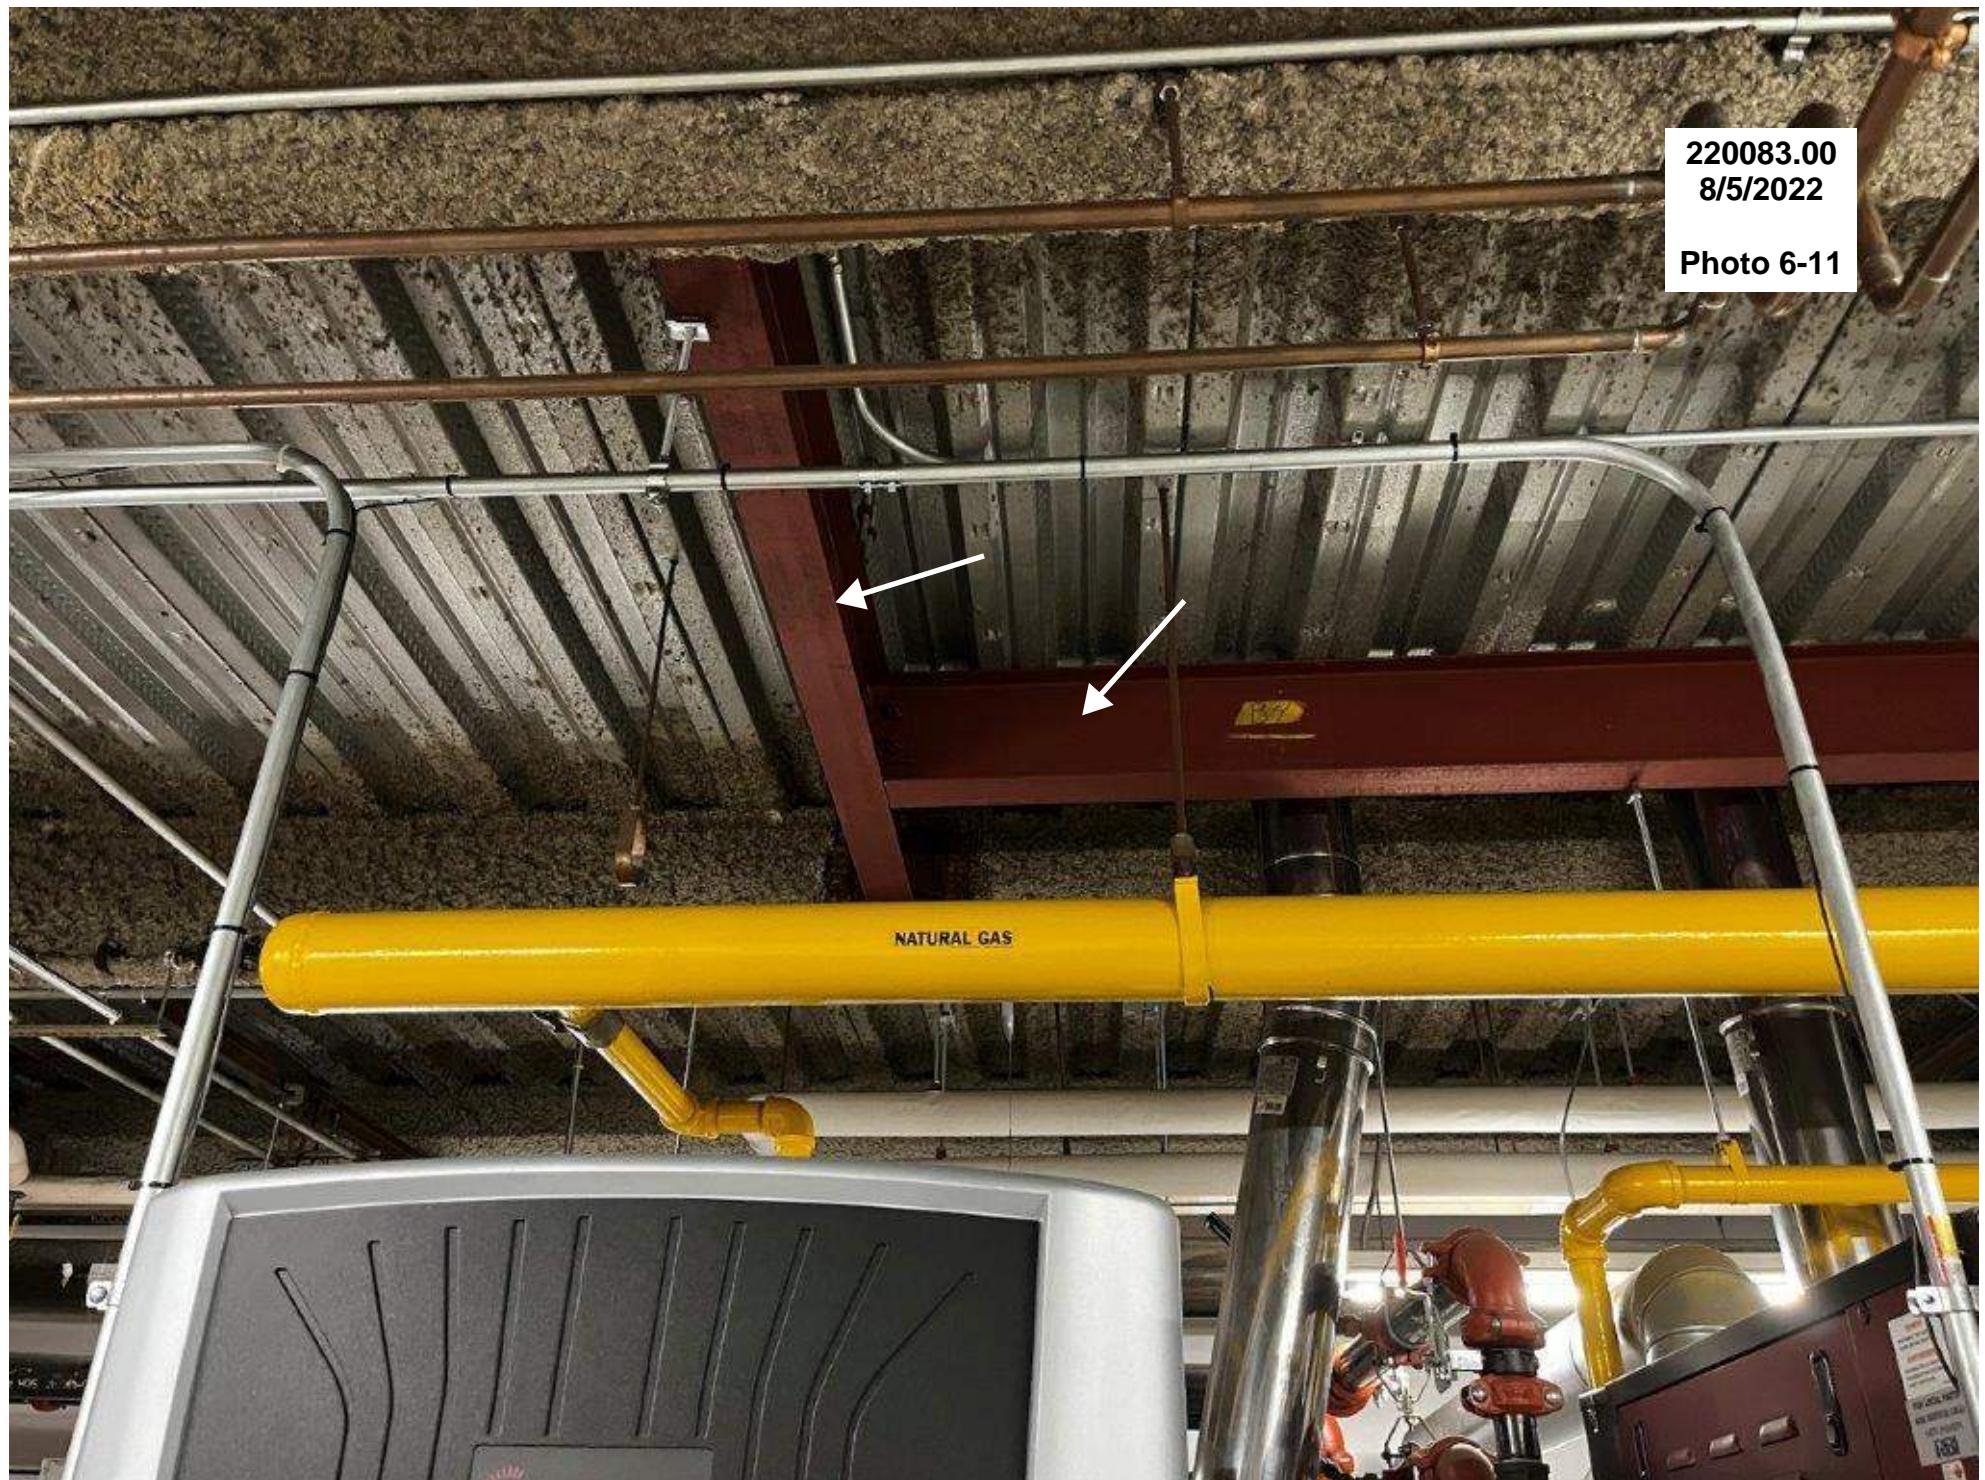
Photo 6-11

penetrations. Some of the steel framing installed as part of these modifications does not appear to be fireproofed (Photo 6-11, white arrows).
