# Capital Needs Assessment and Replacement Reserve Analysis

## Bay Square Condominium

Cambridge, MA

October 19, 2021

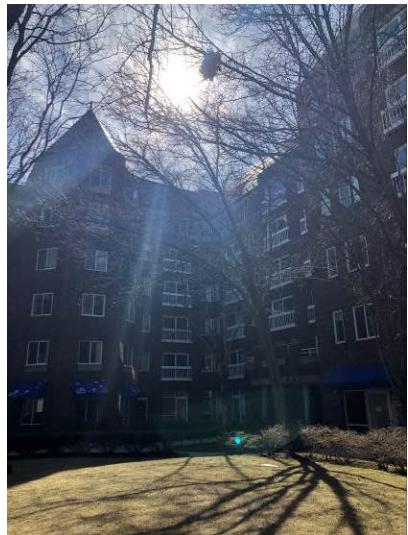
View of the enclosed park at the front of the building.

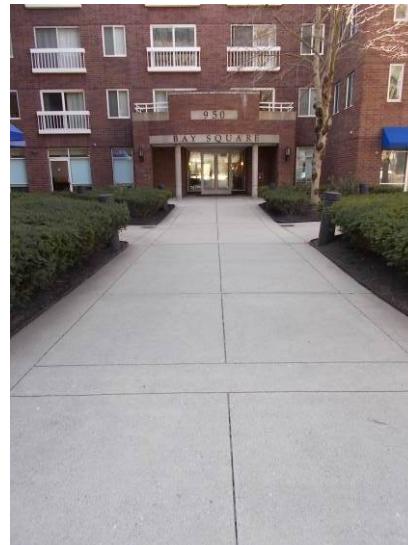
3. The concrete walkways at the front and rear courtyards were observed to be in good condition; repair allowances (including the loading dock driveway and walkway) are shown every five years beginning in Year 3.

The main entry is accessed off of Massachusetts Avenue by concrete paved walkways.

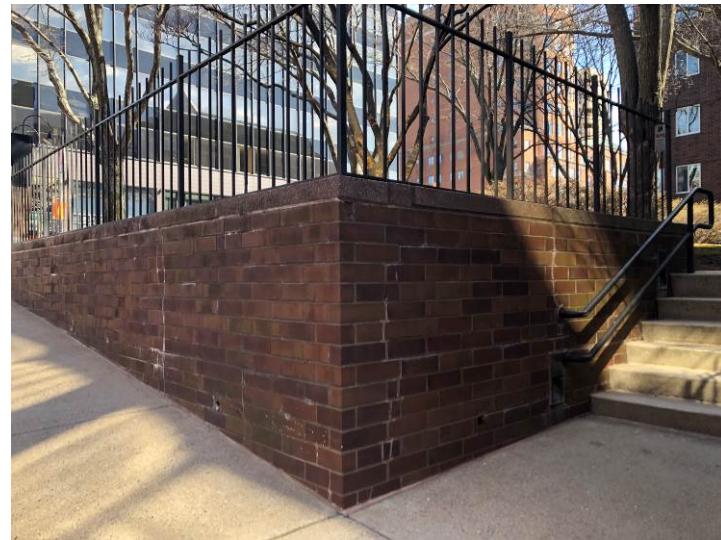
The Bay Street side of the front park has brick retaining walls and recently replaced concrete stairs.

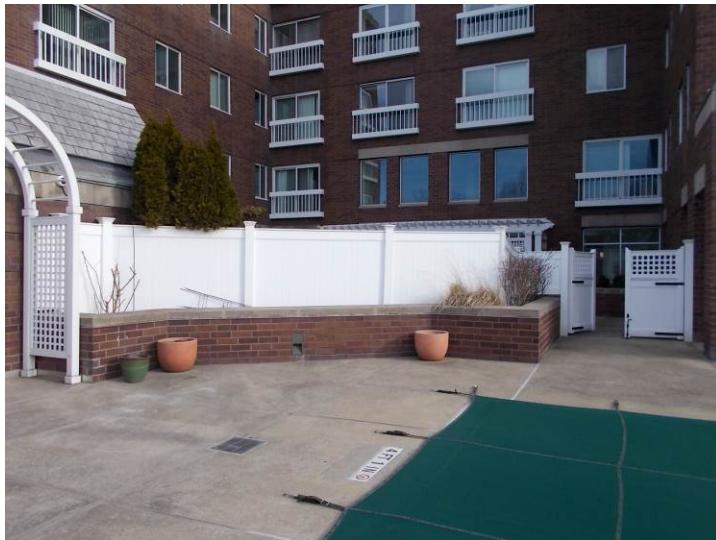
View of the Azek PVC fencing, arbor, and gate which were installed in 2012.

assessment. Replacement of the older PVC fencing is shown based on a twenty-five-year expected useful service life. Replacement of the newer courtyard fencing is not anticipated within the twenty-year timeframe of this plan.

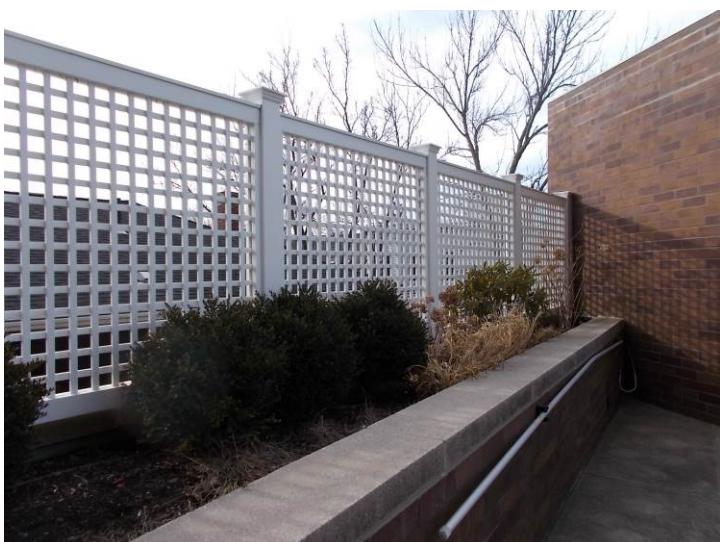
The PVC lattice fencing at the end of the pool was installed in 2017.

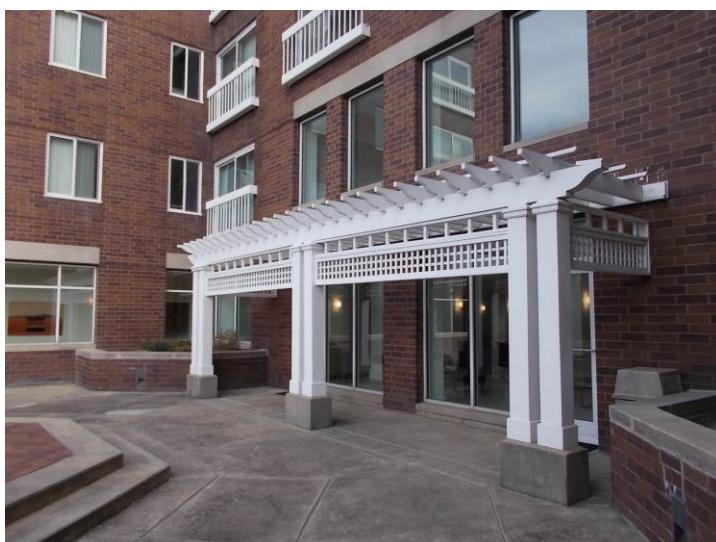
An Azek PVC framed pergola, installed in 2009, frames the rear lobby entrance.

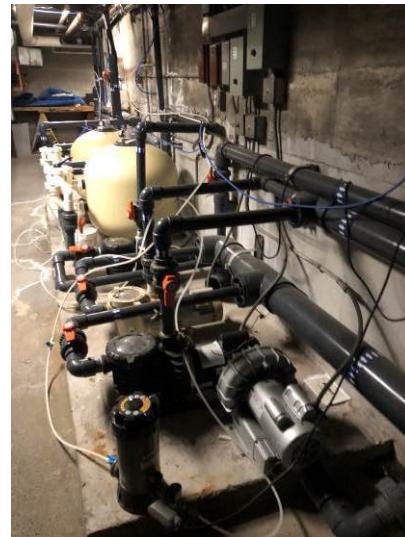
11. The pool/spa spring-anchored mesh safety cover was replaced in 2015. Future replacements are shown in Years 4 and 14.
12. No issues regarding the various pool mechanical equipment – sand filters, separators, chlorinators, pumps, etc. – were reported during the assessment, and periodic allowances for as-needed replacements and upgrades are shown every five years beginning in Year 1.

View of the various pool and spa mechanicals including sand filters, chlorinators, and pumps.

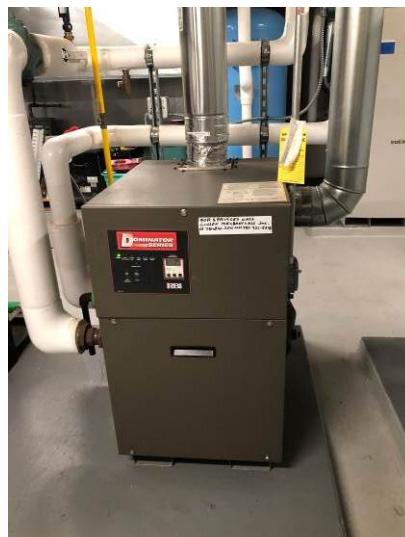
15. The heating boilers date to 2016 and are in good current condition with no operational problems reported during the course of the assessment. Replacement of the 1,500-MBH RBI Flexcore condensing boilers the smaller 300-MBH RBI, high-efficiency boiler is shown in Year 15, based on a 20-year expected useful service life. Costs shown reflect the actual 2016 costs increased for inflation.

The RBI Dominator 300-MBH boiler was installed in 2016 to produce hydronic heat for the boiler, storage, and generator rooms.

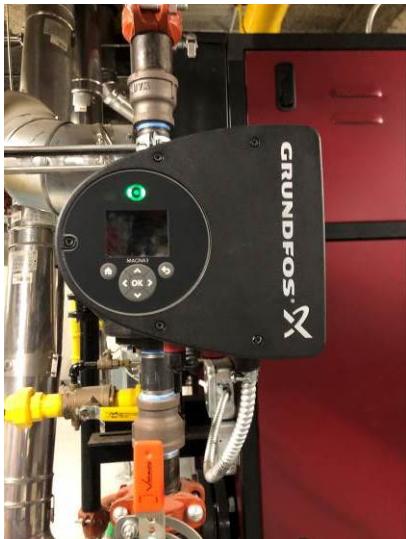
17. Boiler water is circulated through the system heat exchanger by Grundfos stainless steel circulation pumps. All pumps were installed with the boilers in 2016 and costs for replacement are shown in Year 15.

Grundfos Magna3 stainless steel circulator pumps circulate boiler water.

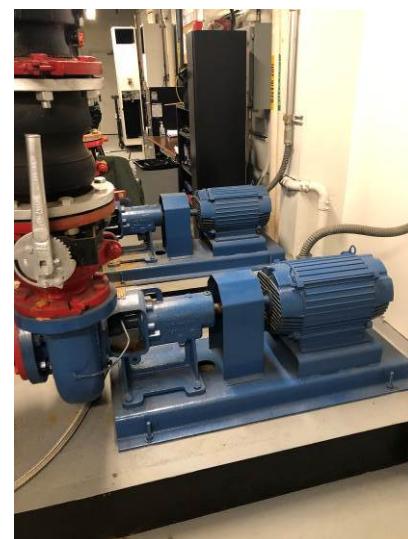
View of the 20-hp, base-mounted cooling tower loop circulating pumps.

19. The Teco service loop pump VFD's were newly installed in 2014. Replacement of these units is shown in Year 8, after fifteen years of use.
20. The cooling tower was newly installed in 2012 and remains in good observable condition with no reported operating issues. Future replacement is shown in Year 16, after twenty-five years of use. Rebuilding of the cooling tower loop pumps and motors are shown in Years 1, 8, and 16 of the plan.

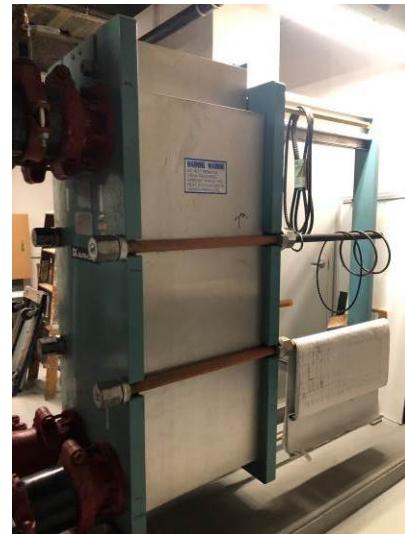
16. The Alfa-Laval plate and frame heat exchanger is periodically opened, inspected, cleaned, and all gaskets are checked and replaced as-needed. The heat exchanger is believed to be original equipment and management plans to replace in the near term. Replacement costs are shown in Year 1. Future preventative maintenance work is shown being funded as-needed from operating accounts.

View of the Alfa-Laval A15-BFG, 4600 sf, 150 PSI, plate and frame heat exchanger believed to be original to the construction of the building.

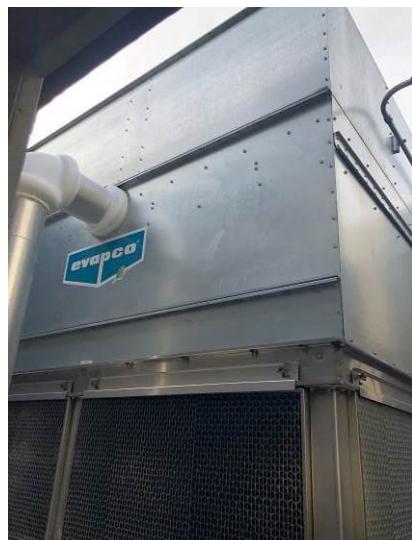
View of the Evapco AT-112-612, induced-draft, counterflow cooling tower located on the roof.

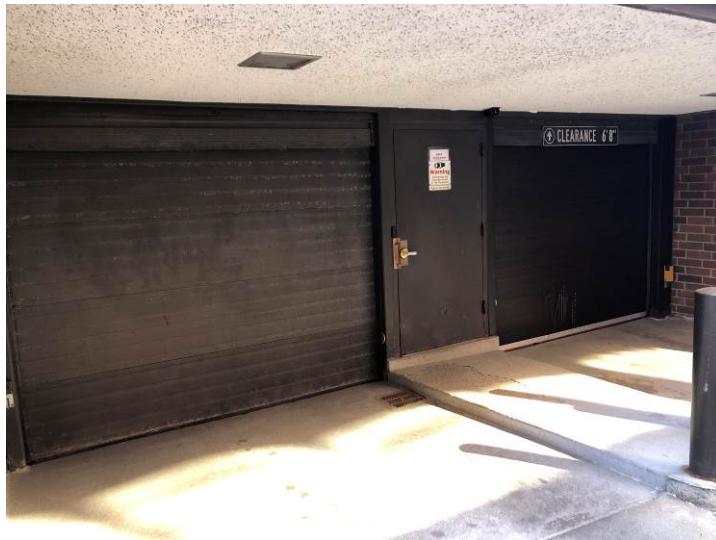
The upper and lower garage each have a pair of fiberglass segmented-panel overhead doors with power door operators.

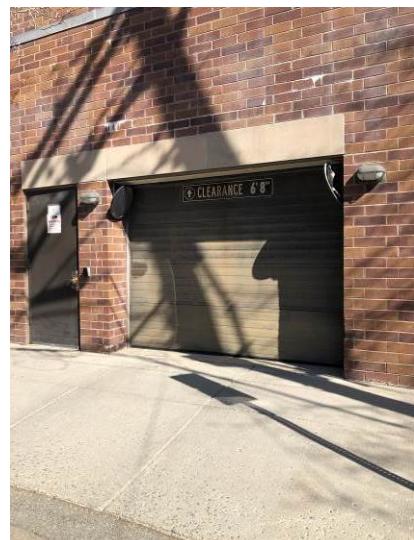
The townhouse garage has a single fiberglass overhead door; access is at the rear of the building

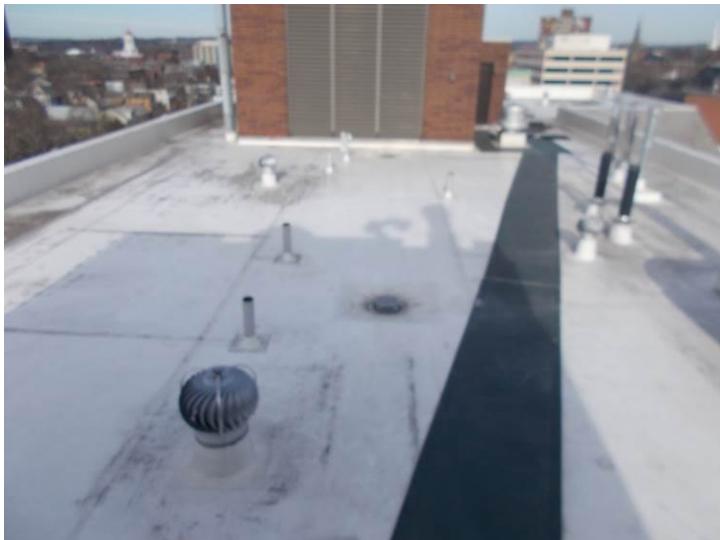
View of the Sarnafil PVC membrane roof installed in 2009.

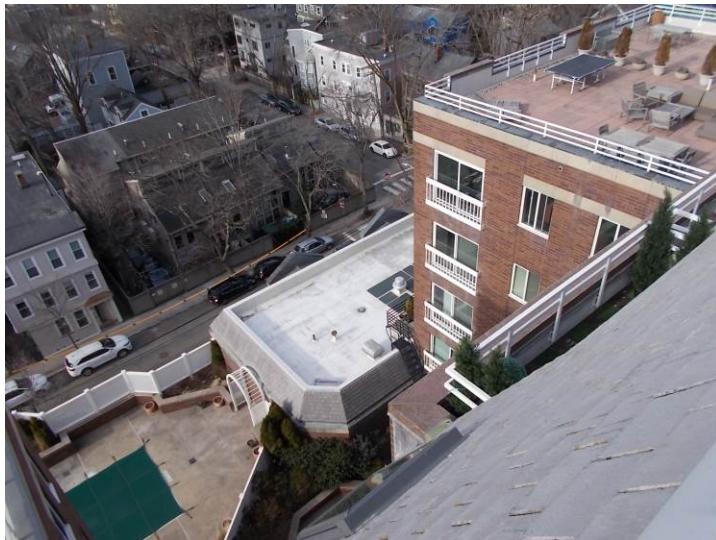
Adhered reflecting polyvinyl chloride (PVC) membrane on the 2nd floor roof installed in 2007.

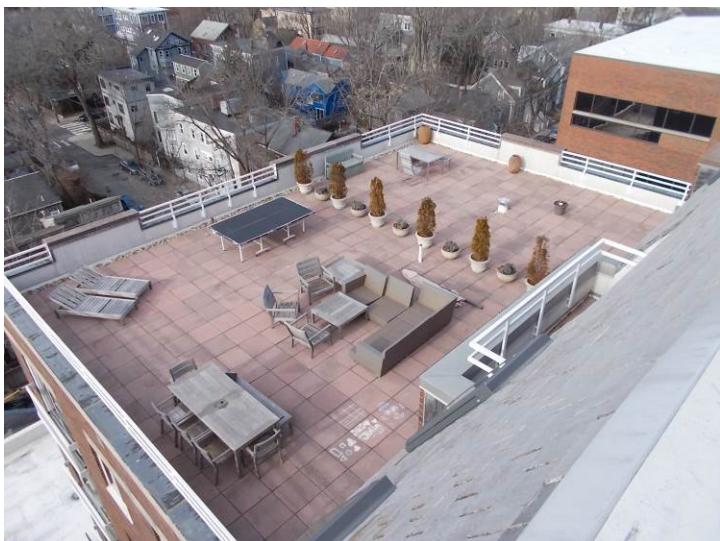
The southwest private terraces had new EPDM membrane installed in 2020 and the concrete pavers were reused/replaced.

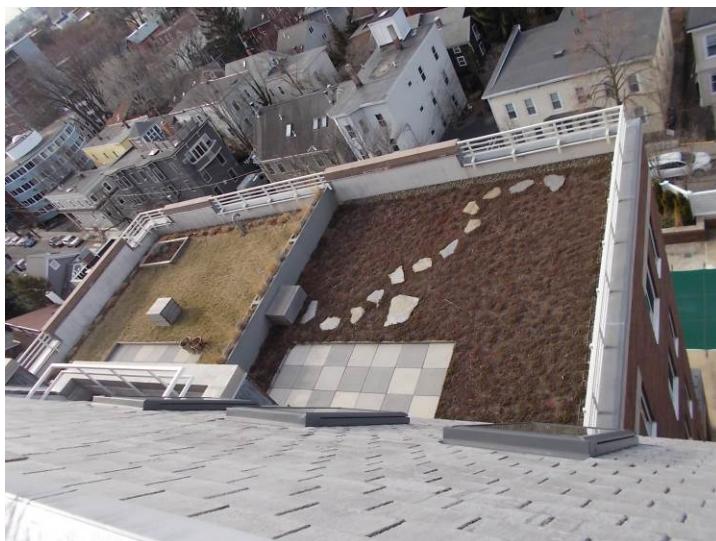
The 6<sup>th</sup> floor southeast private terrace roofs (green roofs) have membranes that are believed to date to 2005.

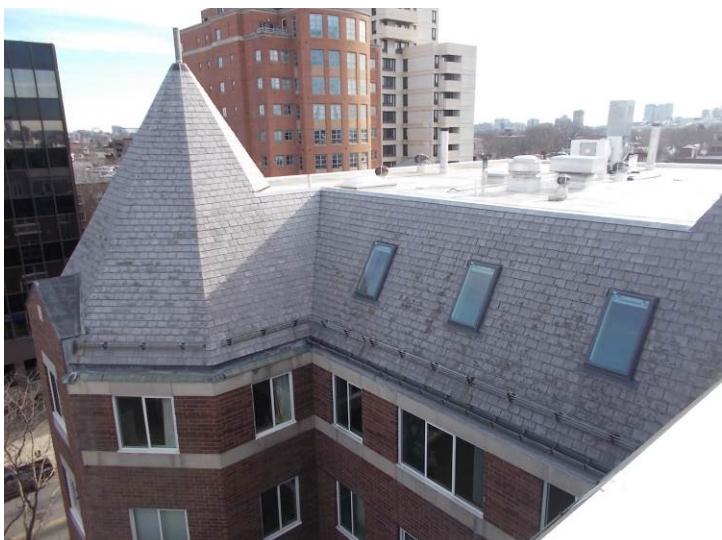
View of the fiber-cement faux-slate shingles on the mansard.

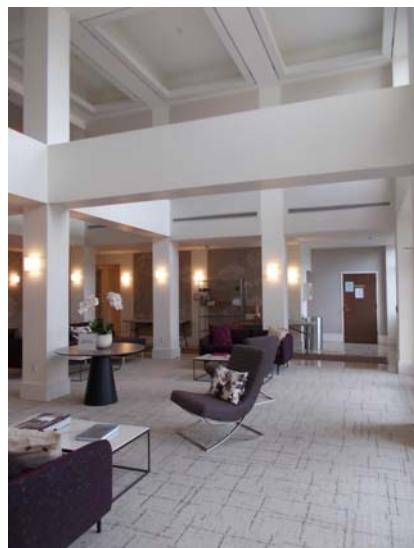
View of the two-story lobby recently refurbished in 2020.

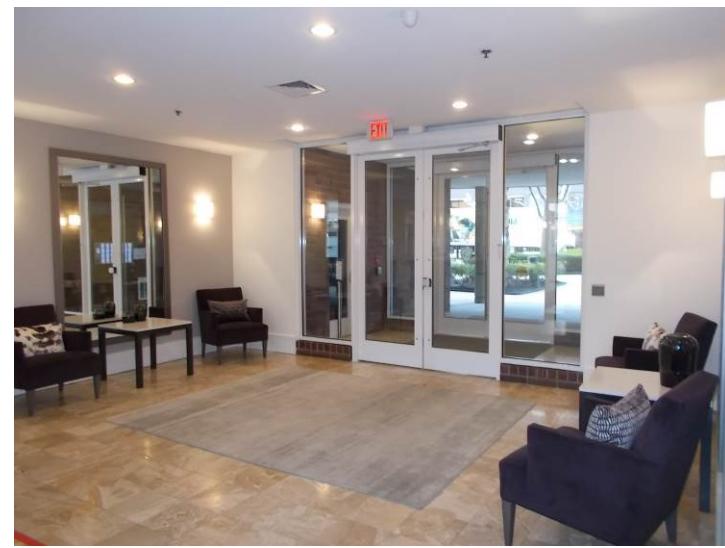
View of the new entry vestibule and entry doors installed in 2020.

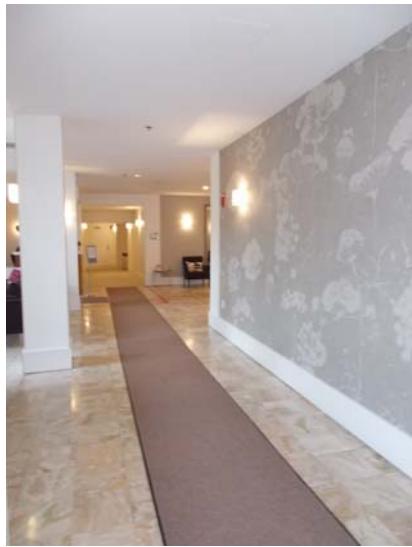
Alternate view of the entry lobby with fabric wall coverings.

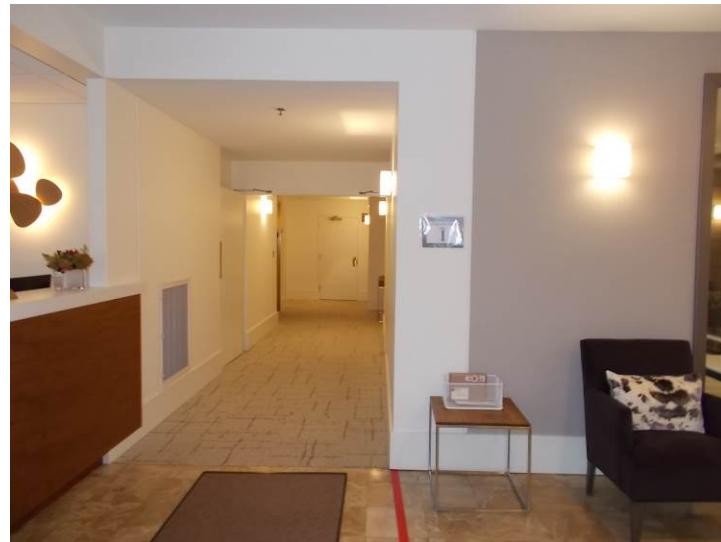
The concierge desk and carpeting were replaced with the lobby refurbishment.

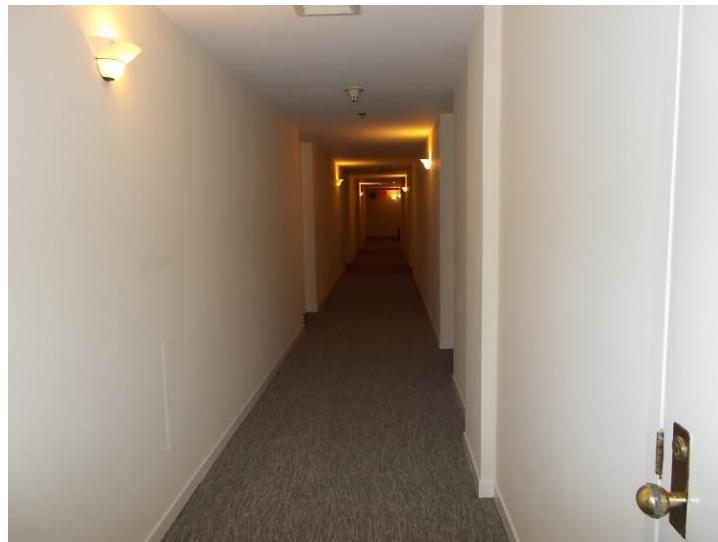
View of a typical common hallway. All halls were painted, and the carpeting was replaced in 2019. The frosted glass wall sconces are believed to be original.

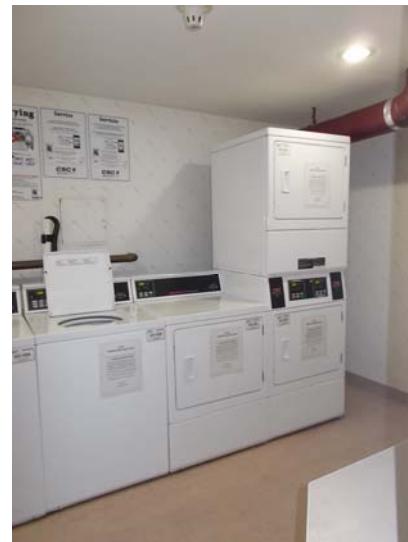
View of the typical laundry room with original wallpaper walls and vinyl composition floor tiles.

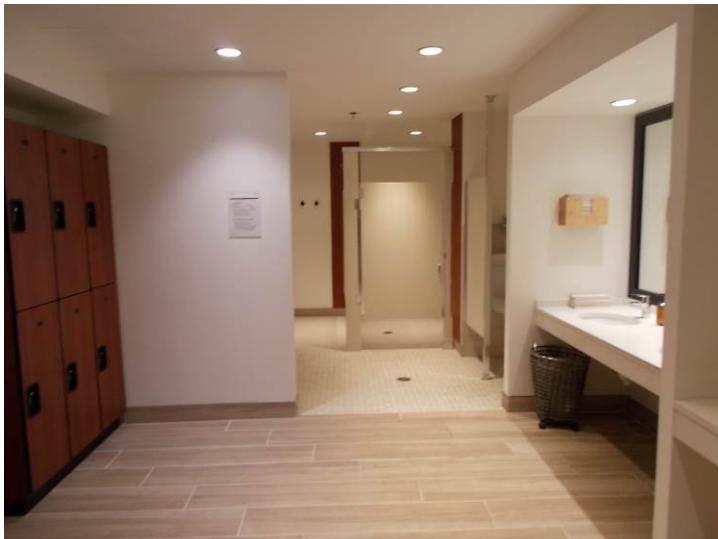
The locker rooms were refurbished in 2019.

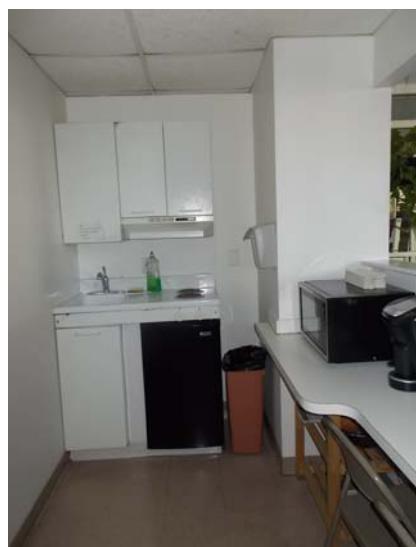
View of the employee kitchenette with original vinyl tile flooring and suspended acoustic tile ceiling.
